Studies on the Failure of Economizer Tubes Involving Acid Dew-Point Corrosion in High Pressure Boilers

Anees U. Malik, Saleh A. Al-Fozan, M. Mobin^{1*}
and Mohammad Al-Hajri

Saline Water Desalination Research Institute (SWDRI)
Saline Water Conversion Corporation (SWCC)
P.O.Box 8328, Al-Jubail, Saudi Arabia
Email:<rdc@swcc.gov.sa>

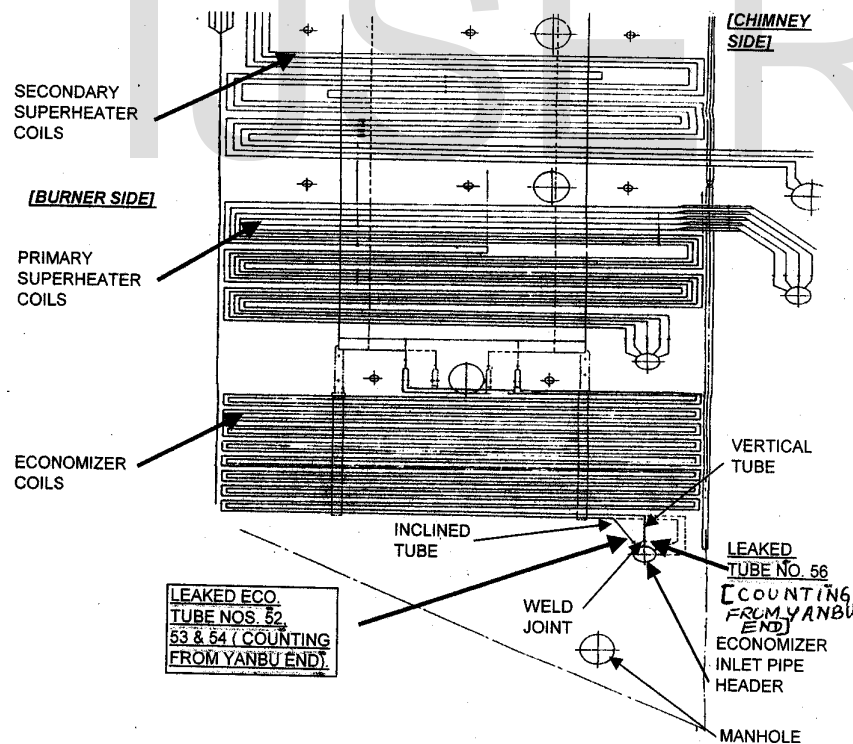
Leakages were reported in the economizer tubes in boiler #7 of SWCC dual purpose power/water plant. The plant had been in service for about 4 years after commissioning at the time of failure. Figure 1 shows a sketch of the boiler leaked economizer coils. Table 1 provides operating parameters of the economizer tubes.

Figure 1. Sketch of Boiler # 7 leaked economizer coils

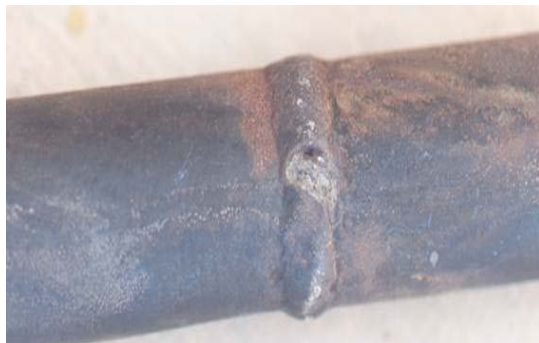
Physical examination of the economizer tube in as received condition shows that most of the corrosion activity was confined to weld or surrounding area. The front side (A) and back side (B) of the economizer tube have different morphologies. Side A (Fig. 2): corrosion products are concentrated at the weldment and the metal is eaten away at the weld. Side B (Fig. 3): it has macropits, pinholes and holes at and in the vicinity of weld. There is marked reduction in thickness of the tube wall in the vicinity of the weld. Figure 4 shows wall thickness at different locations of the tube at side B. Figure 5 shows thinning of the tube wall of economizer tube.

Figure 2. Photograph of economizer tube showing frontal view (Side A)

1. At the front side (A) of the economizer tube corrosion products rich in S are accumulated in the encaved (depressed area) as a result of intense corrosion brought about by corrosive liquid (H_2SO_4). The latter which was presumably formed by the condensation of SO_2 and water vapor at the temperature below the dew-point of the acid. Dew-point of H_2SO_4 ranges from 120 to 150°C for SO_3 concentrate of 15 to 30 ppm. The presence of V_2O_5 in the gas might have promoted the conversion of SO_2 into SO_3 .

1. The main cause of leakage in economizer tubes appears to be dew-point corrosion which occurred as a result of operation of the economizer at temperatures near or below the dew-point of the sulfuric acid. Therefore, maintaining the temperature of the economizer much above the dew-point is the most plausible solution to prevent condensation of acid.
2. Temperature monitoring of the economizer can be helpful in operating the economizer above the dew-point.

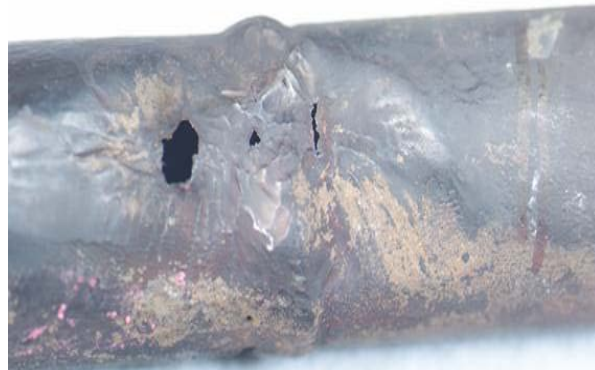
Figure3. Photograph of economizer tube showing backside view (Side B)

2. The backside (B) appeared to be more corroded and has pits and holes with thinning of tube wall. Here again, the flue gas temperature dropped down and approached to dew-point resulting in condensation of H_2SO_4 on the metal surface. The design and location of the economizer tube and V and S content of the flue gas, appear to play an important role in more severe attack at the back side. The attack at this location is presumably more severe due to the fluxing reaction between vanadium oxide and iron sulfate. This resulted in pitting, hole formation and wall thinning at reaction sites.

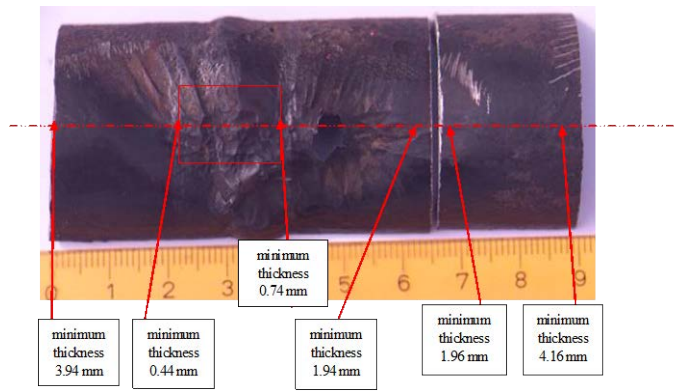
Figure 4. Photograph showing wall thickness at different locations of the tube (Side B)

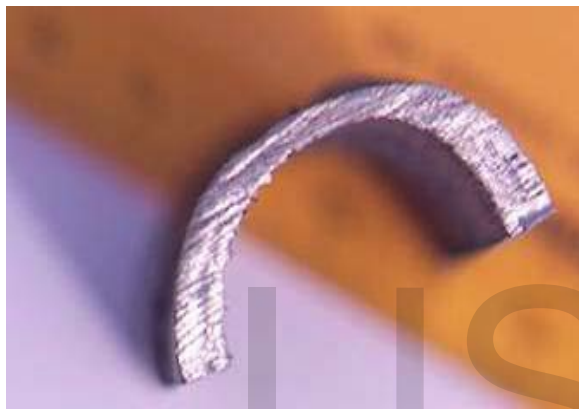
Figure 5. Photograph showing thinning of the tube wall of the economizer tube (side B)

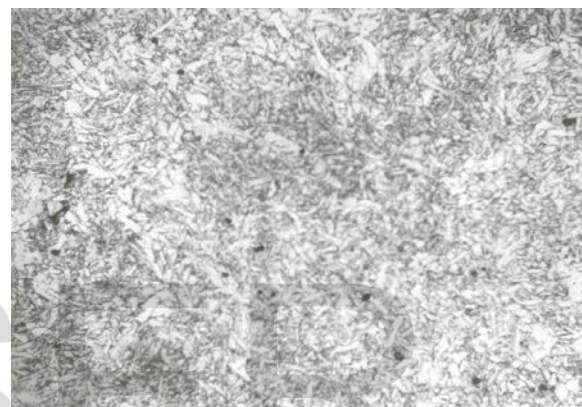
The microstructure of the cross-section of economizer tube show tempered martensitic structure at the weld (Fig. 6).

Figure 6. Photomicrograph of a cross-section of economizer tube at the weld 200 X

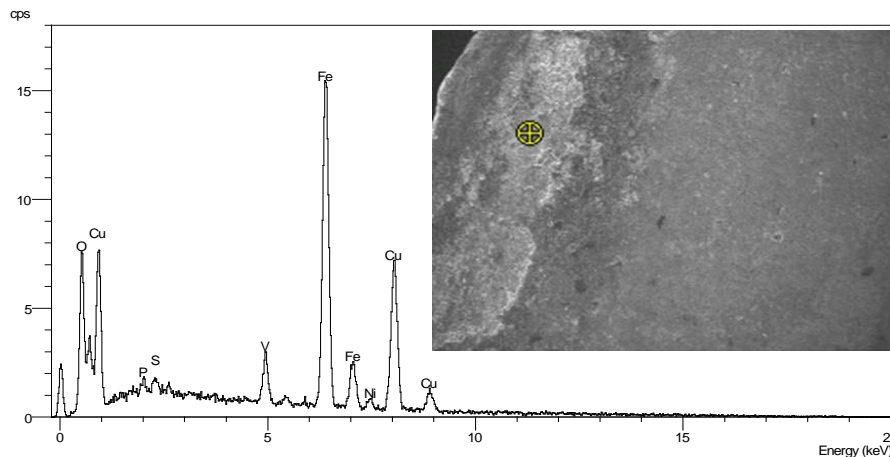
Figure 7. EDX profile of the corrosion products deposited on the pitting area (side B) of economizer tube

The sources of V and S are from condensed flue gas. Cu and P are from water leaked through hole.

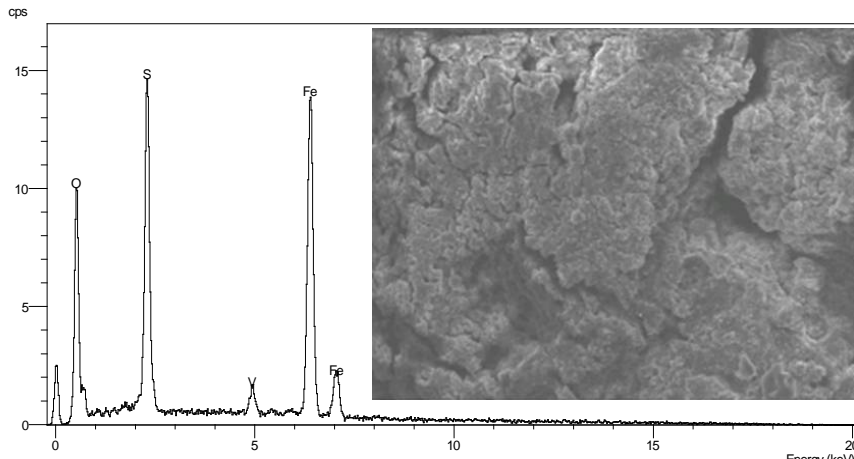
Figure 8. EDX profile of the corrosion products collected from the weld (side A) – outside surface

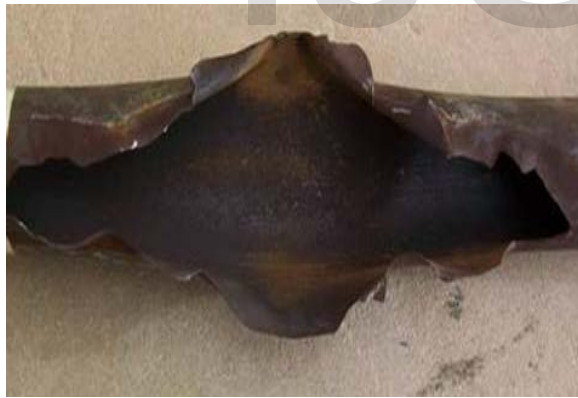
Tripping of boiler in a SWCC power plant occurred as a result of economizer tubes failures. A huge rupture was noticed as revealed by nearly fish-mouthed full opening (Fig. 9). Figure 10 shows back view of the ruptured area of the economizer tube. Figure 11 shows thinning of the cross-section of the tube. The total length of the tube was 145 cm and the length of ruptured portion was 0.28 cm. Due to rupture, the tube reduced its original thickness by 0.25 to 2.00 mm.

Figure 9. Photograph showing economizer tube in as received condition

1. An increase in the economizer feed inlet temperature will help in reducing the severity of cold end corrosion.
2. Sulfur content should be reduced to minimum which can be helpful in combating the acid dew-point corrosion.
3. A powerful and efficient soot blowing system can reduce the possibility of acid dew-point corrosion effectively.

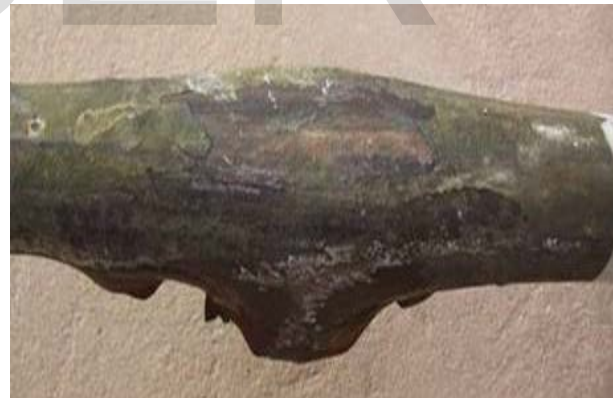
Figure 10. Photograph showing back view of the ruptured area of economizer tube and greenish deposits

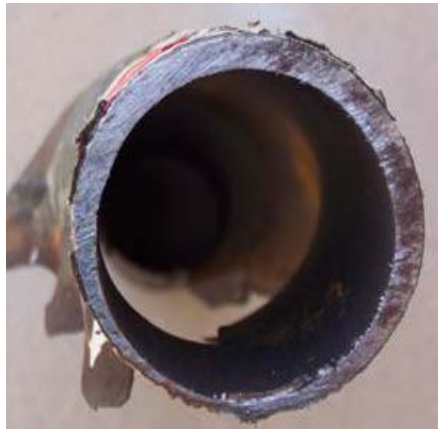
Figure 11. Photograph of the cross-section of the showing thinning of the tube

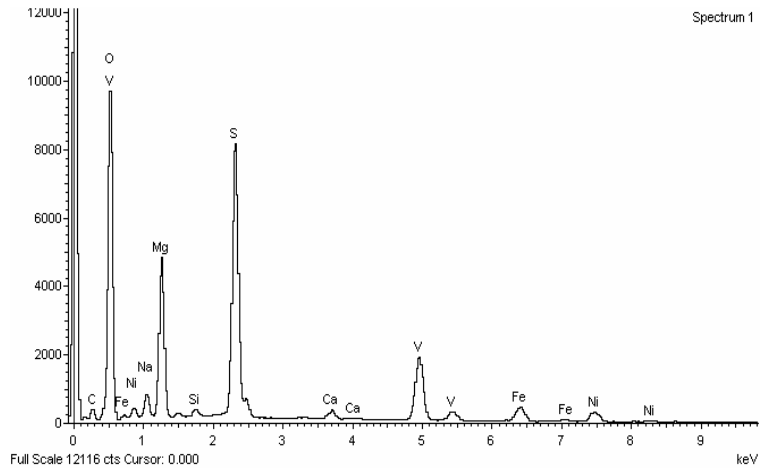
Figure 12 shows EDX profile of the external (fire side) deposits. The profile shows the presence of S, V and Mg in substantial concentration. The source of S and V appears to be the heavy oil (fuel) which is usually rich in these elements. Na, Ni, Fe and C are present in very small concentrations.

Figure 12. EDX profile of the deposits showing presence of S and V

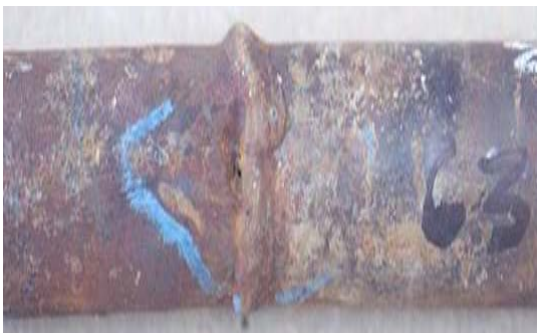
- Tube A: Approx 10 mm hole below the weld point
- Tube B: Approx 10 mm holes above and below the weld joint.

Figures 13 and 14 show closer view of the economizer tube samples A and B, respectively, in as received condition. The tubes show holes due to corrosion particularly close to weld joints. There is a marked thinning of the wall tube at and near the corrosion sites (holes). The corrosion appears to be from out side (fire side) to inside (water side) surface. This is further evident by the measurement of internal and external diameters.

Figure 13. Photograph of the economizer tube A in as received condition showing (closer view)

1. It is advised to avoid the operation of boiler while the connected turbine is out of service.
2. In case, if the boiler is required to be operated while the turbine is down, the feed water temperature should be raised to above the dew-point.
3. It is recommended to decrease the sulfur content in the fuel gases in order to decrease the sulfuric acid dew-point temperature.

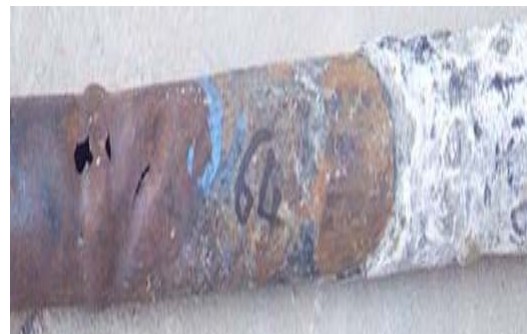
Figure 14. Photograph of the economizer tube B in as received condition showing (closer view)

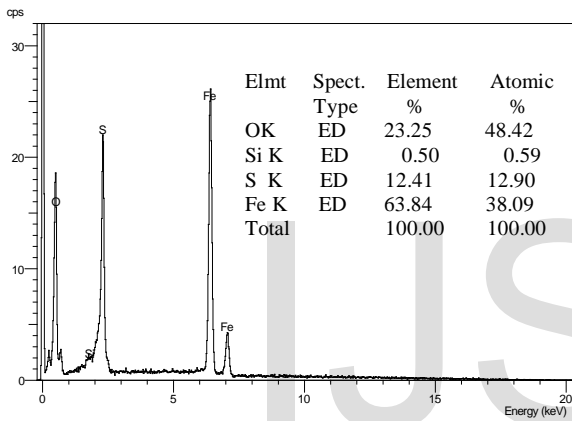
<i>Location</i>	<i>Figure</i>	<i>Elemental Distribution</i>	<i>Source</i>
Scale deposits formed on the outer side (fire side) of the economizer tubes A and B	15	Relatively rich in S (12.4%); Fe (predominant)	Flue gas
Hole (in the weld on the steam and fire sides)	16	Al, Si, Ni, Si, P and S in very low concentration. Iron and iron-oxide in high concentration	Economizer tube

Figure 15. EDX profile of the deposits on external surface of economizer tube A, elemental analysis data are also shown

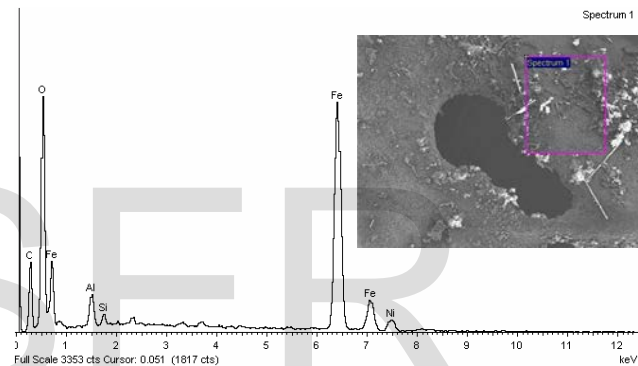
Figure 16. EDX profile of a location (+Spectrum 1) away from the hole in the weld on the steam side of the economizer tube B
