# Assessing on the Geotechnical Problems Which Causes for the Road Failure from Gilgel Beles to Bahir Dar Road Segment

Habtamu Washe Mite<sup>1</sup>, Maschal Tilahun Zenebe<sup>2</sup>,

<sup>1</sup> Department of Civil Engineering, College of Engineering, Assosa University, Assosa, Ethiopia

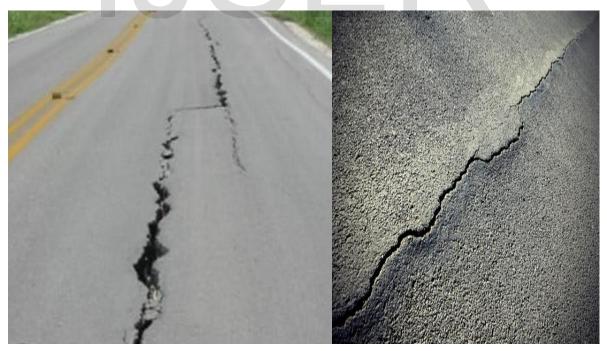
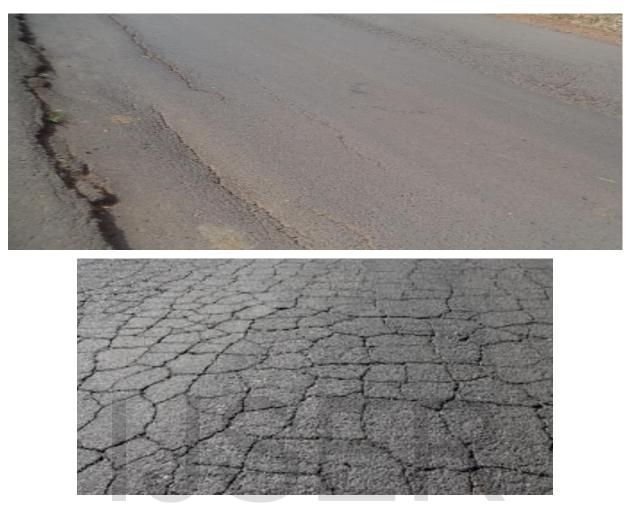
Figure 2: Expansive soil problems that causes the road failure - Cracks on the road

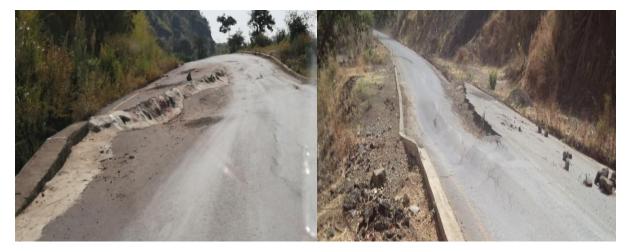
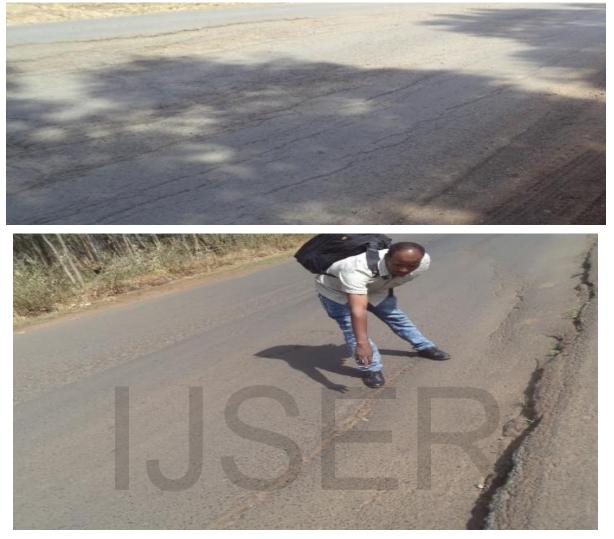
Chagni – Mandura Road Section

(Injibara – Bahirdar Road Section)

Figure 3: compressibility of soil/settlement problem

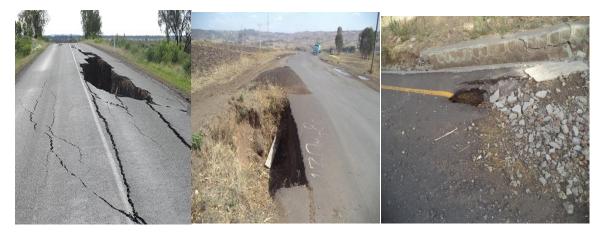
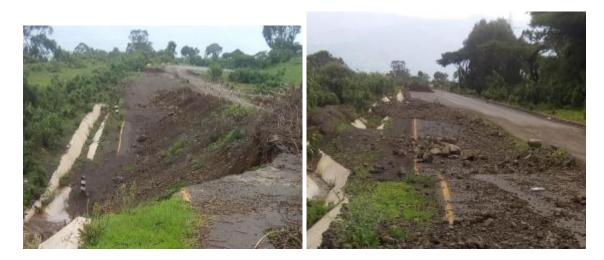
Figure 4: Sinkhole failure of the road due to scouring of water in the road segments

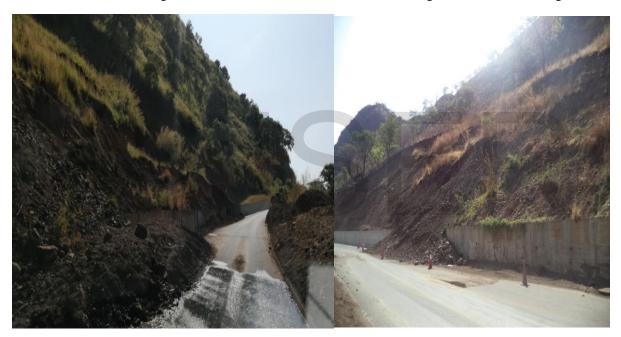
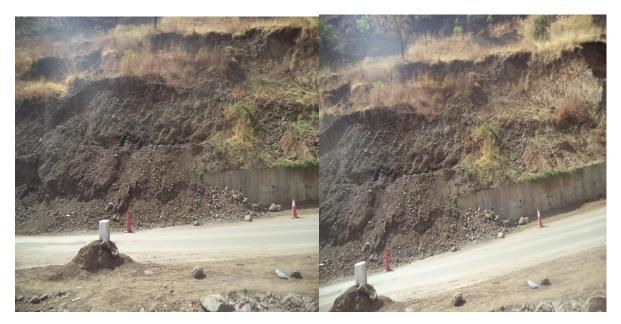
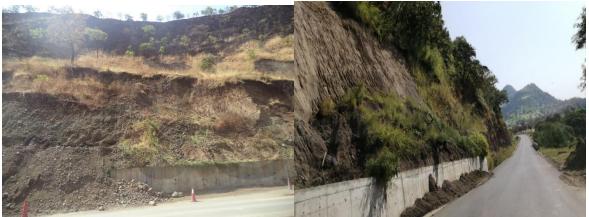
Figure 5: soil slope instability problems (Chagni – Mandura Road Section)

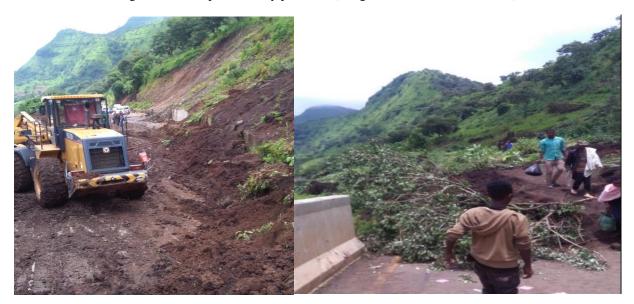
Figure 6: Slope failure(landslide) in the road segments (in Kar Mountain site)

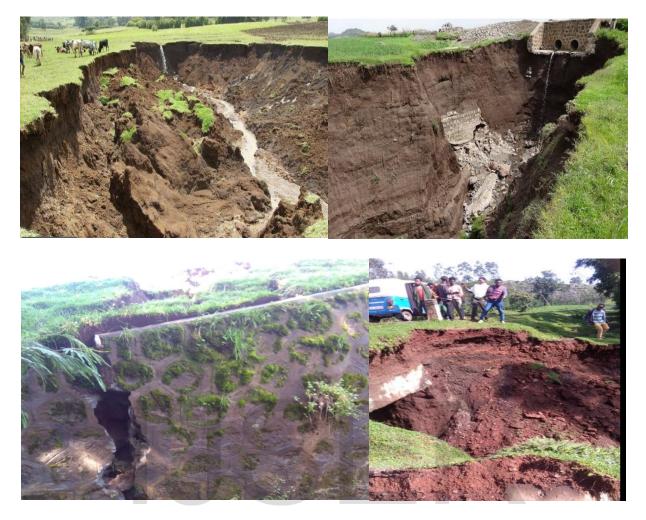
Figure 7: Drainage Problems (Road failure due to scouring of water) (Injibar – Dangila road section)

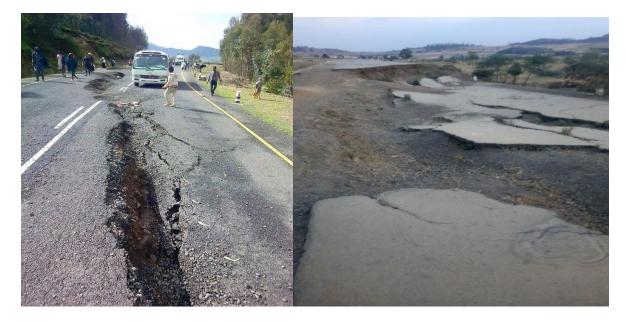
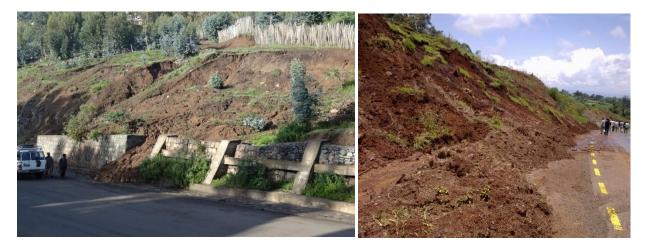
Figure 8: Sliding of Silty clay soil within constructed structure in the study road segment

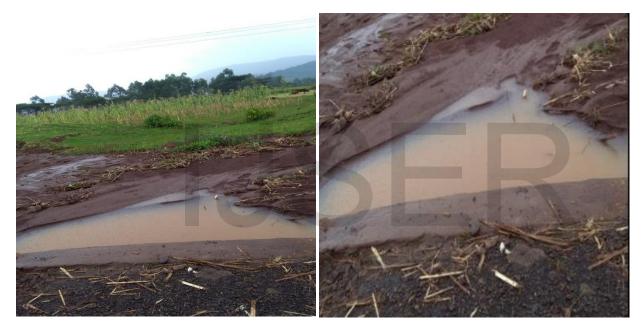
Figure 9: Sedimentation problems

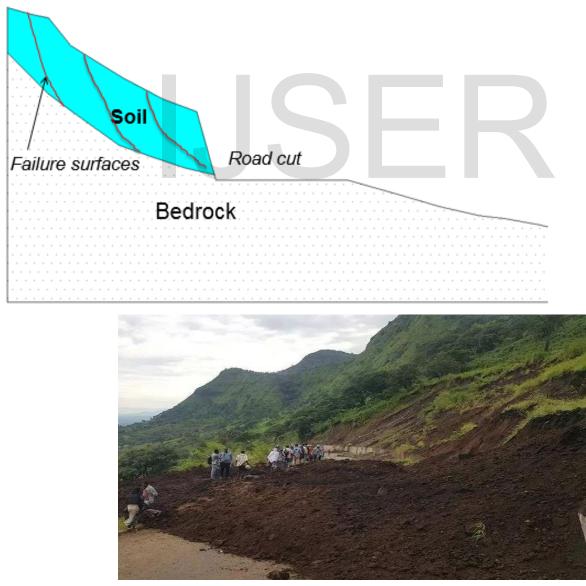
- ✓ The cases of the failure were removal of support due to road excavation has initiated instability of the upslope.
- ✓ The remedial measures are provision of proper retaining structure coupled with drainage systems (surface and sub-surface) and modification of slope geometry (removing material from the area driving the landslide and reducing general slope angle) is the solution.

Figure 11: Model 1- road failures due to instability of slope presentation diagram and images

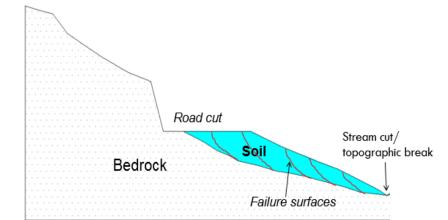
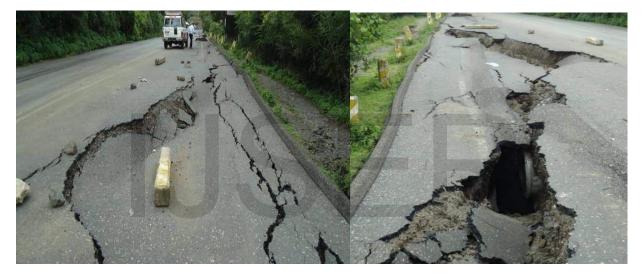
Figure 12: Model 2- road failures due to instability of slope presentation diagram and images

The causes of the road failure were additional load (due to road construction) on a slope which was already unstable or on marginally stable state is initiating instability of slopes

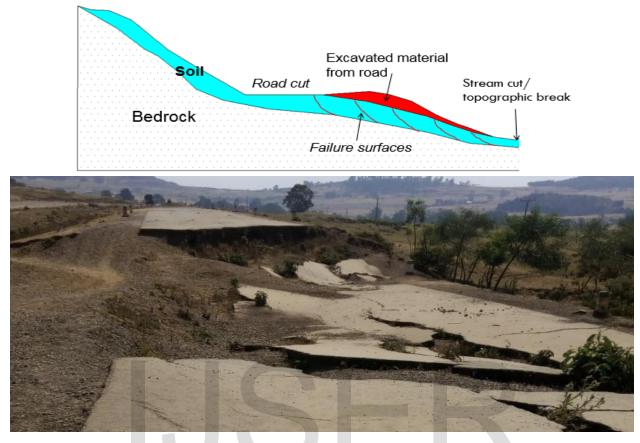
Figure 13: Model 3- road failures due to instability of slope presentation diagram

The causes of the road failure were placing excavated material from roads on marginally stable slopes or on unstable slopes is initiating instability of slopes.

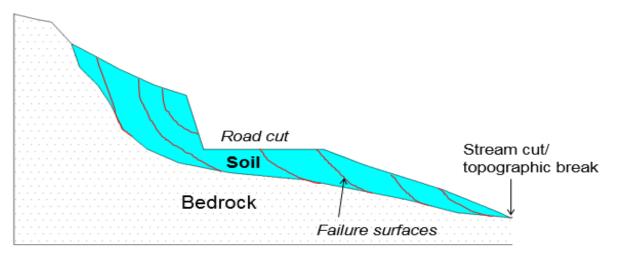
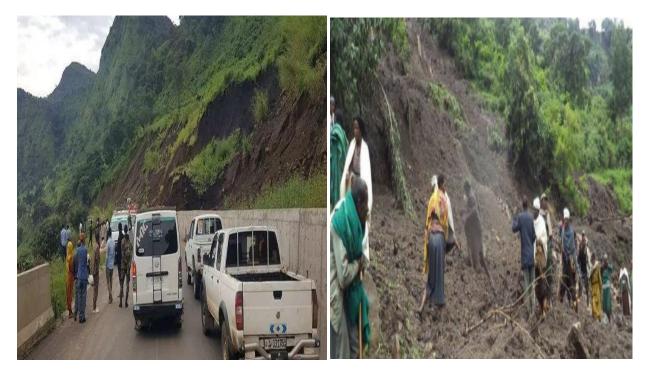
Figure 14 : Model 4- road failures due to instability of slope presentation diagram & images

The causes of the road failure were excavation and placement of additional load on already unstable slope or on marginally stable slope is initiating instability of slopes.
