FAILURE INVESTIGATION OF STEAM BOILER TUBE IN PETROLEUM REFINERY

ABSTRACT

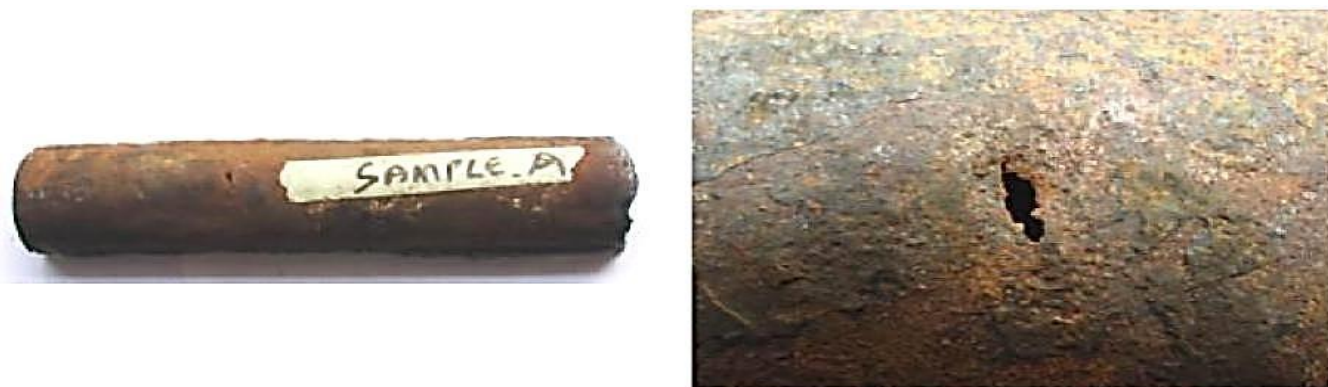
Figure 2: Tube Sample-A obtained from Furnace side for Investigation

In figure 2, the close-up view at the puncture location on the tube OD surface. The puncture contours are elongated in transverse direction and they are uneven. Thinning appears to have taken place at the contours. Surrounding areas is having corrosion patches that have peeled off intermittently.

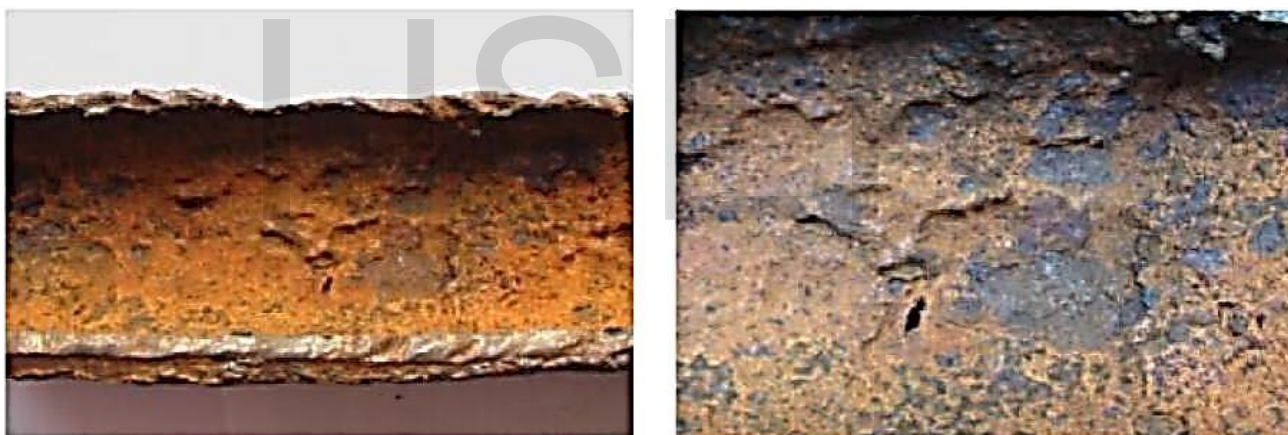
Figure 3: The ID Surface views Showing Thick Crusts of Corrosion Scale

In figure 3 the ID surface views shows thick crusts of corrosion scale. It seems to be porous and the metalwastage is observed having deep and coarse craters.

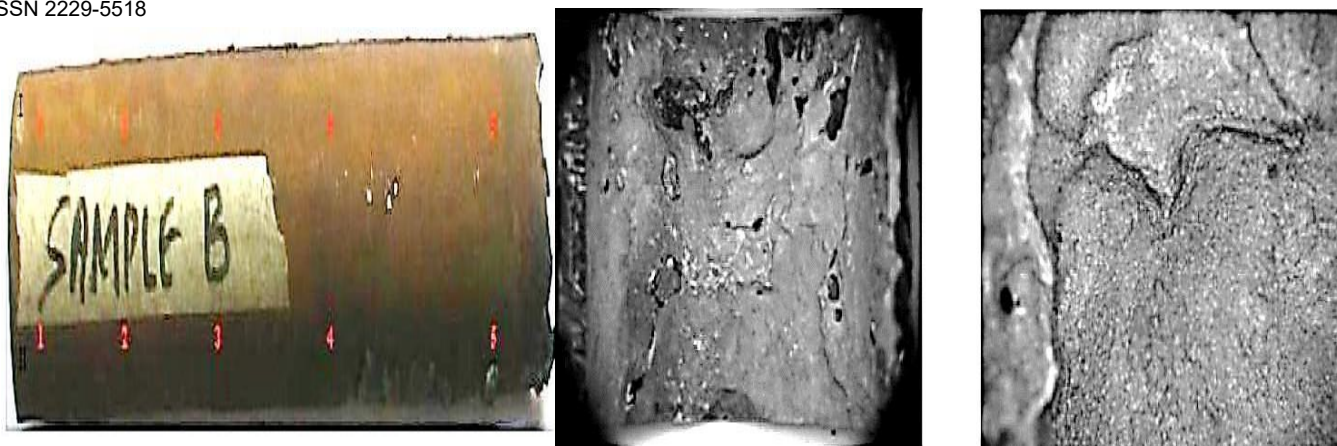
Figure 4: The ID Surface View of the Sample-B Showing Thin Layer of Corrosion Scale

In figure 4, it shows the tube sample-B obtained from tank bank side for investigation which is without any conspicuous puncture. The ID surface view of the sample-B show thin layer of corrosion scale which had peeled off at several places unlike Sample-A with thick layer of corrosion oxides.

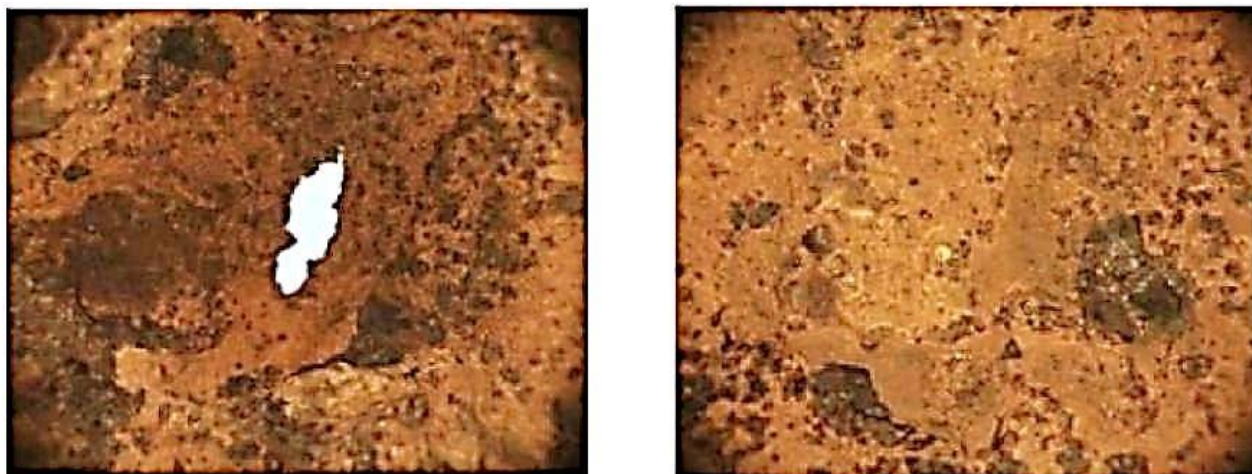
Figure 5: Tube Sample-A ID View in as Received Condition 4X

In figure 5, the low magnification view at puncture location at inner surface. Thinning is observed at puncture contours. Adjacent surrounding area is having fairly thick layer of scale which is porous. At a distances away from the puncture; thick layer of corrosion scale has peeled off at several places. Also the low magnification view on ID surface which is heavily corroded having fairly thick layer of porous corrosion scale which appears to be partly adherent.

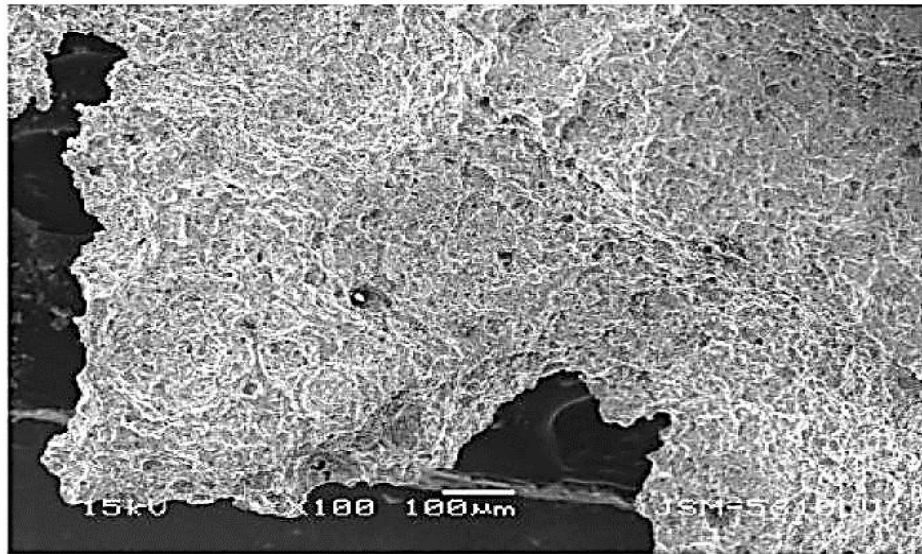
Figure 7: Tube Sample-A with low magnification view at the puncture contours which displays thinning by way of corrosion attack. Micro level corrosion attack is observed.

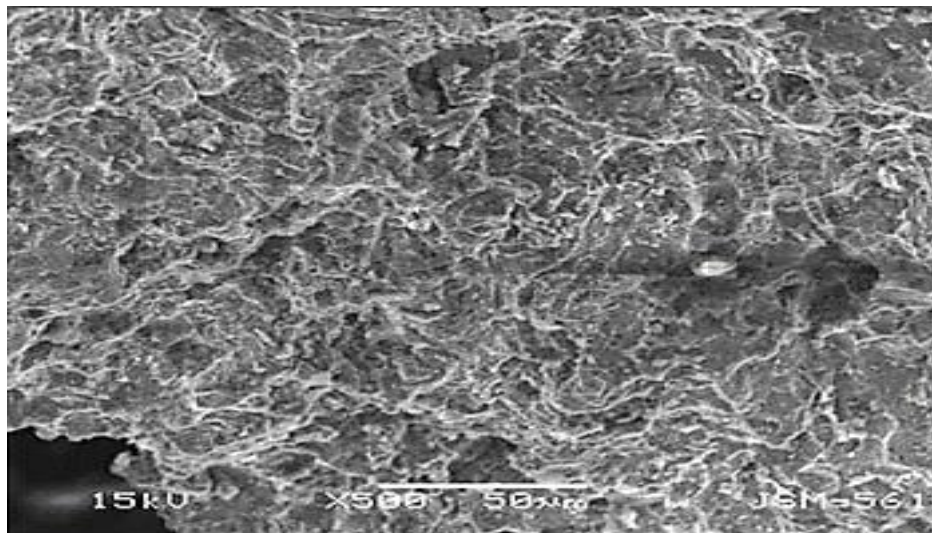
Figure 8: Tube Sample-A with 500X magnification view at the puncture highlights corrosion attack leading to metal removal at micro level and pitting.

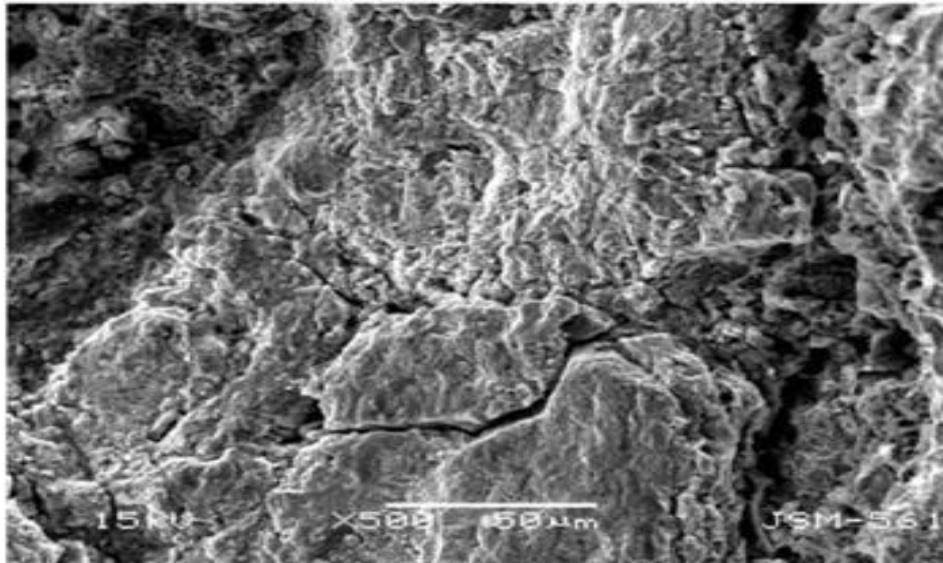
Figure 9: Tube Sample-A with 500X magnification view at the puncture also revealing incipient tendency for stress corrosion cracking.

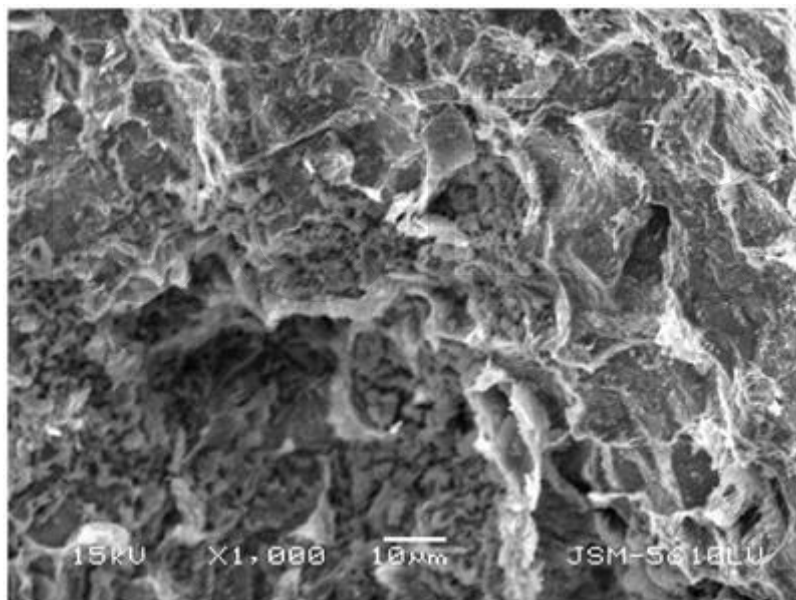
Figure 10: Tube Sample-A with 1000X magnification view near the puncture revealing micro pit filled with oxidescale formation on corroded surface.

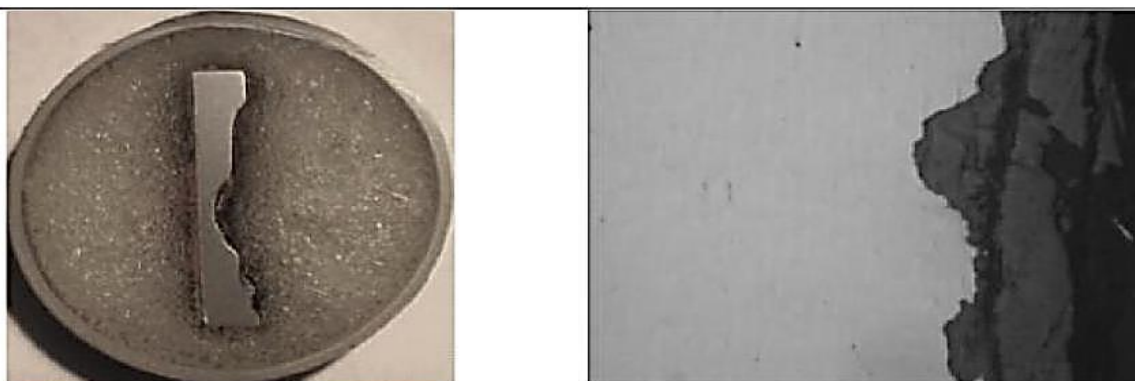
Figure 13: Tube Sample-A specimen in a mounted condition with observed thinning of ID due to pitting like corrosion damage. The unetched view at ID showing corrosion damage with scaling indicating the gouging nature of corrosion damage.

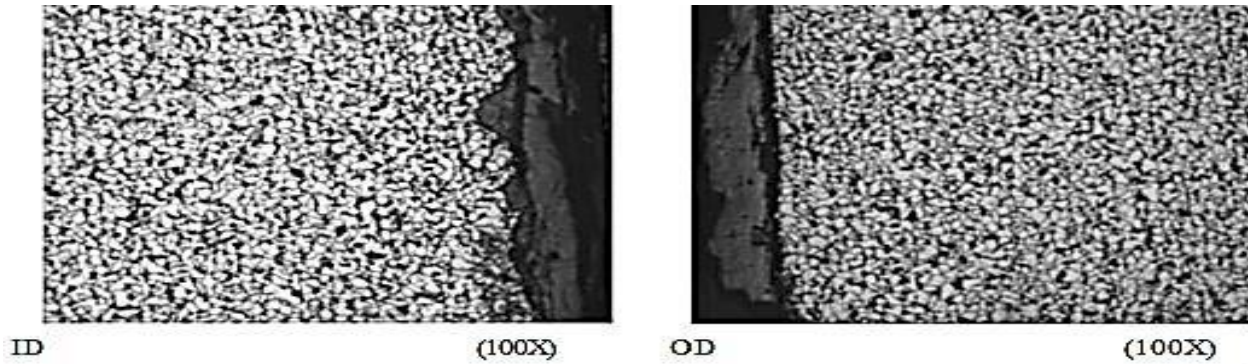
Figure 14: The etched view of ID surface showing pitting corrosion at the edge with matrix of fine ferrite and pearlite. The OD microstructure also showed fine ferrite and pearlite but no indication of pitting corrosion

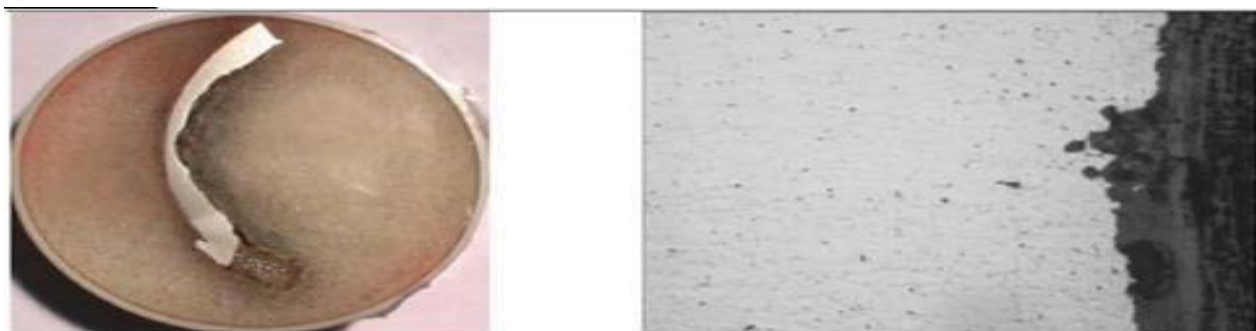
Figure 16: The specimen viewed in a mounted condition showing ID damage by thinning. Also unetched view indicated signs of corrosion and scaling.

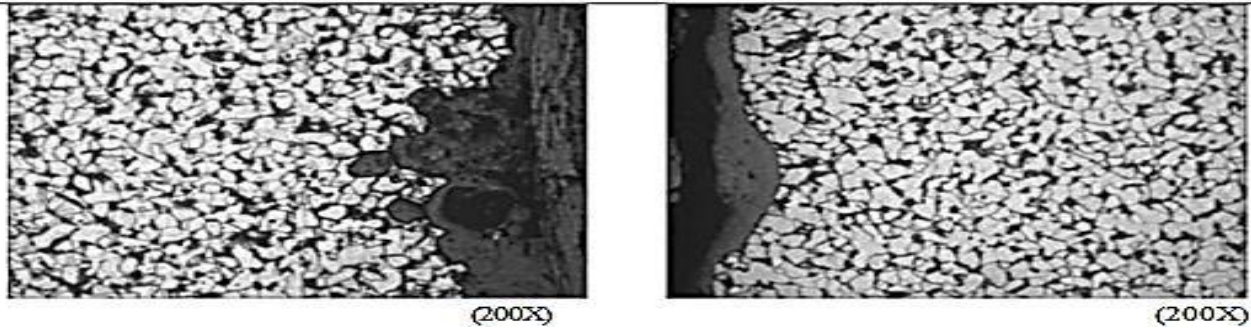
Figure 17: The etched views of OD & ID surfaces showing corrosion damage at the ID edges with signs of micropitting corrosion. The microstructure is fine grained ferrite and pearlite structure.

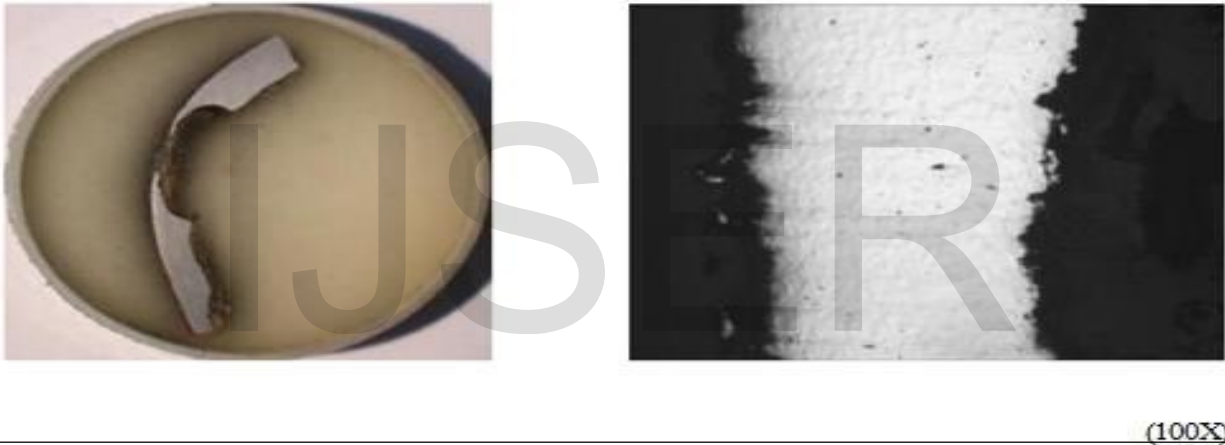
Figure 18: The specimen viewed in as mounted condition showing coarse gouging from ID that eventually led to the puncture.

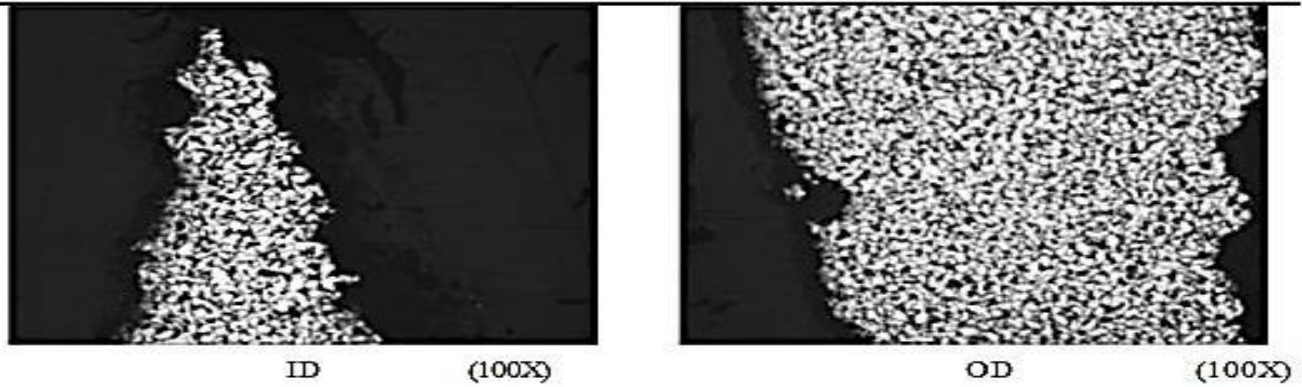
Figure 18: The etched views of OD & ID surfaces showing corrosion damage initiated from either side at the tip of puncture. The microstructure is fine grained ferrite and pearlite structure.

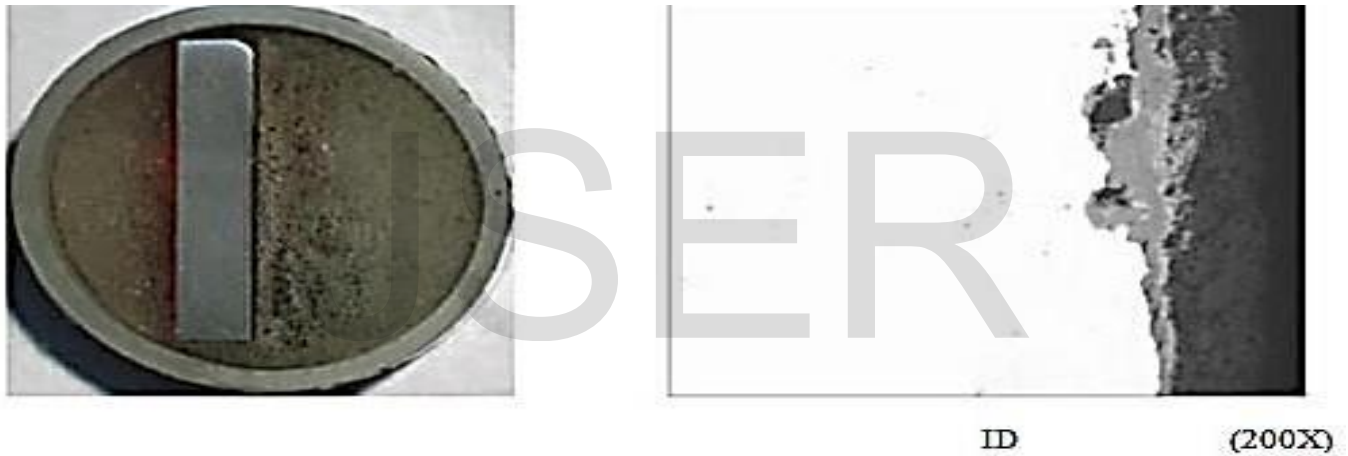
Figure 19: The specimen viewed in as mounted condition showing no significant corrosion damage at both the at ID and OD surfaces. The unetched view at ID showing marginal corrosion damage at the edge.

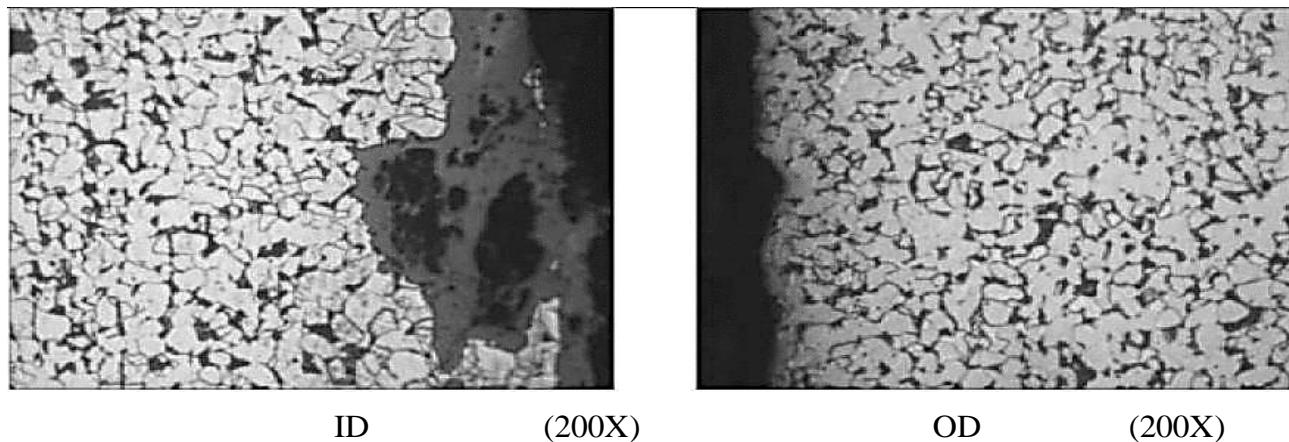
Figure 20: The ID microstructure of ferrite & pearlite with slight banding having marginal corrosion damage. The OD microstructure of ferrite and pearlite without significant any corrosion damage at the edges.
