Hydrogeological Issues Associate with Hydropower Tunnels through Hard Rock Terrain: An Experience from Sri Lanka

E. P. S. Pathirana, H. A. Dharmagunawardhane

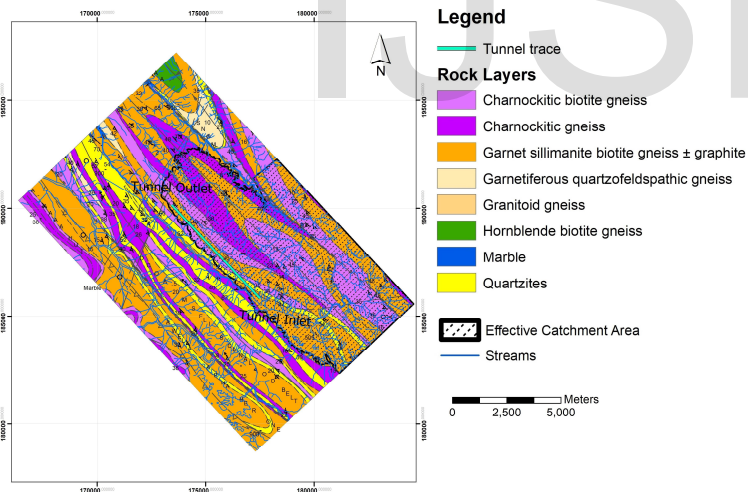
Fig 02: Effective catchment area of the Castlereagh tunnel

The Castlereagh tunnel (Figure 02) runs through different crystalline rock types such as, Garnet sillimanite biotite gneiss, Charnockitic biotite gneiss and Quartzite. 30% of tunnel length passes through sound Charnockitic biotite gneiss and rest in other rock types. Highly weathered Kaolinize zone was observed in small part close to the tunnel inlet. The tunnel runs nearly parallel to the general strike trend of the rocks. There is a fault zone present in the area close to the tunnel inlet. Highly fractured quartzite beds are present in a small part of the tunnel near the inlet. Rock layers found in the tunnel area shows variable strike and dip directions. Mostly, shear zones and strike of the rocks are parallel or nearly parallel. During the excavation of the tunnel, unexpectedly a highly weathered and sheared kaolinized zone was observed which 160 m in length. The most problematic part was between 270 m to 400 m, along the hillside near the tunnel inlet. Enormous and unmeasurable amount of water leaked into the tunnel in this zone. New springs also encountered, and it was feared that collapsing of tunnel or even possibility of draining the Castlereagh reservoir could take place. Because of this problem, additional geological and geotechnical investigations had to be carried out to further investigate surface and subsurface conditions. This problem made one-year delay for the project and

additional cost. As a solution, the tunnel was lined by concrete. Highly weathered part of the tunnel was stabilized by using reinforced concrete, steel ribs and rock bolts. The effective catchment area of the tunnel was estimated as 57.1 km². The south-west side of the catchment area is small, but north-east side of the catchment area is large. Most of the catchment area is a hilly terrain.

Effective catchment area consists of rocks such as Garnet sillimanite biotite gneiss, Charnockitic biotite gneiss, Quartzite, Charnockitic gneiss and Garnetiferous quartzofeldspathic gneiss. Most of the tunnel length is passing through sound rocks. But small portion, close to the tunnel inlet, rock is highly weathered and kaolinized. Also, quartzite bed is highly fractured. These secondary porosities are interconnected, and the rock as a whole has a good permeability. These features of the area create a weak zone which can leak water into the tunnel. Considerable water leakage was found through weak zones connected to the Castlereaugh lake with the tunnel.

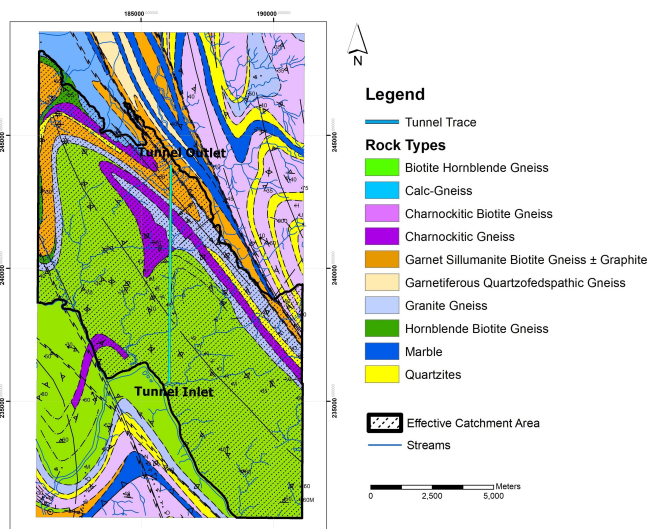
Fig 03: Effective catchment area of the Polgolla tunnel

The Polgolla tunnel (Figure 03) is passing through different rock layers, mainly Garnet sillimanite biotite gneiss, Charnockitic gneiss, Biotite hornblende gneiss and Granitic gneiss. Also, Biotite gneiss, Marble, Quartzite are present in lesser amounts. 60% of the tunnel passes through biotite hornblende gneiss. The tunnel runs parallel and nearly parallel to the general strike trends. There are three deep shears or fault zones present in longitudinal profile of the tunnel. The shear zone three runs along the axial plane of a synform and above the tunnel trace, small rift runs along a ridge. While excavation of the tunnel, water ingressed into the tunnel at 7800m length. This becomes a beginning of series of problems, which brought enormous volume of sand, silt, and rock debris into the tunnel. These disturbances delayed the construction of tunnel. The problem was solved by placing a reinforced concrete lining, grouting, rock support bolts and construction in drainage holes of this problematic section. 73% of the length of the tunnel was stable and is unlined while only 27% of the length has been lined with reinforced concrete. Although the tunnel was stabilized after the tunnel after its construction. But fallen rocks were found during after inspection within the tunnel. These rock falls mainly had taken place because of erosion in unlined section due to flowing water. But there is no any significant water leakage into the tunnel or from the tunnel, reported after the construction of the tunnel.

The effective catchment area of the tunnel is estimated as 127.8 km³. The area in general is geomorphologically flat. The effective catchment area is large. The tunnel is 8.0 km long and runs through different kind of rocks and structures. The effective catchment area contains Garnet sillimanite biotite gneiss, Charnockitic gneiss, Biotite hornblende gneiss, Granitic gneiss, Marble and Quartzite. About 70% of the tunnel passes through Biotite hornblende gneiss and the rock is sound and contains less weak zones. There are no any hydrogeological problems reported in this 70% but remaining part of the tunnel is problematic. The main reasons for the problems are related to the

geological structures crossed by the tunnel. Problems occurred due to the weak segments which created by deep shear zones. Also, some of these zones are found to be situated along the axial plane of the synform and antiform which running through the tunnel forming weak zones. While the tunnel excavated across these weak zones, water ingressed into the tunnel.

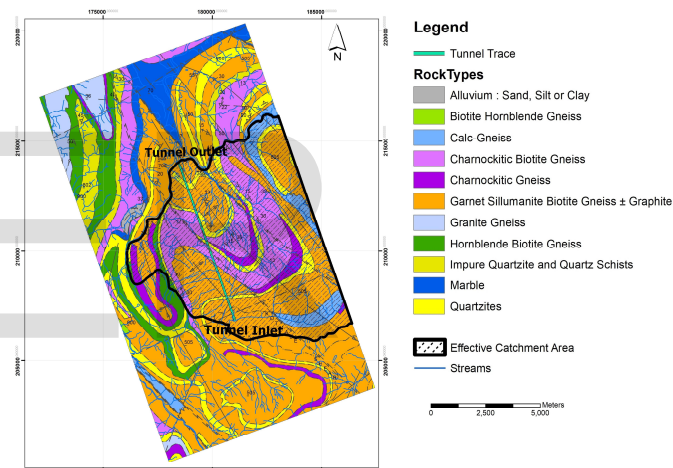
Fig 04: Effective catchment area of the Kothmale tunnel

The entire length of the Kothmale hydropower tunnel (Figure 04) passes through slightly weathered and very strong rocks. However, the intake area and small section of the tunnel has weak rock. The tunnel crosses a quartzite band in the chainage between 3800 and 4100m. The major rocks encountered here are Garnet sillimanite biotite gneiss, Charnockitic biotite gneiss and Quartzite. Tunnel runs nearly parallel to the direction of the strike. Folding, fracturing and foliation shear zones are the major geological structures encountered in the area of the tunnel. The tunnel crosses and surrounded by synforms and anti-forms. Prominent fracture systems found in the catchment area are mainly, foliation joints and shear zones parallel to lineaments. The tunnel passes through two major lineaments, namely Ela fault and Ganga lineament which appear as narrow shear zones. Major foliation shears with slickensided surface are present at a considerable distance of the tunnel.

Only a few problems were encountered during the excavation of the tunnel. When the tunnel was passing through weathered rocks, especially in shear / fracture zones water ingressed into the tunnel at the chainages of 2750 and 5100. Attitudes of foliation changes occur around chainage 5100, only a limited amount of water ingressed into the tunnel in this region. In order to overcome this problem, steel arch supports were used in the area crossing the lineament. Other weak zones were treated by shotcrete to consolidate the rock, steel ribs, cavities filled with concrete, rock bolts and control blasting.

The effective catchment area of the Kothmale tunnel is 62.6 km² which contains Garnet sillimanite biotite gneiss, Quartzite, Charnockitic biotite gneiss, Calc-gneiss, Charnockitic gneiss and Hornblende biotite gneiss. The tunnel is 7 km in length therefore the tunnel crosses many structures. At the central part of the tunnel crosses the Kothmale shear zone and "Ganga lineament". These structures are weak zones and responsible for the hydrogeological problems encountered during the construction period of the tunnel. There are some interconnected joints, fractures and "Ela fault" found in Garnet sillimanite biotite gneiss rock, which situated in the tunnel intake area, and these structures favors water inflow into the tunnel.

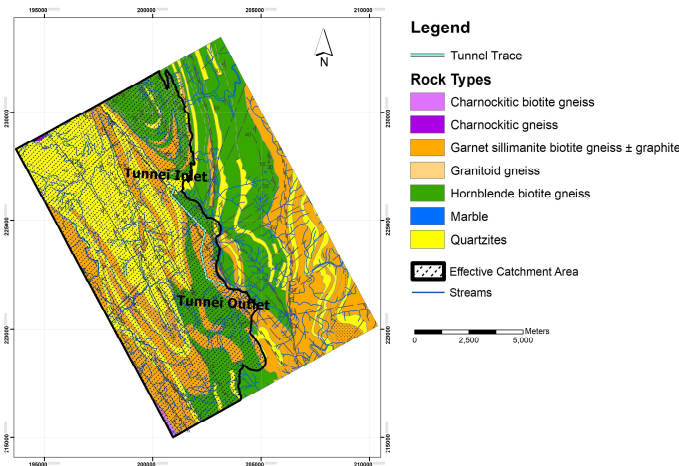
Fig 05: Effective catchment area of the Victoria tunnel

The Victoria tunnel (Figure 05) is passing through different rocks such as Hornblende biotite gneiss, Garnet sillimanite biotite gneiss and Quartzite. Downstream area of the tunnel close to the surge shaft is very close to a mega lineament. Also fractured rock layers present with over turned folds. The tunnel crosses through the Victoria shear zone. During the excavation of the tunnel, there was a heavy seepage and caving of

roof at the downstream part of the tunnel. Due to this problematic situation tunnel path and location of surge shaft were change into new locations. Field studies suggested that there is a possibility for adverse tunnel conditions in new tunnel path too. These problems were confirmed during excavation of tunnel although the new path of tunnel did not have critical conditions as before. Fissure grouting method was used to stabilize the zone of excavation and cement grout also injected. The whole tunnel was lined to solve the problems.

The effective catchment area of the tunnel is 105.1 km² consisting mainly garnet sillimanite biotite gneiss, hornblende biotite gneiss and quartzite rocks. The first part of the tunnel excavation, the tunnel was crossing some major shear zones and lineaments. In addition, some highly fractured quartzite rock bands were also crossed. These geological structural features created some weaker zones in the tunnel which initiate huge water leakages into the tunnel.

After some re-examinations, the tunnel path was rearranged to evade identified weak zones created by geological structural features and to reduce the risk kind of water leakage in to the tunnel. As expected, the new tunnel path was excavated through sound rock which contained less weak zones and therefore, only limited number of hydrogeological problems throughout the new tunnel path was encountered.
