Study of IQS & Improvement in Harvester Combine IQS Score by TQM Approach: A Case Study of Harvester Combine SWARAJ – 8100 Model

Harish C. Tiwari, Sarabjot S. Mann

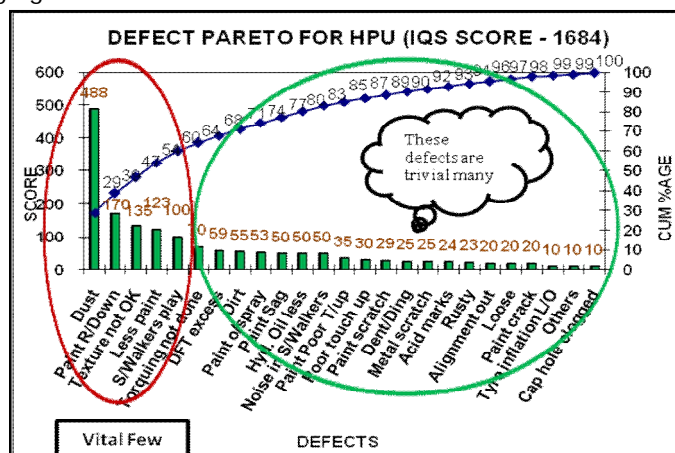
Fig. 6 Defect Pareto for HPU

Inference: Top five HPU defects were Dust (Score-488, 29%), Paint rundown (Score -147, 10%), Texture not ok (Score – 135, 8%), Less paint (Score – 123, 7%) and Straw walkers play

(Score – 100, 6%). These five defects cover 60% score of total HPU defects and selected for further analysis.

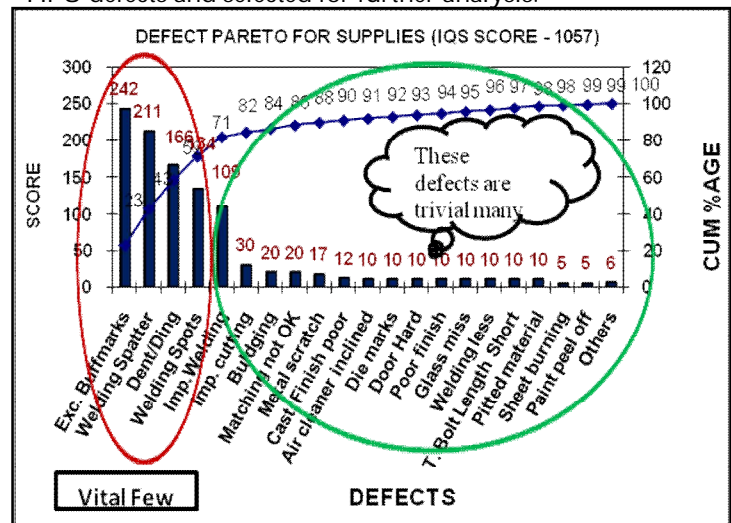
Fig. 7 Defect Pareto for Supplies

Inference: Top four Supplies defects were Excessive buff marks (Score – 242, 23%), welding spatters (Score – 211, 20%), dents/ding (Score – 166, 16%) and welding spots (Score – 134, 12%), These five defects cover 71% score of total Supplies defects and selected for further analysis.

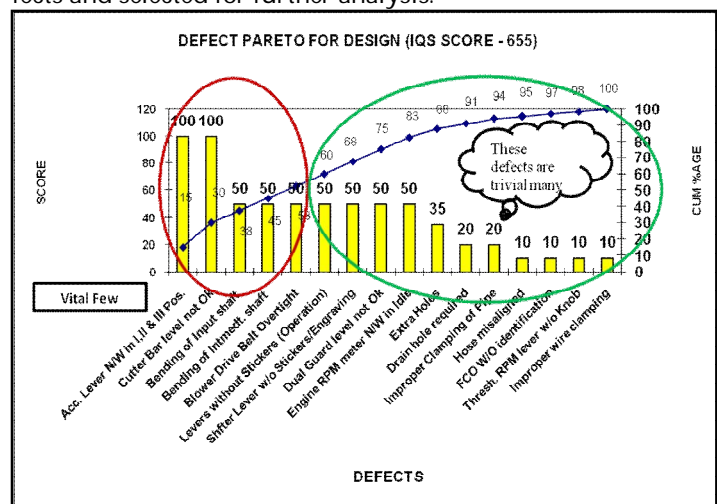
Fig. 8 Defect Pareto for Design

Inference: Top five Design defects were Accelerator lever not working in I, II & III position (Score – 100, 15%), cutter bar level not ok (Score – 100, 15%), bending of input shaft (Score – 50, 8%), bending of intermediate shaft (Score – 50, 7%) and blower shaft over tight (Score – 50, 7%).

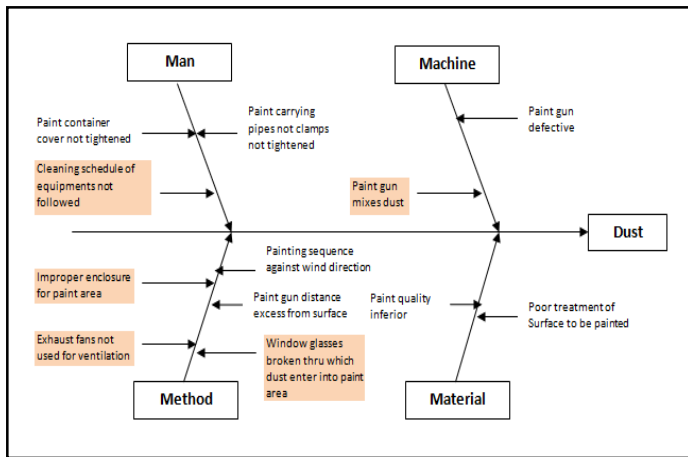
Fig. 9 Cause & Effect diagram – Dust (HPU)

Inference: Paint gun mixes dust, improper enclosure of paint area, exhaust fans for ventilation not working, window glasses broken through which dust entered into paint area & cleaning schedule of paint equipments not implemented & followed were valid causes for Dust in paint.

I. Dust defect reduced from 488 to 442 score having 9.5% improvement. Dust defect didn't improve much, in spite of all possible solutions due to incomplete enclosure of paint area. Dust was entering above the fiber partition where as in a paint booth, if provided, there is a controlled atmosphere.

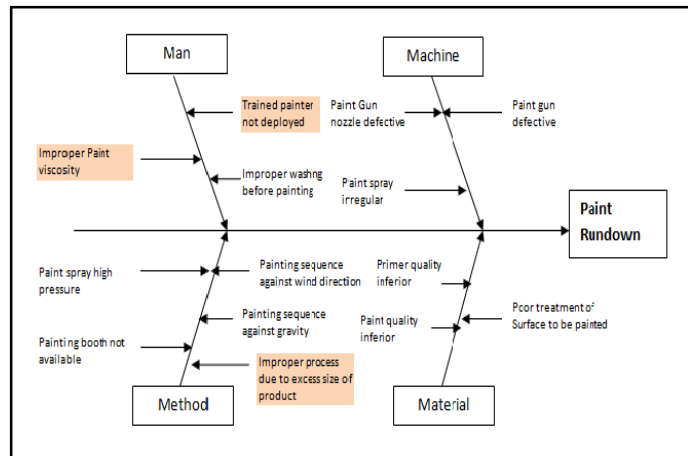
Fig. 10 Cause & Effect diagram – Paint rundown (HPU)

Inference: Improper paint viscosity, trained painters not deployed & improper process of painting due to excess size of product were valid causes for paint rundown.

II. Paint rundown defect reduced from 170 to 81 score having 52% improvement. It was due to the training provided to the new/semi skilled painter, paint viscosity control and introduction of elevator for painting at elevated position of HC.

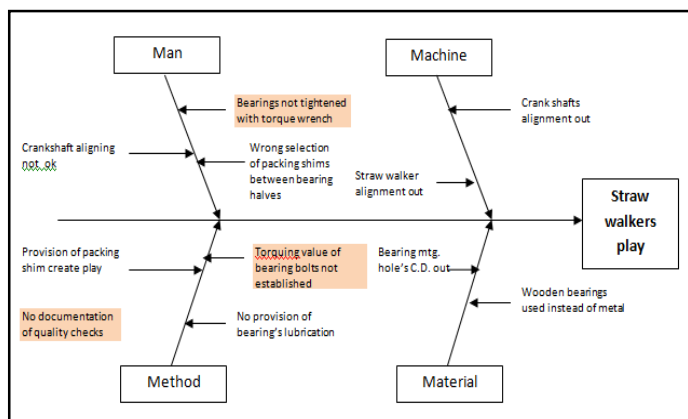
Fig. 11 Cause & Effect diagram – Straw walker's play (HPU)

Inference: Straw walker's bearings not tightened with torque wrench due to non establishment of torque value & no quality check reports were valid causes for straw walker's play.

V. Straw walkers play defect reduced from 100 to 0 score having 100% improvements. In assembly during analysis, it was observed that there was no documentation of critical quality checks due to which workmen don't have fear for penalties against loose work. Travel History card was developed and implemented on each HC so that workman can be traced out due to which problems appear at any stage or in field.

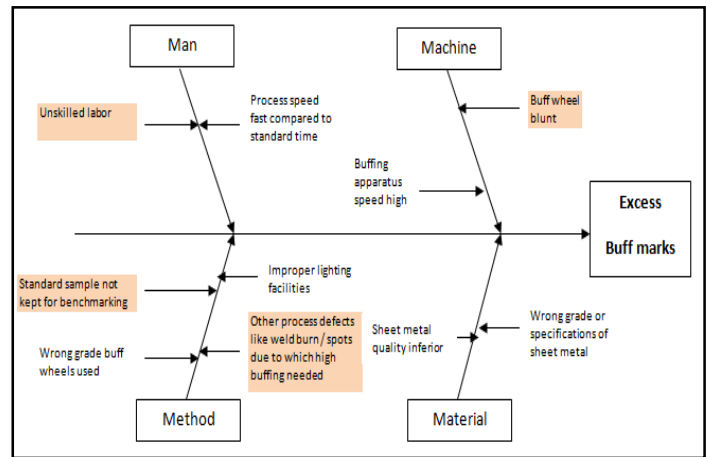
Fig. 12 Cause & Effect diagram–Excess buff marks (Supplies)

Inference: Unskilled labor, buff wheel blunt, standard sample for benchmarking at supplier end & excess welding bead were valid causes for excess buff marks.

VI. Excess buff marks defect reduced from 242 to 167 score having 31% improvements. High current settings during welding lead to thick bead weld. It was dressed by blunt buffing wheel which was not replaced after its standard time. Due to this, buff marks appear on welding portion. Standard sample for reference also kept at supplier end. Training of manpower, supplier visit and technical supervisor ensured at supplier end.

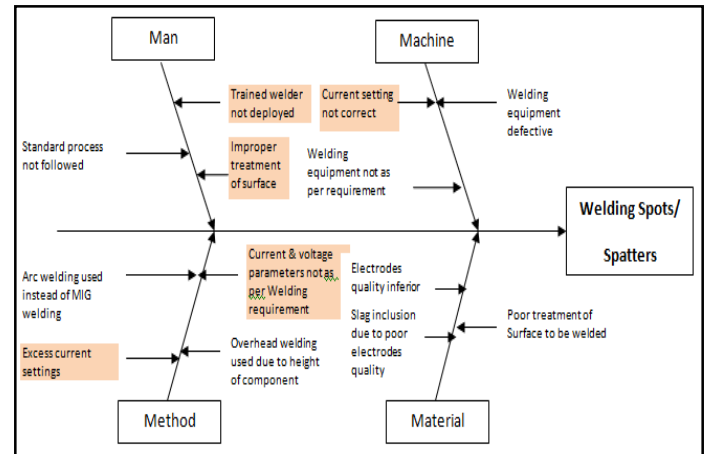
Fig. 13 Cause & Effect diagram – Welding spots/spatters (Supplies)

Inference: Trained welder not deployed, Improper dressing of surface & current setting not correct were valid causes for welding spots/spatters.

having 55% improvement. Excess are length during welding by untrained welder, poor surface preparation before welding and dress up after welding and improper current settings were major causes of this defect.

IX. Welding spots defect reduced from 134 to 101 score having 25% improvements. This defect has same reasons as of welding spatters in addition, sheet metal having less thickness used by supplier than required.

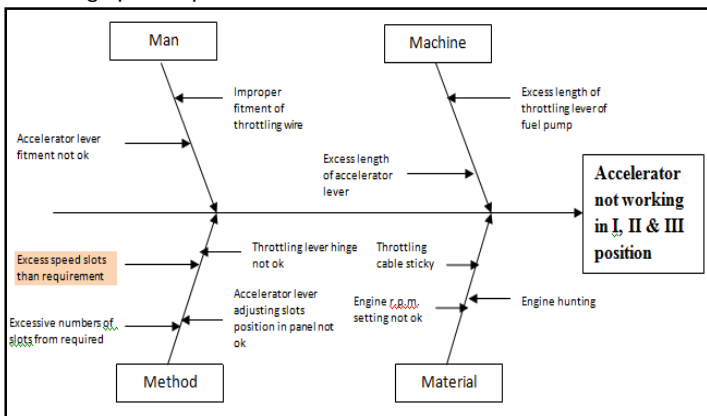
Fig. 14 Cause & Effect diagram – Accelerator not working in I, II & III position (Design)

Inference: Excess slots than requirement i.e. only three slots were sufficient for speed variation Harvester combine as it is operated in fields or on roads. Moreover, it has hi-lo gear also

by which three speeds can be operated in six speeds by engaging hi-lo gear.

X. Accelerator not working in I, II & III position defect reduced from 100 to 0 score having 100% improvement. There were five slots in panel for various speeds of HC. Engine supplied by Ashok Leyland which is supplied to various HC manufacturers, having limited throttling as specific requirement of HC. It runs in fields with low speed and on road with full speed. So, two slots were deleted in panel. Now, only three slots provided for speed adjustment

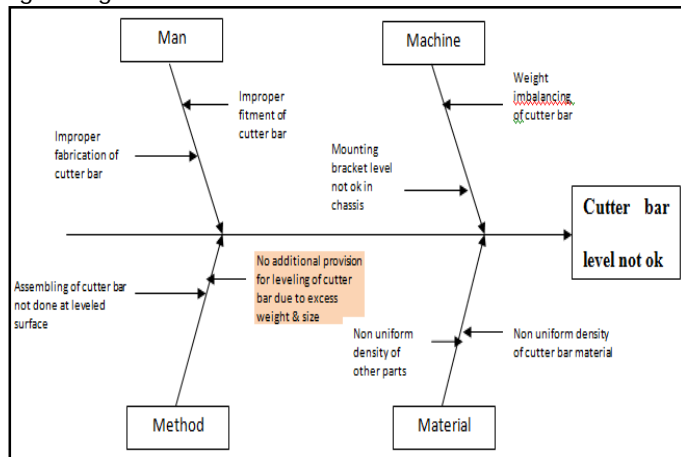
Fig. 15 Cause & Effect diagram – Cutter bar level not ok (Design)

Inference: Due to excess width i.e. 4.2 meters & heavy weight i.e. 1000 kg; it was difficult for alignment of LHS & RHS of cutter bar between 20 mm.

XI. Cutter bar level not ok defect reduced from 100 to 0 score having 100% improvement. Cutter bar having 4.2 meters length and 1000 kg weight is being fitted on HC at two brackets. Due to this, it was very difficult to level it within required limits i.e. L.H.S should be only 20 mm up from R.H.S. Packing shims implemented between cutter bar and its mounting brackets of various thickness to level it.
