The Application of Geophysical Methods in Determining the Causes of Borehole Failure: A Case Study of Dextol Hostel, Abeokuta, South Western Nigeria.

**Adeolu Aderoju O., Hansen-Ayoola A.O., Olanrewaju Olajuwon

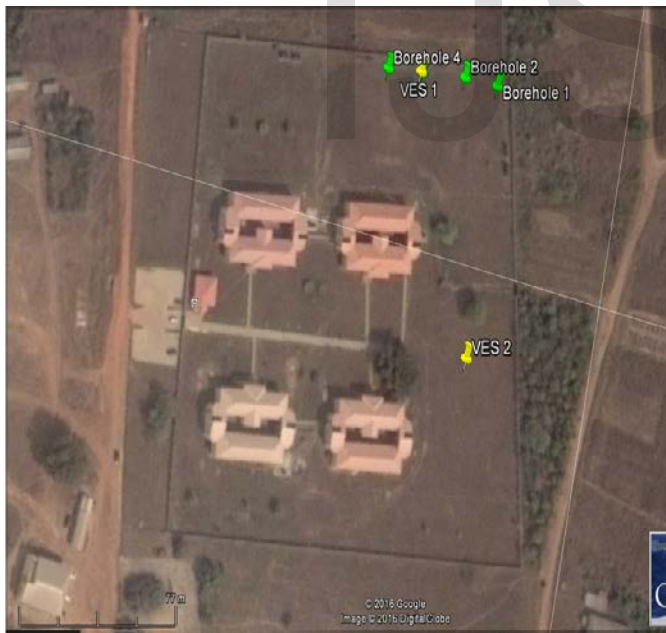
Figure 4: Satellite View of the Study Area with the VES Locations and Borehole Locations [5]

The Study area is a massive four winged complex (Figure 4). Four (4) boreholes have been drilled in the compound, two of the boreholes are not serving at all (Borehole 1 and 2) (i. e. completely failed) while the other two which are close to each other are serving but the water yield is very low (Borehole 3 and 4) (yield is less than 400 litres/24 hours). So they were considered to be failed boreholes. The four wells are drilled almost on the same traverse line with less than 15 meters distance between each well. It was first suggested that the boreholes must have failed due to their inability to access a water bearing fracture that could serve the compound.

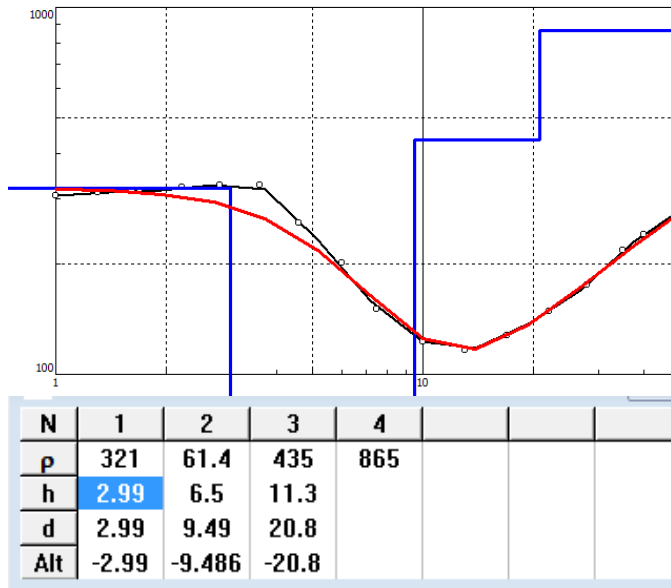
Figure 5: Graph and Results display of VES 1

The results from the first VES that was carried out at BH 3 revealed that the subsurface has four geo-electric layers. The first layer predicted to be the top soil with resistivity value of $321 \Omega\text{m}$ and thickness of 2.99m while the second layer being a sandy clay unit shows a decrease in its resistivity value to $61.4 \Omega\text{m}$ with a thickness of 6.5 m, the third layer which was considered to be a moderately weathered basement rock has an increased resistivity value of $435 \Omega\text{m}$ to the depth 20.8m, the last layer which is considered as fresh basement has resistivity value of $865 \Omega\text{m}$ with an infinity thickness (Figure: 5 and 8a)

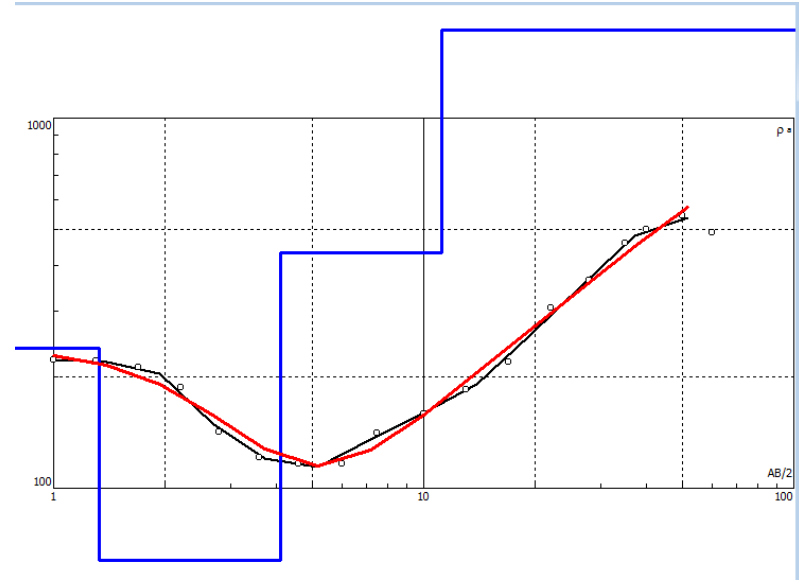
Figure 7: Graph and Results display of VES 2

The VES 2 also shows a curve with four geo-electric layers, the first layer is predicted to be the top soil with the following properties; apparent resistivity: $239 \Omega\text{m}$, thickness of 1.33 meters, the second layer is considered to be a sandy clay unit with resistivity value of $63.8 \Omega\text{m}$, and 2.73 m, the third layer is considered to be a moderately weathered basement rock with resistivity value of $433 \Omega\text{m}$ and a thickness of 7.0 m. the last geo-electric layer is considered to be a fractured basement rock with resistivity value of $1729 \Omega\text{m}$ to an infinity depth.

The second VES was recommended for drilling, the report stated that the well be drilled to a depth of 60 – 70 m, wherein upon encounter with viable aquifer before the stipulated depth, the driller can terminate using his discretion. When the borehole was drilled, the first minor fracture predicted produced very little water upon drilling while the second fractured

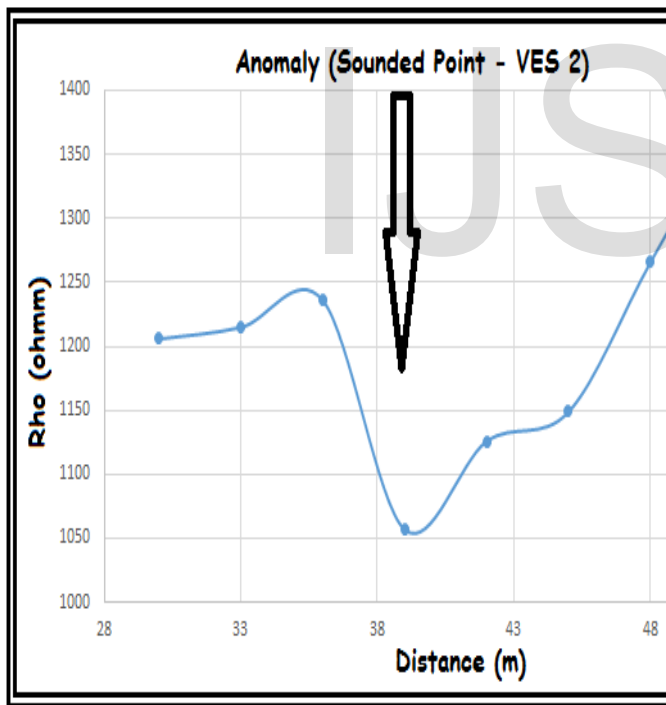
Figure 6: Horizontal Profiling graph with anomaly at $AB/2 = 39$ m

The horizontal profiling along the traverse line that cuts through the second sounded point revealed an obvious anomaly which is indicative of fracture at $AB/2 = 39\text{m}$, this point was sounded and the fracture was confirmed to be existing at the section (Figure 6).

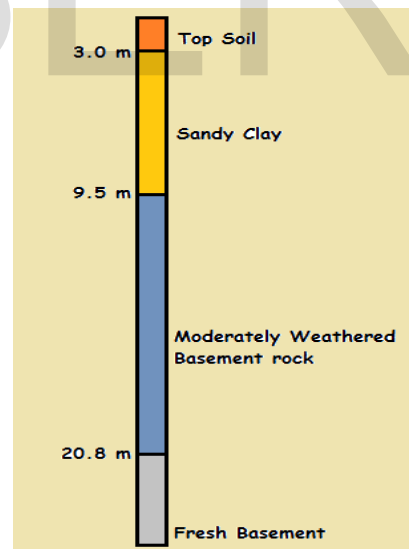
Figure 8a: Geo-

The two results obtained revealed that the subsurface has similar or close geologic settings, the overburden soil for the first VES is thicker and has better propensity for bearing water although such water may not be substantial. This explains the reason why Borehole 3 and 4 were still producing very little water when pumped. Conversely, VES 2 has a thin overburden (loosed earth materials), this may be phreatic aquifer. The geo-electric layering reveals that there are two fracture aquifers in the fourth layer of the section, the first projected fracture is a minor one at depth 24 – 28 m, the second fractured aquifer was projected to be at 45 – 50 m.
