# Accident Analysis of Narora Fire Accident

G DivyaDeepak

**Abstract** - A major accident took place in a nuclear power plant located at Narora in Northern India. A huge fire with bright yellow - red flame was seen at both the ends of generator. Extensive damage to the power & control cables and bus ducts took place during this accident. The vertical aluminum ducting above the neutral transformer has completely melted. The ducts ending near the excitation panels had been shattered. All the panels of AVR, Field Breaker & thyristor cubicles were completely damaged in the fire. Mechanical failures include fatigue fracture of Blades of the turbine. [1] In this project work, we have analyzed the narora fire accident and performed a root cause analysis and suggest the various alterations which can help prevent such accidents in future. In this paper I have analyzed in depth about the fire accident that took place in a nuclear power plant at Narora using the Root-Cause method and Top-Bottom analysis. I have determined the strengths and weakness of the safety system that was available during that time using Defence-in-Depth concept. Furthermore I have also provided technical design solut

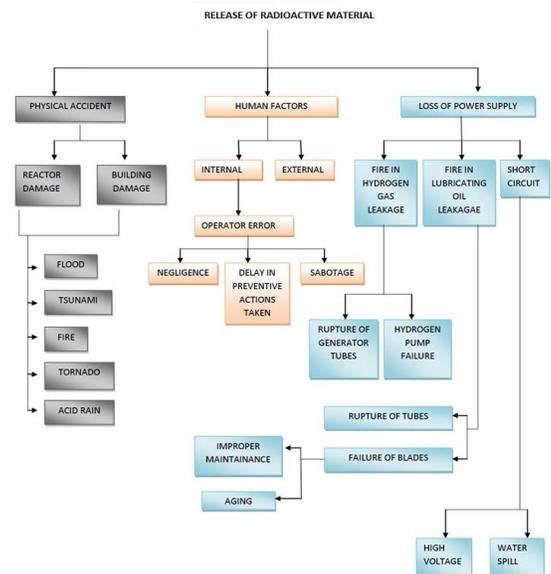
Figure2

6.1. Redesign of turbine blades.

This includes increasing the thickness of the turbine blades and the convexity of the turbine blades. The reason for this being Increased convexity avoids back-rake stress reduction. Thus we have less chances of stress accumulation
