Renovation of Sāttankulangarai Narasimhamoorthy Temple-A Case study

Abstract— Kerala the land of temples, ‘the Gods own country’, exhibits a unique and simple style of architecture. The Kerala temple architecture has its roots in ‘Vastusastra’ which is not a religion document but a scientific treatise. The temple architecture is considered as a science of scale and proportion. It is a product of Bakthi cult starting from the dawn of 9th century and received a fillip during the age of Kulasekharas as a part of the activity connected with popularisation of Hinduism. The long unbroken chain of Kerala kings who were the protectors of the Hindu religion was much involved in the construction of temples and its renovation. The contributions of the rulers were strong and solid. Sāttankulangarai Narasimhamoorthy temple, an embellishment in wood crafts of Central Travancore is located at Chengannoor in Alappuzha district. The origin of the temple renovation dates back to the 14th century. This timber temple a masterpiece in wood crafts having its superstructure including the walls made of timber. The Climate Index (decay hazard) was found to be very high and the Equilibrium Moisture content

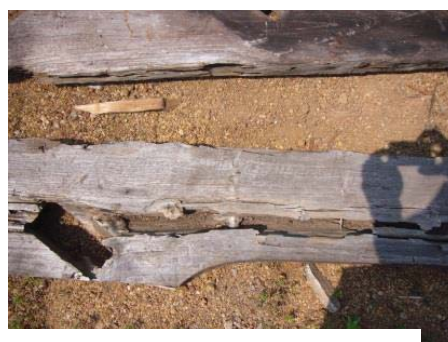
Fig 11 Decayed rafters

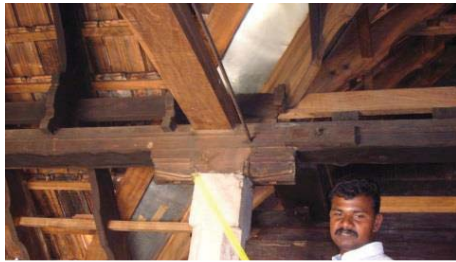
wood for the repair of members by replacing the old is against the canons of *jīrnodharana* mentioned in the traditional treatise. The identity and authenticity of the object is lost by the use of new species of wood. The replacement of decayed wood with a new specie wood was also against the conservation practice of the international preservation community ICOMOS and ICCROM which supports the use of existing materials. By using different specie the identity of the object is lost. The identity of the building is related to the substance acquired through its history. As far as possible it should be replaced with the wood of same species. The authenticity of its substance has to be maintained. The eave boards and the tiles were replaced. The beams which were decayed were also replaced. The beauty of the building is not only related to its form but to the 'patina' of its materials. The new timber used stands out from the old timber members. The *namaskāra mandapa* which was destroyed in a mishap was reconstructed in front of the Ganesha shrine outside the *chuttambalam*. The new *kuta* construction is shown in Picture 12. Anti-termite treatment is done for the *agramandapa* and the *gopura*. The size of the wooden members was retained. The black colour of the *balikallu* (offering stone) is maintained by applying sesame oil mixed with roasted powdered sesame seeds which retains the traditional practice. The same traditional technique could have been used for the foundation of the *srikovil* instead of painting it with black cement paint. The white stains which had occurred on the ornamental timber ceiling of the *gopura* due to water seepage as seen in Picture 13 were cleaned with a brush and clear varnish was applied on the ceiling as shown in Picture 14. *adhishtāna* was painted with black cement paint. The renovation was carried out only on the *chuttambalam* and the ancillary structures which had shown signs of decay. The work was done on contract basis by inviting tenders and following the usual contract procedure. The decay of wood was mainly seen in the *chuttambalam*. The documentation of the *chuttambalam* was carried out prior to the renovation work. *Chuttambalam* is a quadrangle with a *sala* type tiled roof construction surrounding the *srikovil*. It houses the *thidapally* (kitchen) where the food is cooked for offering the deity, the *mulayara* (room for germinating seeds for pujas and occasions).

Fig 12 Decayed Beams being Replaced with New

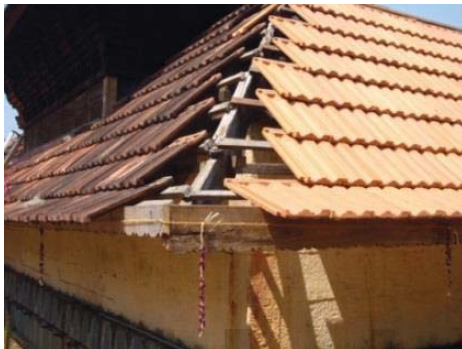
Fig 13 Old Tiles replaced with new

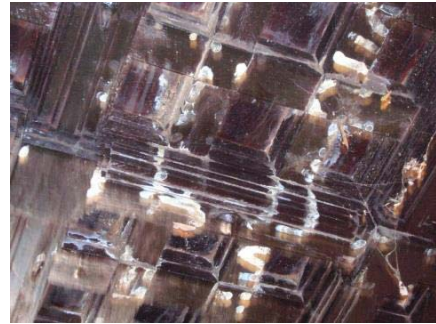
The temple has a sloping two tiered *gopura* on its northern side which forms the main entrance gateway to the temple as shown in Picture 1. It is constructed in accordance to the human scale. No *gopura* exists on the western side as there is a temple pond on the west side. The wooden ceiling of the *gopura* is decorated in a chequered pattern. The stains were removed during the renovation and clear varnish was applied on the surface.

Fig `6 Ceiling of Gopura before Renovation

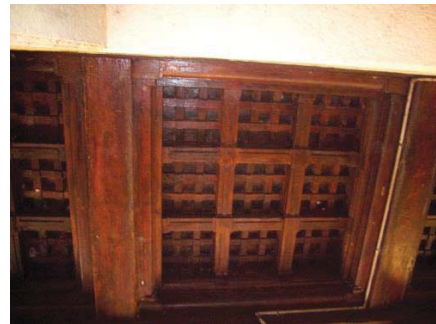
Fig 17 Ceiling of Gopura after Renovation
