Challenges Facing Assessment of Accident Vehicles in Ghana

Anthony Simons, Eric Kofi Gbadam

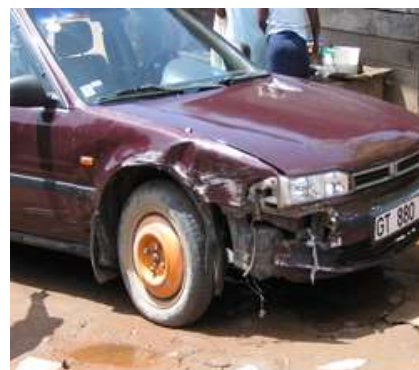
A saloon car, Honda Accord, as shown in Fig 7 was driven into a gutter when the driver avoided hitting some kids playing on the street. The car was insured and road worthy, the conditions of brakes were satisfactory and tyres were 15% worn. Offside front fender and rear right of the vehicle body were damaged. Both the radiator and the engine also got damaged (engine seizure). Engine seizure occurred when the driver was sending the accident vehicle to the garage. Unknown to the driver, the radiator was leaking and short of water, consequently, the engine got overheated and finally got seized. The vehicle in question was inspected at the garage in the presence of the workshop manager, the insurer and the managing director of the insurance company. The entire alleged damaged items were checked. In addition, it was found that the driving mirror Right Hand (RH) though not physically damaged, was not functioning (could not change positions) when tested.

(a) Offside Front Fender Buckled

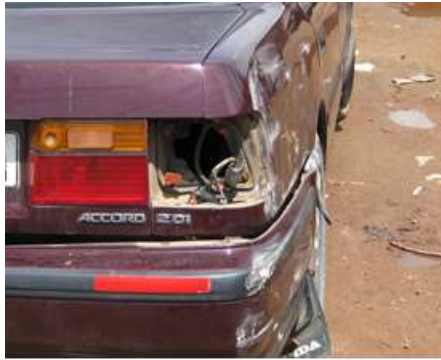
(b) Rear Right Side Damaged
Fig 7 Damaged Honda Accord Saloon car

When the estimated cost of repair was submitted, it was detected that rear bumper had been added and so was the cost for total spraying of the vehicle, when indeed it was only the rear right side of the bumper that got damaged as could be seen in Fig 7 (b) and could also be easily repaired. It was only the right side that should have been sprayed.

Investigations were conducted as to why the rear bumper had been replaced and the vehicle totally sprayed. After cross-examining the workshop manager and the insurer and inspecting the vehicle again, it was found that the rear bumper had a crack in it before the crush and the owner (insurer) wanted to replace it and spray the whole vehicle instead of the affected portion at the expense of the insurance company. Finally, the insurer was made to pay for two-thirds of the cost of both the spraying and the rear bumper. Consequently, the payment of indemnity was delayed.

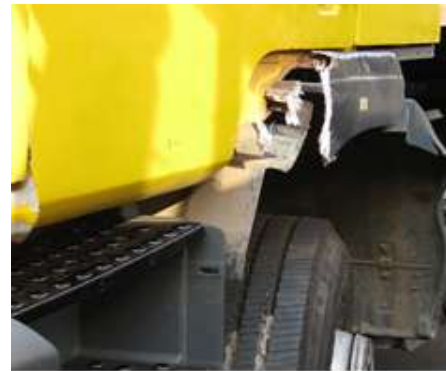
In this case a MAN truck (articulator) was involved in an accident and the bonnet got damaged to some extent as can be seen in Fig 8(a), (c), (d) and (e). Also, the stepwell left as shown in Figure 8(b), and the headlight left were damaged (Fig 8(e)).

(b) Damaged Stepwell Left

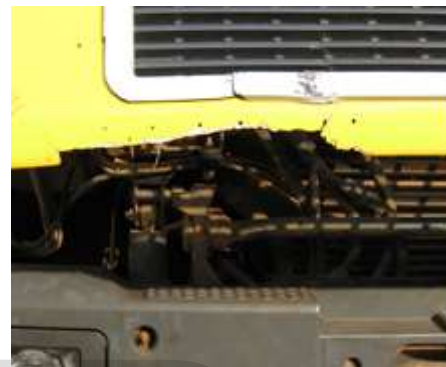
(c) Damaged Bonnet Right Side

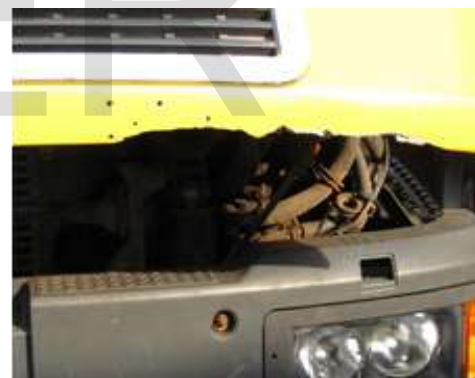
(d) Damaged Bonnet Left Side

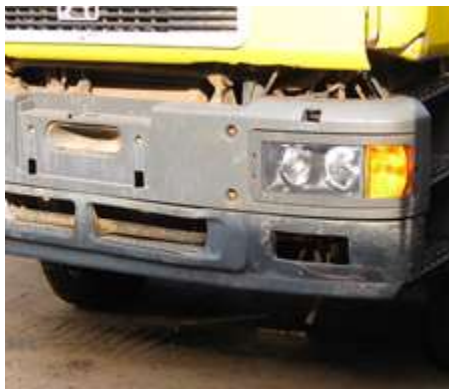
(a) Newly Installed Bumper and Headlight

The repair works were carried out at the insurer's workshop without any survey by a mutual assessor (engineer). A bill was presented to the insurer for payment of repair works. The insurance company then sent an engineer to carry out a survey on the vehicle, only to find out that the truck had already been repaired. He observed that the truck was in good condition and the state of brakes were satisfactory and the tyres were in good condition (5%). It should be noted that the procedure for accident repair works was not followed.

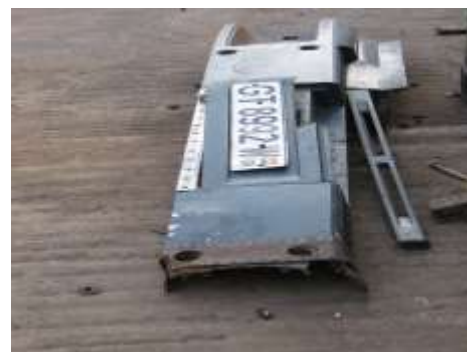
(e) Damaged Front Bumper

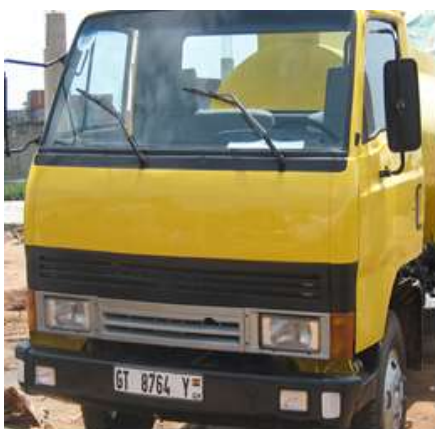
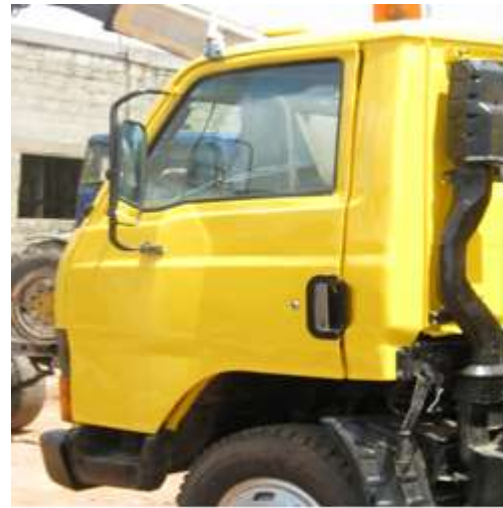
The assessing engineer of the insurance company was called upon to survey a Swaraj Mazda truck which belongs to a telecommunication company. Together with the manager of the insurance company, the engineer found the said vehicle already repaired and sprayed as shown in Fig 9 and that a bill of GH¢11,485.05 had been prepared to be sent to the insurance company. It was learnt that the mechanical engineer of the telecommunication company instructed the automobile workshop to carry out the repair work which indicated that both the mechanical engineer of the telecommunication company and the workshop manager did not follow the process and method for accident repair works.

(a) Front View of Vehicle

(b) Left Side View
Fig 9 Swaraj Mazda truck

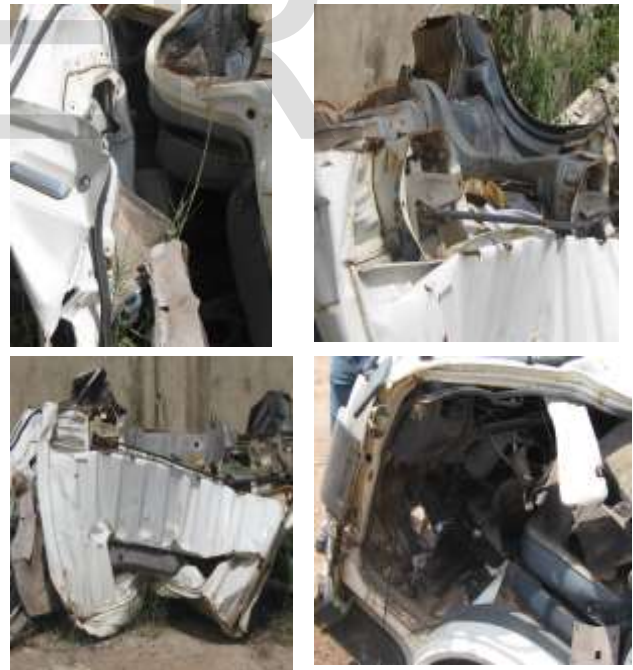
It should be stated that the conducts of both the mechanical engineer of the telecommunication company and the workshop manager were highly unacceptable with respect to the accident repair work and insurance claims. They were questioned on their behavior and upon further interrogation the workshop manager showed the remains of the crushed truck as shown in Fig 10.

Fig 10 Remains of Damaged Swaraj Mazda Truck

the workshop manager did because it was difficult to determine that the remains of damaged Swaraj Mazda truck as shown in Fig 10 was the real state of the truck just after the accident. This situation could have delayed or nullified the payment of insurance claim to the insurer which in this case is the telecommunication company.
