Expected Seismic Performance Of Buildings Located In Wagnaghat And Kandaghat Area Of Solan, District

Ankur Thakur¹, Dipali Sharma¹, Parveen Kumar¹, Nikita Gupta¹, Poonam Dhiman²

ABSTRACT— The Himalayan belt of India lies near the fault separating Indo-Australian and Eurasian plate. It is but natural that this area is seismically active and lies in zone IV. Despite this fact, most of non-engineered buildings in Himachal Pradesh have poor configurations and construction quality. In this paper, an effort is made to study structural irregularities and construction defects of buildings situated in Wagnaghat and Kandaghat (district Solan, HP). Some of the factors which were included in the survey are : offsets, cantilever slab loaded above, setbacks, soft storey, unequal heights of the column , honeycombing, cantilevered slabs loaded above, open ground storey etc. Along with above mentioned defects, other factors like segregation, exposed bars, verticality of columns, poor bricks quality were also acknowledged. An effort has also been made to suggest some remedies for the above mentioned irregularities and defects.

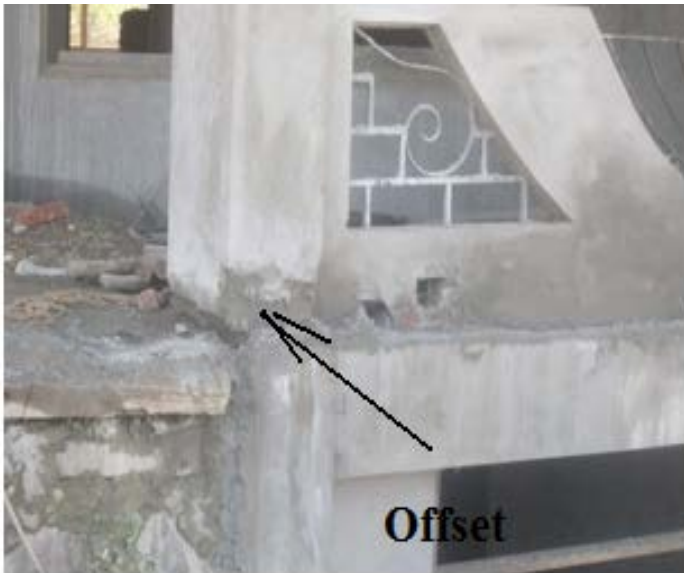
Fig. 2. Offsets

The building shown Fig. 2 is located in wagnaghat and is under construction. This buildings has four stories and is made of RCC with brick infill panels. The column under construction has offsets in them. Due to the misalignment of the reinforcing bars in the two columns, during an earthquake, there are chances of sudden failure of this joint. So, at the time of construction, utmost care must be taken to get true vertical line in columns.

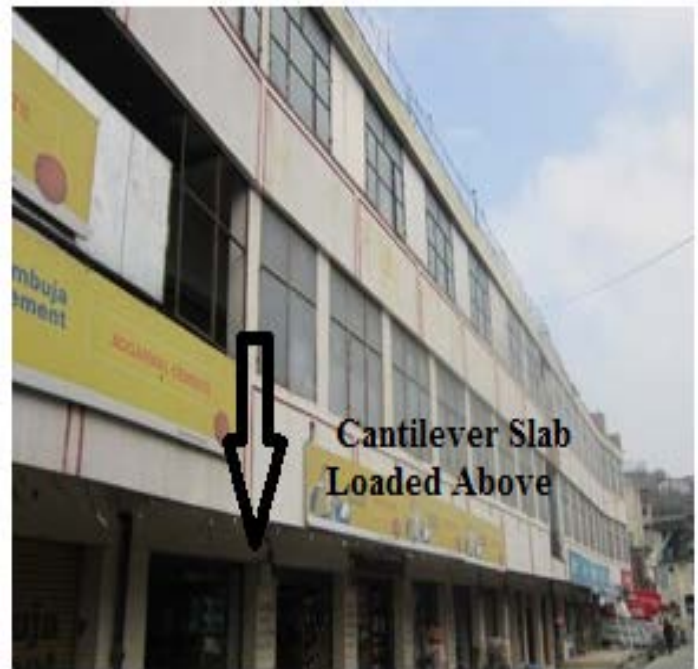
Fig.3 (a) Cantilever Slab Loaded Above

The cantilever portion of the building must be used as free spaces like balconies with less loads. Fig. 8 shows a commercial building located in the marketplace of Kandaghat. It has a cantilever slab that is loaded heavily. Fig. 3 (a),(b) shows a residential house situated in the market of Kandaghat in which the cantilever portion has been used as the living room. The extra weight loaded above proves to be detrimental during an earthquake. In order to correct this defect, in Fig. 8, columns must be provided at the cantilever ends as shown by black circles so that load is distributed uniformly. Whereas, in Fig. 9 the bottom portion of the cantilever must be either provided with one more column or must be covered with walls on the two sides.

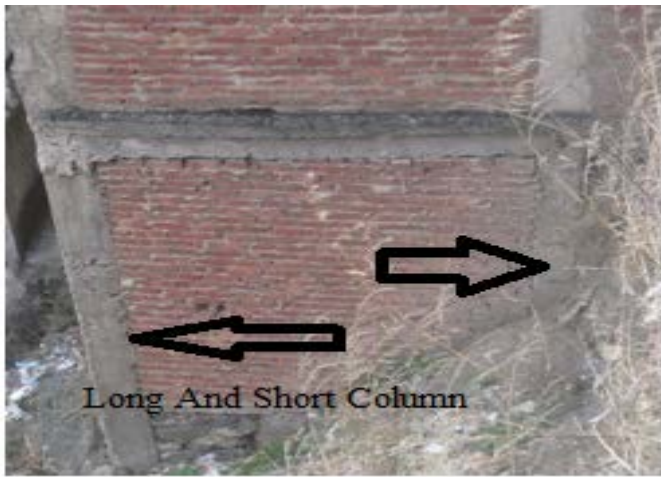
Fig.4. Short column Effect

Buildings on slopy ground have unequal height of the columns (Fig. 4) along the slope, which causes ill effects like twisting and damage in shorter columns

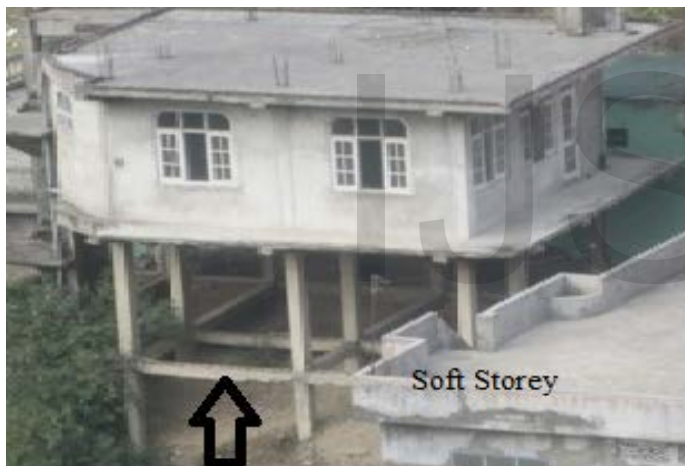
Fig. 5. Soft Storey

A soft storey as in Fig. 5. is one in which the lateral stiffness is less than 70% of that in the storey immediately above, or less than 80% of the combined stiffness of the three stories above. Many buildings with an open ground storey (soft storey) were observed. The essential characteristic of a weak storey consists of a discontinuity of stiffness, which occurs at the second storey connections. This is caused by lesser strength or increased flexibility and also the structure results in excessive deformations in the first storey of the structure, which in turn results in concentration of forces at the second storey level. These stories are more likely to get collapsed or were severely damaged during earthquake.

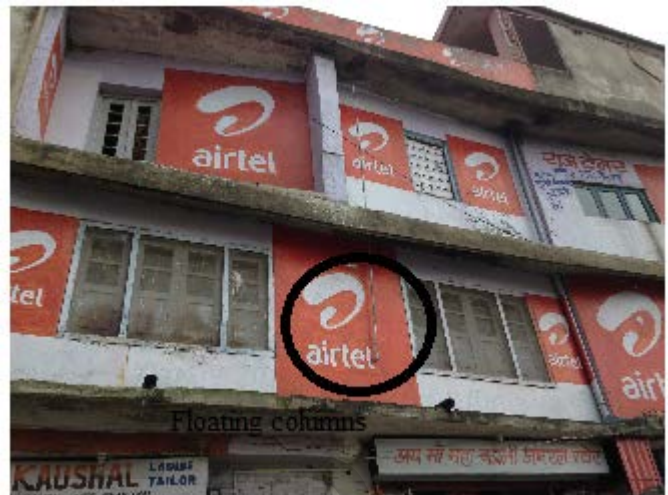
Fig . 6. Floating Columns

Buildings with columns that are hanging or floating on beams of an intermediate storey and not attached to the Foundation so this building have discontinuities in the load transfer Path. Fig. 6 clearly show that the column do not continues up to the foundation and in the middle storey there is hanging column. Due to this, Shear and overturning forces are induced that can leads to the failure of the building.

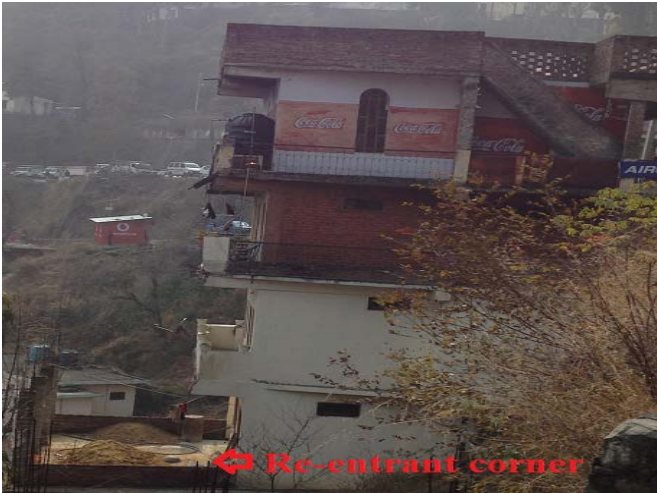
Fig. 7. Setbacks (Re-entrant corner)

According to IS 1893 (part 1): 2002, plan configurations of a structure and its lateral force resisting system contain re-entrant corners, where both projections of the structure beyond the re-entrant corner are greater than 15% of its plan dimension in the given direction. Buildings with vertical Setbacks cause two types of problems:

- (i) Sudden jump in earthquake forces at the level of discontinuity
- (ii) Torsion

- 1.IS 1893 (Part 1):2002 must be followed strictly in order to sustain earthquake damage.
2. Ductile detailing using IS13920 should be mandatory.
- 3.The general solution for a structure with setback is that the building must be divided into different blocks with a separation joint at the junction.
- 4.More care is necessary at the time of planning for reducing these irregularities.
- 5.The torsional effects in a building can be minimized by proper location of vertical resisting elements and mass distribution.
- 6.Shear walls must be properly employed for increasing the stiffness where ever necessary and must be uniformly distributed.
