Modified Binders (developed In-house) for Boiler Pressure Parts Hot Reheater & Cold Reheater Coils to prevent failure and misalignment during operation

Index Terms— Boiler, Reheater, Tube failure, Binders, CRH, HRH

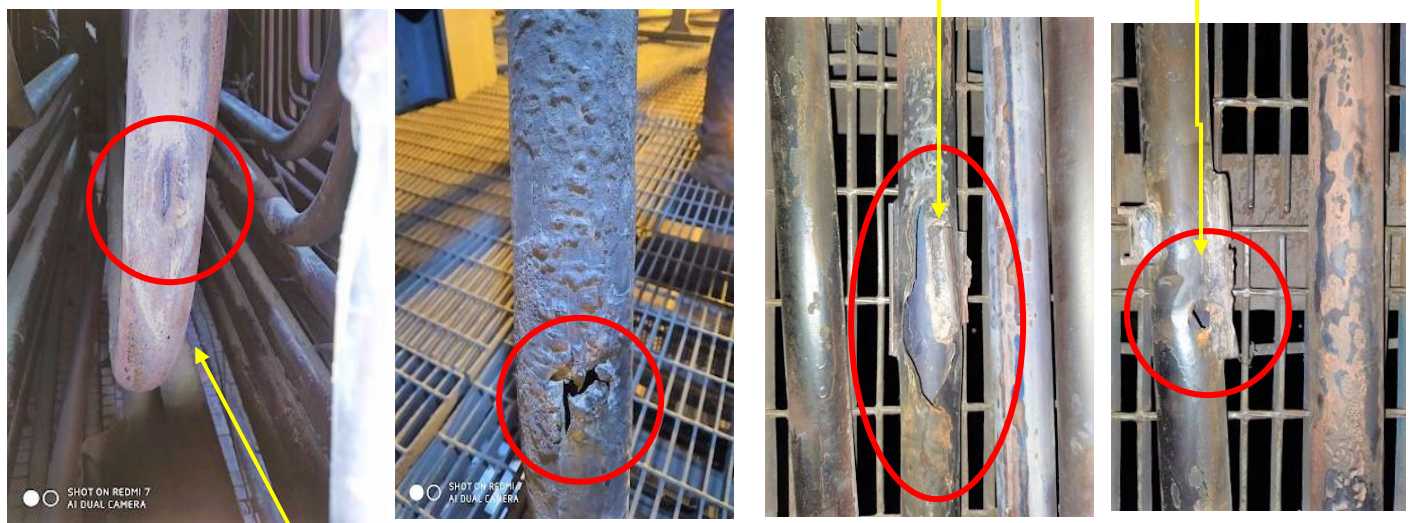
The Attachment weld failures was happening due to lateral expansion of reheater coils, but the original binder only compensates the vertical expansion resulting stress developed at weld joint which causes failure of tube at the point of weld.

The Overheating was happening due the misalignment of coil tubes. The original binder was not designed to realign the misaligned tubes. This causes overheating of tube resulting failure of tubes and forced unit outage. MPL had

Reheater failed tubes due to overheating

Reheater failed tubes due to stress at weld

- New developed binders have provision of unrestricted vertical movement of tube in either direction and hence tubes in align condition during all operational situation.
- New developed binders are designed in such a way that it is not welded at any point of the tubes for their installation resulting no stress developed on tubes during all operational condition.
