Influence Of Subsurface Courses Materials On Pavement Performance: A Case Study in Yebu-Agaro Road

Anteneh Geremew, Prof. Emer T. Quezon, Getachew Kebede

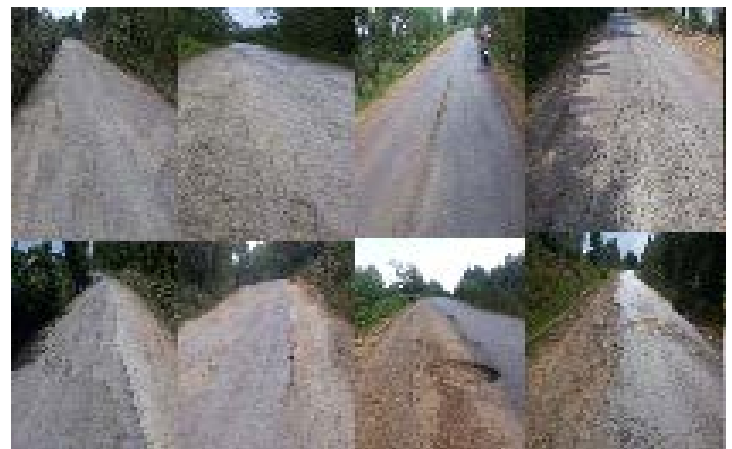
Figure 1.1 Current Condition on some Sections of Yebu-Agaro Road

Currently Condition of a road some part of Yebu-Agaro road is failed by different types of failures such as reflective crack, block crack , pothole, rutting and alligator crack , so it's not suitable for driving even also affect the vehicle operating cost for the road users. Misunderstanding the nature of soils and their properties can lead to construction errors that are costly in effort and material. It is for this reason that this research study to undertake investigation of subgrade soil on asphalt pavement performance along Yebu-Agaro road.

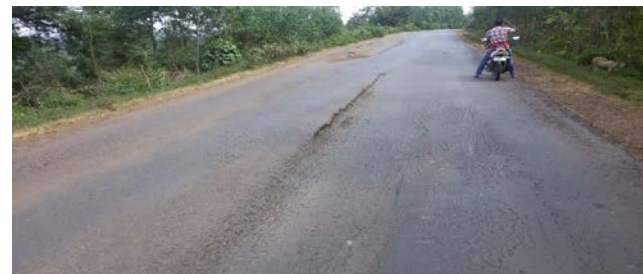
Figure 2.2. Pavement defects in the study area

The following representative photographs can show the type and extent of failures along the road. In the figure below, there were five major types of distresses observed along the study area of Yebu-Agaro Road. The researcher had organized the possible distress types based on the existing condition of the pavement surface together with the extent of damage.

The following Figures show the different photos taken from the field Observation of the different types of distress along Yebu-Agaro Road section.

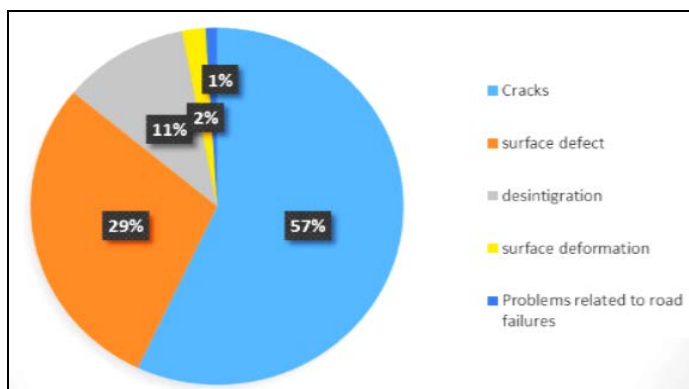
Figure 3.1: Common distress types obtained during Field survey

In Figure 3.1, there were five (5) major types of Road failures observed along the study area of Yebu-Agaro Road section. It was organized the possible distress types based on the existing

Road condition of the pavement surface together with the extent of damage. The detailed Road inventory was carried out along road section. In order to evaluate the carrying capacity of the materials to the traffic loading at its service time, the analysis was made. From the traffic analysis, the cumulative Standard Axle is 3.052 Million. According to the ERA pavement design manual, the Traffic Class is "T5" with ESAs ranging from 3-6 million. The thickness of each layer of the embankment of the road section is a function of the ESAs and the CBR of the sub-grade layer. From the CBR test, the sub-grade strength class can be classified as S₄ with CBR ranges 8%-13%. Hence, according to the ERA road design manual, the thickness of the base course and sub-base course for traffic class T5 with ESAs of 3.0-6.0 million should be at least 20cm and 25cm, respectively. Based from the actual measurement, the average thickness of the base course was 9.4 cm and that of the sub-base course was 14cm. This showed that the base and the sub-base course were not be able to carry the traffic loading at its service time.

TYPE OF DISTRESS	POSSIBLE CAUSES	SUGGESTED MAINTENANCE WORKS
Reflective cracking	<ul style="list-style-type: none"> □ Differential movement between the asphalt and concrete layers and can deteriorate further under heavy traffic. 	Crack seal/fill
Pothole	<ul style="list-style-type: none"> □ Continued deterioration of another type of distress, such as cracking, raveling, or a failed patch after pieces of the original pavement surface have been dislodged □ Weak spots in the base or subgrade Severity of the surrounding distress and traffic action accelerate potholes 	Temporary repair through filling it with a pre-mixed asphalt patching material. Permanent repair through filling it with new base and surface material
Rutting Crack	<ul style="list-style-type: none"> □ Consolidation or lateral movement of any of the pavement layers or the subgrade under traffic. □ Insufficient design thickness □ Lack of compaction □ Weaknesses in the pavement layers due to moisture infiltration Weak asphalt mixtures 	Cold mill and overlay or thin surface patch

Alligator crack	<ul style="list-style-type: none"> □ Excessive loading , Weak surface, base, Thin surface or base and Poor drainage 	Full-depth patch
Block Crack	<ul style="list-style-type: none"> □ Mix was placed too dry □ Fine aggregate mix with low penetration asphalt & absorptive aggregates □ Aggravated by high traffic volume 	Any surface treatment or thin overlay
Raveling	<ul style="list-style-type: none"> □ Lack of compaction, construction of a thin lift during cold weather, dirty or disintegrating aggregate, too little asphalt in the mix, or overheating of the asphalt mix. 	Surface treatment, such as seal coating, surface dressing, thin overlaying of surface

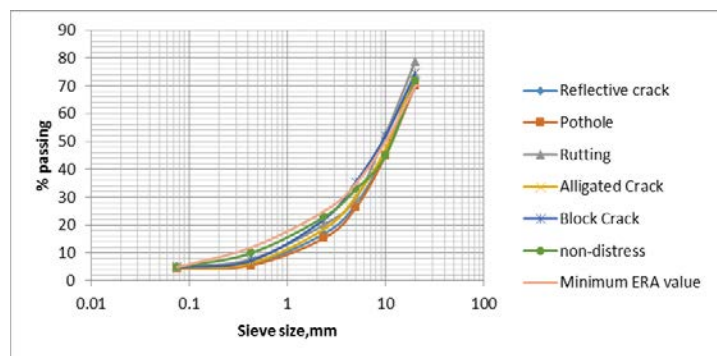
Figure 3.2 Comparison of ERA Standard and Actual Observation (Base Course)

In case of Base course materials Cu =25, which is greater than 4 shows a wide variation of size particles. Cc =4, indicates poor

graded particles, According to USCS, the % of sand retained above 2mm was greater than 15% so; base material at is classified as poorly graded gravels with sand.

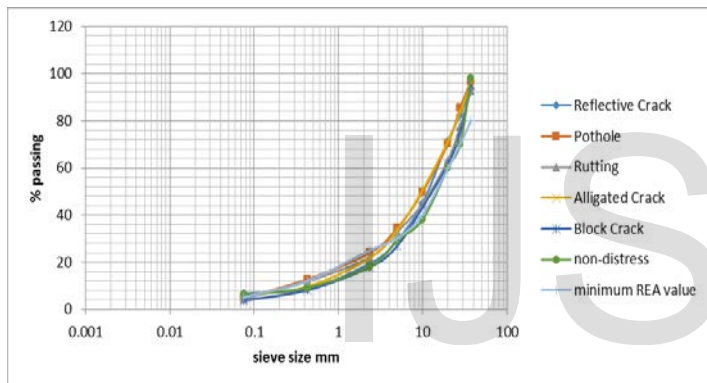
Figure 3.3 Comparison of ERA Standard and Actual Observation (Sub-Base Course)

For the Sub-base materials $C_u = 22.5$, which is greater than 4 shows a wide variation of size particles, $C_c = 2.5$, indicates well graded particle. According to USCS, the % of sand retained above 2mm was greater than 15% so; sub-base material at is classified as well-graded gravels with silt.
