Plate Cutting Error in Fabrication Shop & their Remedial Measure with Industrial Case Study

Vijay Lahri, Avinash Juriani, Anurag Lakhanlal Vaishya

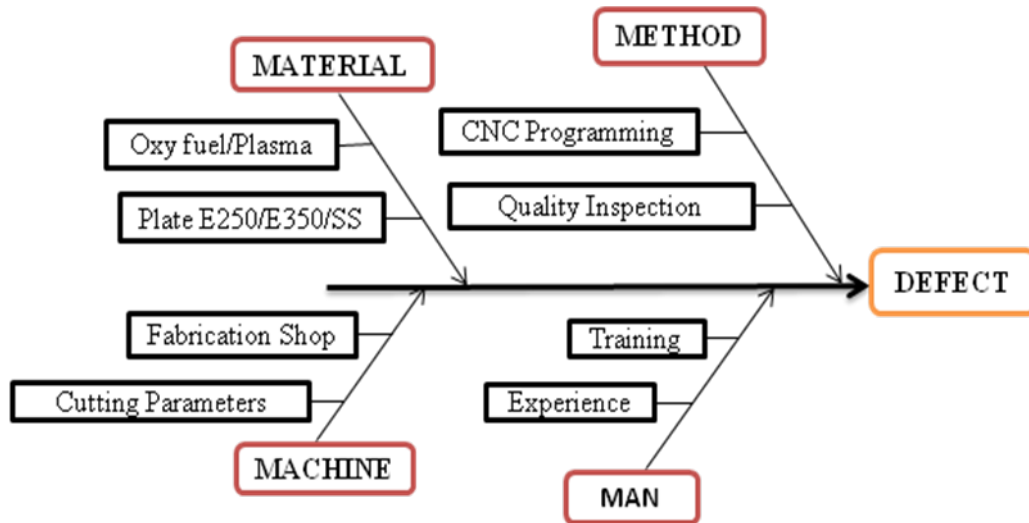
Fig. 2- Ishikawa Diagram

In this case study continuous observations of CNC oxyfuel/plasma cutting machine were taken for two weeks with previous data regarding plate wastage. After a rigorous discussion with all operators of particular machine and their in-charge. We finally found many errors were generated during cutting of mild steel plate of grade E350/250 with thickness from 8mm to 80 mm.

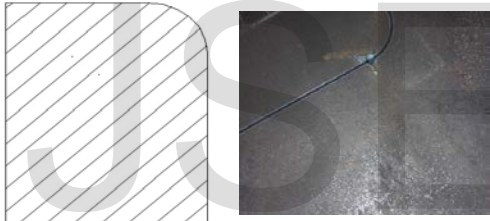
Sr No	Errors	Section View	Causes of Errors
1.	Edge Fusion

Torch Feed Speed too low. Flame Too strong. Clearance between nozzle and plate too great. Clearance between nozzle and plate too small. Nozzle too large for the cutting thickness. Flame with excessive oxygen surplus.
2.	Chain of molten beads

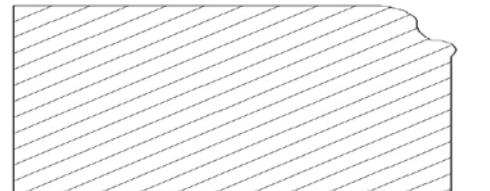
Flame too strong. Clearance between nozzle and plate too small. Flame with surplus fuel gas. Nozzle too large for the cutting thickness. Clearance between nozzle and plate too great. Torch feed speed too low.
4	Top edge cut away with adhering slag.

Cutting oxygen pressure too high. Clearance between nozzle and plate too great. Flame Too strong.

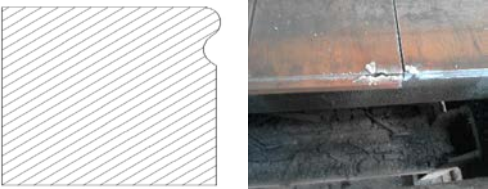
5.	Concave below top edge.

<p>Cutting Oxygen pressure too high. Cutting Oxygen Jet turbulent. Nozzle Dirty. Clearance between nozzle and plate too great.</p>

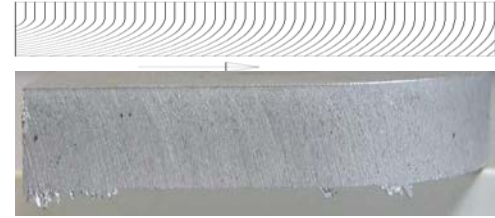
<p>Torch feed speed too high. Nozzle damage or worn. Nozzle dirty. Cutting oxygen jet turbulent.</p>
13	Excessive back scoring.

<p>Torch feed speed too high. Nozzle too small for the cutting thickness. Not enough cutting oxygen. Cutting oxygen pressure too low. Clearance between nozzle and plate too grate.</p>

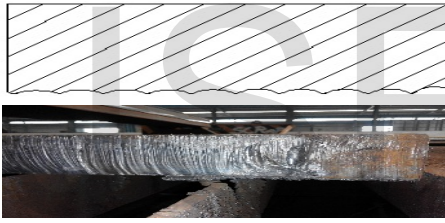
Torch feed speed too high. Torch feed speed irregular. Clearance between nozzle and plate too small. Flame too weak. Content of alloy components too high.
18	Irregular scoring depth.

Torch feed speed too high. Torch feed speed irregular. Flame too weak.
19	Cut surface undulating in direction of cut.

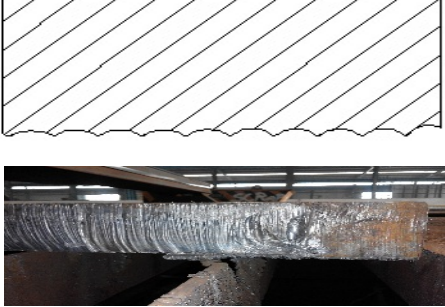
Torch feed speed too high. Content of alloy components too high. Carbon content too high. Cutting oxygen jet turbulent. Flame with surplus fuel gas. Nozzle damage or worn. Nozzle dirty. Nozzle too large for cutting thickness. Torch feed irregular.

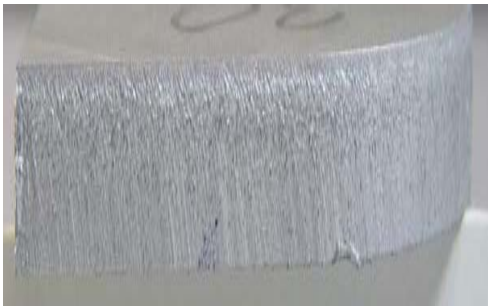
21	Cutting process interrupted.

<p>Torch feed speed too high. Nozzle damaged or worn. Nozzle dirty. Nozzle too small for the cutting thickness. Flame too weak. Cutting oxygen jet turbulent. Surface of plate dirty e.g. paint. Lamination in plate. Slag inclusions in plate. Segregation line in plate. Scale or rust on surface of plate. Not enough cutting oxygen. Clearance between nozzle and plate too great. Flame pops. Plate with finely distributed inclusions.</p>
22	Isolated instances of erosion.
