PREMATURE FAILURE OF DISTRIBUTION TRANSFORMERS –A CASE STUDY

III. CASE STUDY

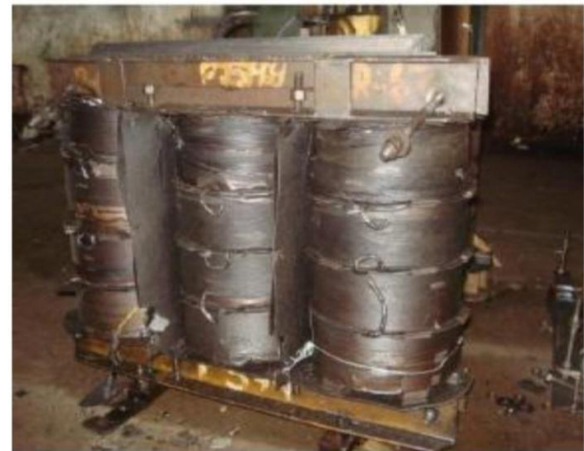
Figure 1

It was found by inspection that all three high voltage (HV) windings were damaged as shown in Fig.1. All three low voltage (LV) windings were also found burnt and paper insulation was damaged as shown in Fig. 2

This could be a classic example of overheating of both low and high voltage winding. The overheating may be due to prolonged overloading. Prolonged overloading may be caused by use of inadequate size fuses. It has been observed that line operators use more than the recommended capacity fuse wires either due to lack of knowledge or just to avoid frequently replacing the fuse especially in remote rural areas. Since this transformer was installed in rural area this must have been the reason for failure. In case of prolonged overloading, the additional loss generates more heat, which affects the burning of winding insulation, causing ultimate failure of the transformer. Cold load pickup (CLP) current may also be one of the causes of its failure. CLP is a

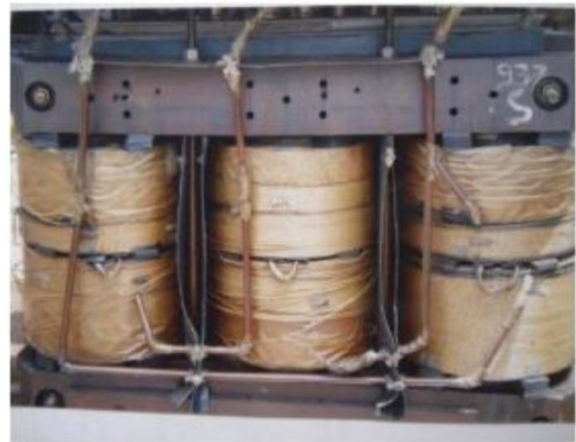
Figure 4

It was found by inspection that all three high voltage windings were damaged as shown in Fig. 4. Fig. 5 gives the rear view of HV windings.

This transformer failed due to unbalanced loading and poor maintenance. In case of unbalanced loading, voltage is generated on the neutral and will remain floating between neutral and earth. Since the neutral is solidly grounded through external link, a circulating current will flow through the loop of delta winding. This additional circulating current will superimpose on the main branch current of the delta winding and will cause additional heat, which may lead to the failure of the HV winding insulation. Proper and timely maintenance could have saved this transformer. R phase of LV winding could have burnt due to line to ground fault. In this situation, heavy current would have been drawn that cause not only the LV winding to burn but also punctured the HV winding as shown in Fig. 6.

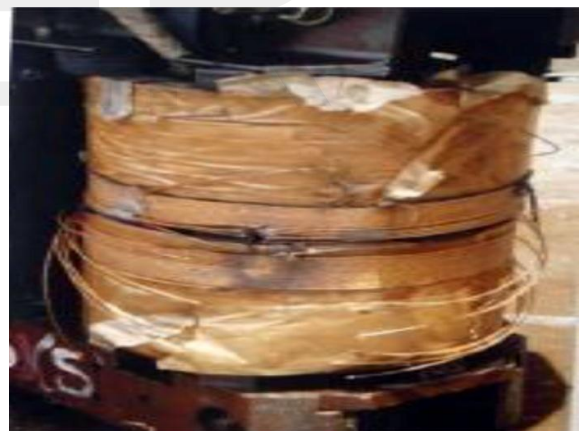
Figure 6

Fig.6 gives the view of R phase of HV winding in which burnout and breakage / puncture of coil can be seen clearly. Out of three windings of LV only R phase was in damaged condition, as shown in Fig. 7. Other two phases were in healthy condition

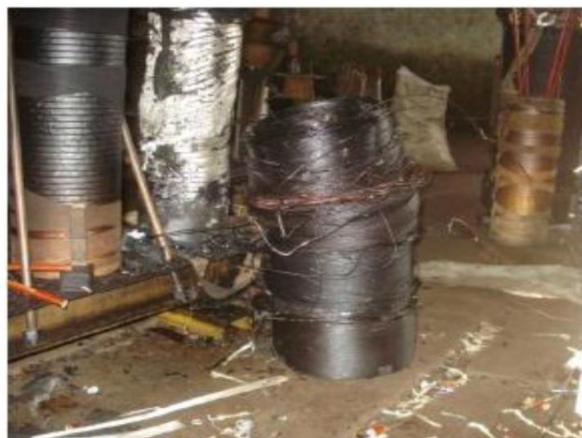
Figure 8

It was found by inspection that all three HV windings were severely damaged. Fig. 8 gives the view of one phase of HV winding and clearly shows the burnt condition. One phase of LV windings was found in an extremely smashed condition. The remaining two phases of LV windings and paper

It is a case of continuous overloading as all three phases of HV and LV are utterly scorched. Sometimes all the load of a failed transformer is shifted to a nearby transformer which is already overloaded and a new transformer is not immediately available. This could have been the reason for failure of this particular transformer. The reason for severe destruction of R phase of LV winding may be the high impedance fault along with overloading. High impedance faults are often caused due to trees touching the lines. This causes continuous heavy earth fault current which may lead to failure. Since this transformer was installed in a remote rural area, routine maintenance i.e. trimming of trees might not have taken place.

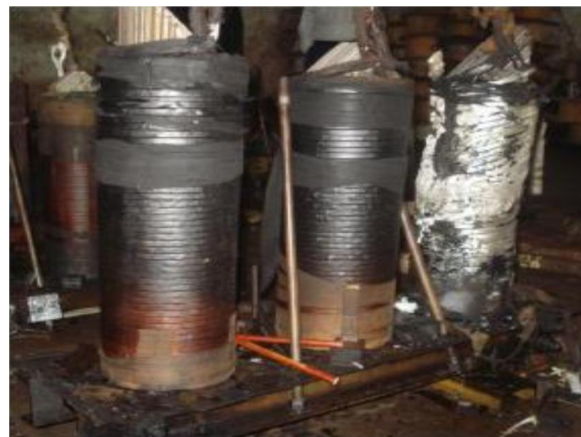
Figure 9

insulation were also found in severely burnt condition as shown in Fig. 9

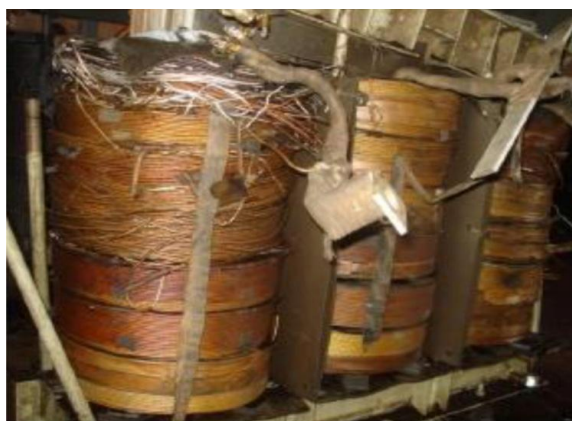
It was found by inspection that all three HV windings were severely damaged. Figure 10 gives the view of HV winding and clearly shows the burnt condition. One phase of LV windings was found in burnt conditions shown in Fig.11 Remaining two phases of LV windings were in healthy condition.

Overloading/unbalanced loading is the major cause of failure of this transformer. This overloading/unbalanced loading may be due to new connections to consumers above the capacity of the transformer or due to power theft. Often a number of new connections are added to the existing transformer without calculating the load which it can supply and line operators connect these new loads to the most reachable conductor i.e. B phase. Unequal loading in three phase causes over loading in one phase.

Theft of power by hooking the power line has been a regular phenomenon in both rural and urban areas. It can be assumed that power theft by some of the consumers might have been done by hooking the approachable bottom most conductor i.e. B phase of the system. This resulted into severe overloading and burning of B Phase of LV winding as shown in Fig.11. The B phase of HV winding was also overstressed by this overloading and got damaged as shown in Fig 10. Oil samples are taken from each transformer for DGA and all results are reported in Table I.

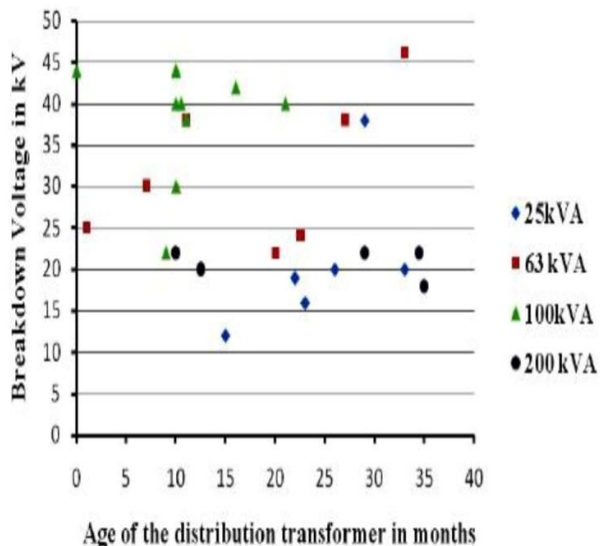
Figure 15 BDV of the oil specimens of present study

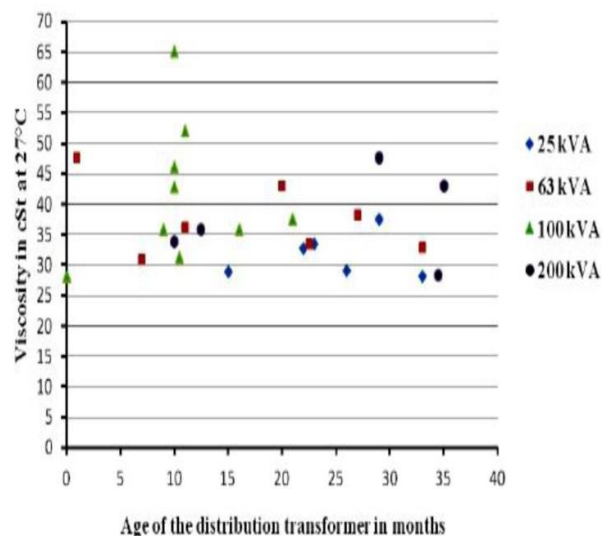
Figure 17 Viscosity of the oil specimens of present study

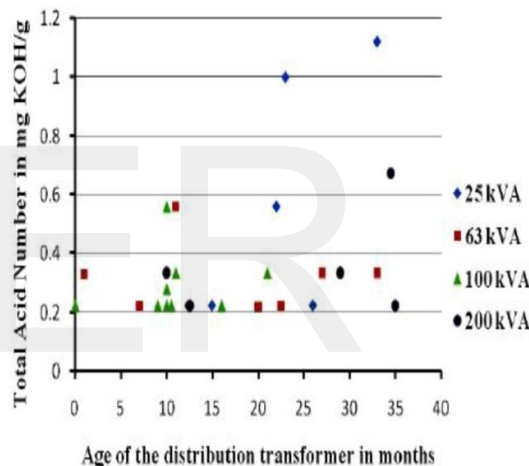
Figure 22 Total Acid Number of the oil specimens of present study
