Quality Improvement in Finished Cold Rolled Sheet by reducing the defect

Ranjan Prakash*, Baidya Nath Roy**

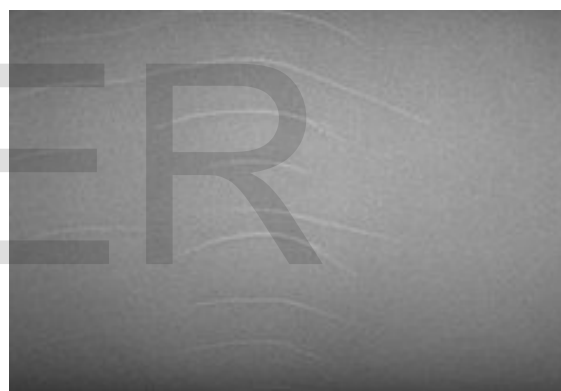
D. General stickers: General stickers are irregular kinked lines which take on a sickle-shaped appearance with increasing width (50 to 400 mm wide) and are mainly distributed over a large area in the centre of the strip, with reference to its width. They are also referred to as flowing material shapes or Luders lines (see also Fig. 1).

Fig: 1.0 Sticker Mark

Because of the crown of the strip and the resulting higher pressure on the strip centre, the flaw is positioned in a large area at the centre of the strip width in the case of strips with an optimum symmetrical profile. If the crown of the hot strip, which determines the profile of the cold strip, is too high or too sharp, the result may be a narrow but very pronounced track of stickers along the centre of the strip width. Strips with profiles which are too low or too flat may have very wide sticker areas or sticker tracks in the outer thirds of the strip width. In the case of strips which have a slightly wedge-shaped, asymmetrical cross section, the stickers will be located away from the central position at the highest part. The creation of general stickers is affected by a wide variety of process parameters, some of which have contrary effects. The causes of stickers and possible countermeasures are considered below. General stickers and their causes Stickers are created on the temper mill when coils annealed in a bell-type plant are uncoiled if the force required to open or separate the coil windings is in excess of the yield strength of the annealed material.

13. Stickers: Low tension in Tandem mill gives less residual stresses inside the rolled sheet by which sticker defect can be minimized. Annealing temperature should be kept as per grade of the material it should not be higher than the proposed annealing temperature.

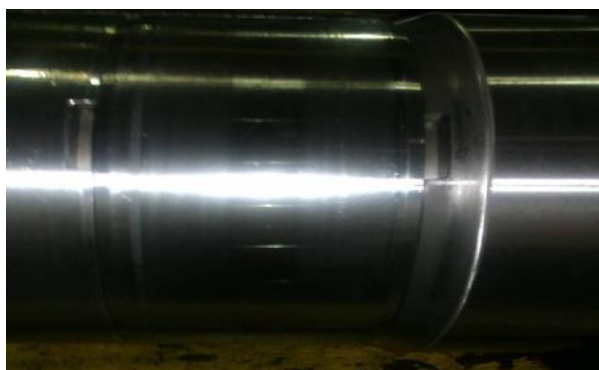
A survey of mill elements known to contribute to chatter was made, identifying defects in the work roll bearings inner races that were likely to create similar markings to the ones experienced in the mill, as shown in Figure 2. These defects were present in all the mill work rolls and were likely created during the chocking and de-chocking operations. [16].

Fig: 2 Defects in work roll bearing inner races

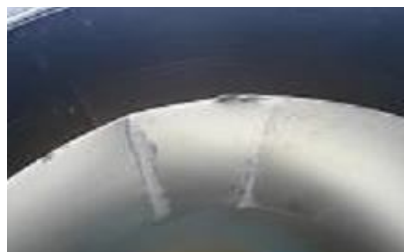
The line marks are observed running perpendicular to rolling direction in both inner and outer wraps of coils during inspection. They come in the form of lines or flowery pattern per-

pendicular to the rolling direction extending from one edge of the strip surface as shown in Fig.3. The pitch of the defect is the circumferential distance of the inner wraps (about 2mts.) and gradually reduces in intensity towards centre portion of the coil.

Fig.: 3 Tong mark defect as seen at Recoiling line

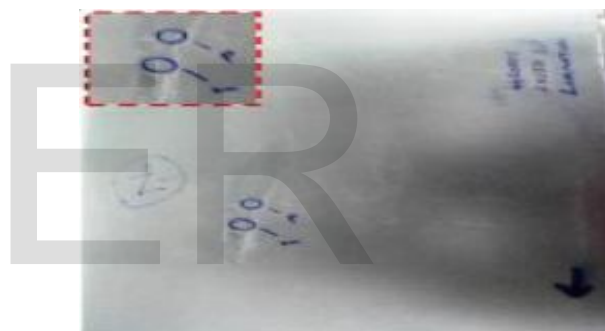
This is the slag and oxidized metallic inclusions at the surface of the internal pipe due to solidification shrinkage prevent welding during hot rolling. This defect is similar to sliver but the peeling surface is more extensive. This defect may arise from exposed blowholes. When surface have oxidized and fail to weld up during hot rolling.

Fig: 4 Sample of Lamination defect.

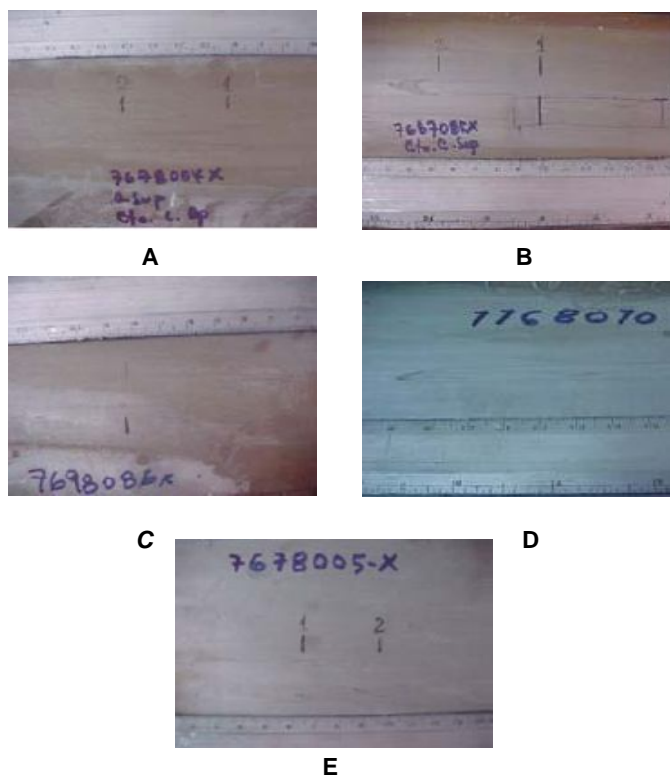
Fig: 3 Metallographic specimens cut out from tested coils

The position of defects, with respect to the strip width, is different from one strip to another, consequently seems not to be related to rolls or equipment damage, even the defects appearance is quite similar, width of 8-15mm and length from 70 to 100mm. After un-etched metallographic examination of specimens cut longitudinally with respect to the rolling direction it can be observed for A coil (Fig. 3), the defect consists on sub-surface iron oxides which have variable thickness (max. 26µm) and are found along the surface at the depth varying in the interval: 16-23µm.

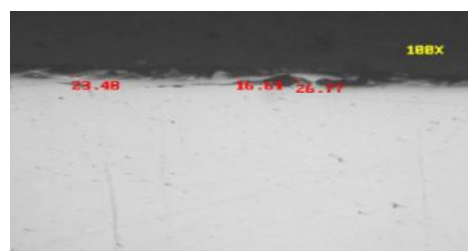
Fig.: 4 Un-etched specimens (A coil)

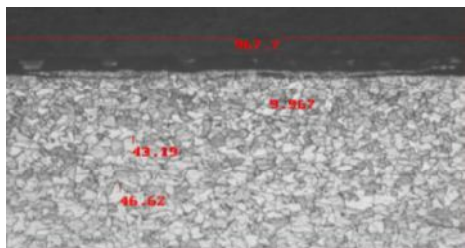
The same defect has been observed for specimen no.2, the maximum depth being 26µm. In Fig.4 shows that the defect belongs to a region without decarburization and the average grain size increases from the surface, where is 9, to 5-6 at 400µm depth.

Fig.- 5 Metallographic examination of (A coil; x100)

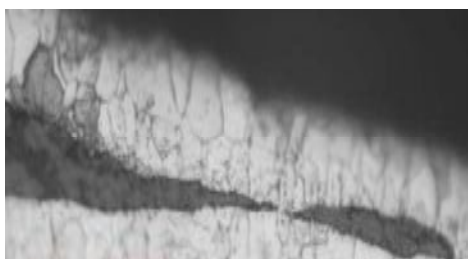
In Fig.6 is shown the defect zone at x500 magnification and can be seen the decarburization in the zone of defect.

Fig.- 6 Etched specimens (A coil; x500)

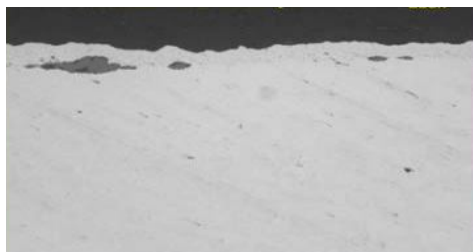
The same results has been shown in Fig.7 for the specimen no.2, which is at 3cm distance from the specimen no.1.

Fig.- 7 Un-etched specimens (C coil)

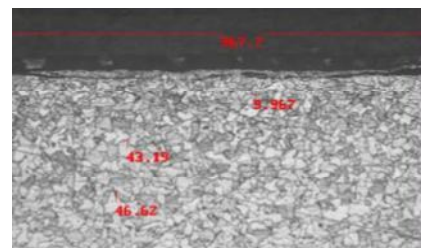
In Fig.8 is shown the specimen no.1 from C coil in etched condition. It can be observed that the defect is discontinuous and some regions of it are connected to the surface.

Fig.- 8 Metallographic examination of etched specimens (C coil; x100)

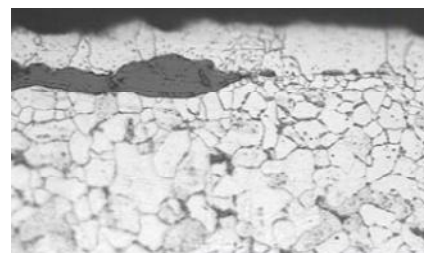
Fig.-9 Metallographic examination of etched specimens (C coil; x500)

In these figure (Fig.9) can be observed a light decarburization, but only along of a one grain size depth. In Fig.3D is shown the defect on the surface of D coil and the position for cutting of metallographic specimen. From Fig 10 can be observed that the defect is similar to the previous presented and consisting of rows of iron oxides along the strip surface and at a depth of 30-40µm.

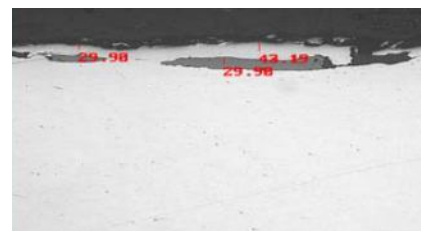
Fig.- 10 Un-etched specimens (D coil).

The defect thickness varies between 20 to 36µm.

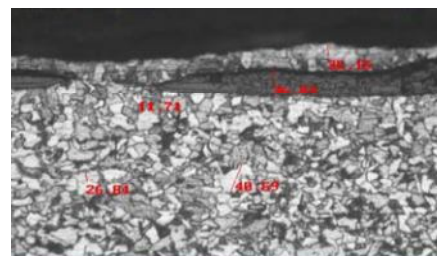
Fig.- 11 Etched specimens (D coil; x100)

In Fig.11 is shown the etched image of the specimen and can be observed the grain size variation across the thickness and the absence of decarburization along the iron oxides from the

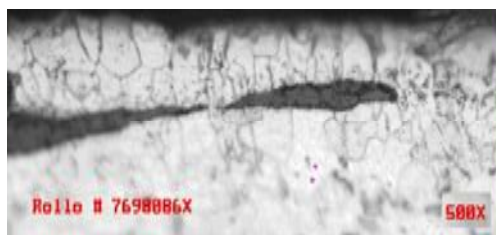
surface. In Fig. 12 is shown the defect zone at x500 magnification and can be observed the decarburized zone over the defect.

Fig.-12 Etched specimens (D coil; x500)

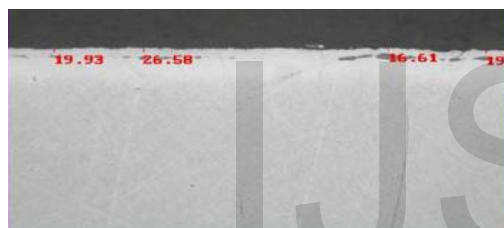
Metallographic examination at the same magnification performed over another zone of the specimen far away from the defect is shown a decarburized zone with the same depth as in Fig.12. In Fig.3E is shown the E coil surface defect. From the sample presented in this figure has been cut a metallographic specimen, cross to the defect, at 5cm from the defect tip. In Fig. 13 is presented the un-etched image of the strip cross section in the defect zone and can be observed that under the strip surface there are rows of iron oxides which thickness varies between 10 to 17 μm and they are at 16-27 μm under the strip surface.

Fig.-13 Metallographic examination of un-etched specimens (E coil)

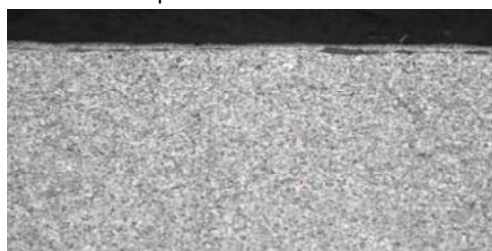
In Fig.14 the fine granulation of this strip has been observed the cross section of the specimen in the area of defect zone.

Fig.- 14 Etched specimens (E coil; x100)

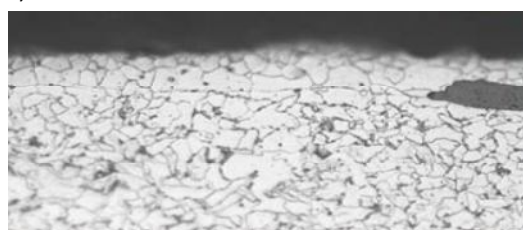
In Fig.15 the same thing has been observed at higher magnification (x500).

Fig.- 15 Etched specimens (D coil; x500)

At this magnification can be observed that the iron oxides are connected to the surface by very fine cracks, which cross the grains, parallel to the specimen surface. A light decarburization has been observed over this crack.
