# Root cause analysis of formation of Black/Brown patch defect on cold-rolled steel sheet surface

# Muhammad Bilal<sup>\*</sup>, Ayesha Naseer<sup>\*\*</sup>

"NED University of Engineering & Technology, Pakistan. Department of Industrial & Manufacturing Engineering" "NED University of Engineering & Technology, Pakistan. Department of Materials Science and Metallurgical Engineering"

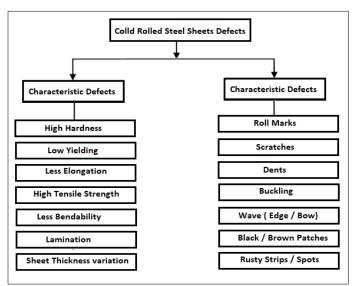
Figure-2: Some common defects of cold rolled steel sheets

These defects, as shown in Figure-2, are harmful from the quality perspective as the are not desired by the end customer. These defects create problem in mass production of manufacturing parts during the production. Every defects has its own nature, initiation point and initiation root cause. Similarly each defect can be minimized by focusing the individual parameters to root out the cause and eliminate it. Less the defects are more suitable is the sheet for the customers. A few defects are minor in their nature while many others including Black Patches are severe in its nature depending upon its quantum. Many dark spots on both surfaces of rolled sheets have been observed in the cold-rolling steel sheets during the manufacturing of sheets. Majorly in the shape of elongated patterns, varying in color from dark gray to black. This not only adversely affects the quality / physical appearance of the finished sheets, but also creates unfavorable conditions when coating the steel strip with zinc during galvanizing on the sheet. [5] For sheet metal used in automobile and manufacturing industries, cold rolled sheets over hot rolled sheets are preferred due to their excellent mechanical properties and surface finish. As A2-Wheeler, 3-Wheeler and Multi Wheeler cold rolled coils are utilized in manufacturing [6]. In cold rolling, metal working is done by passing sheets from roll Pairs. Coil proceeded for annealing is again processed for skin pass purpose which enhance yield point by cold reducing to less than 2% and eliminate fluting phenomenon during forming. Also it Improves and Imparts strip flatness, roughness and surface texture.

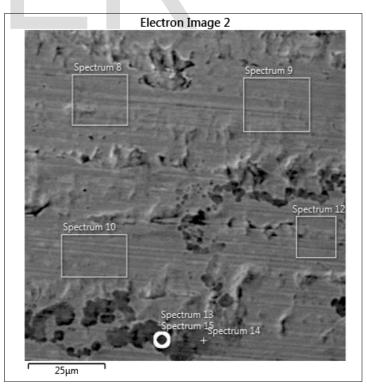
Picture-5: SEM Image Result of the Black Patch surface of sheet

Spectrum-14 and Spectrum-15 from the Figure-5 were deeply analyzed to determine the constituents. Spectrum results are available in Figure-6 and Figure-7. These graphs are helpful to find the root cause of the black layer formed on the defected steel sheet surface.

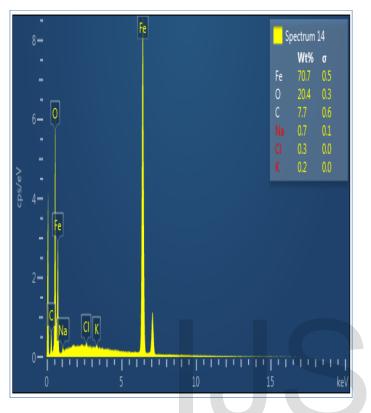
Figure-6: Spectrum-14 Results of the Black Patch surface sheet

Results suggests a highlighted group of elements like sodium, Potassium and Chlorine present at the surface having Black/ Brown Patch. To properly analyze the spectrum of defect free portion has to be taken into account.

If we compare both the spectrum-6 and Spectrum-7 as shown in Figure-9 and Figure-10 of clean surface and Spectrum-14 and Spectrum-15 of the defected potion of the sheet as shown in Figure-6 and Figure-7, there comes a clear idea of presence of additional elements of Sodium, Potassium and Chlorine. Therefore, Oxides of Chlorine and potassium can be the possible material provider of the Black Patch defect.

It is recommended that the Rinsing (Water Cleaning) of the coils must be taken with care to reduce the residual chloride on pickled surface. The control of chloride ion concentration should be less than 3mg / L. To achieve this, wringer rolls at the end of all Acid concentration tank should be cleaned properly to avoid the strip surface residual chlorine ions.

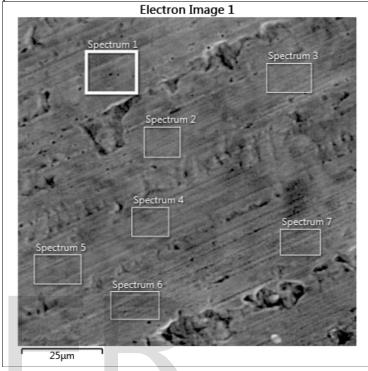
Figure-8: SEM Image Results of the defect free surface sheet

Spectrum-6 and Spectrum-7 from Figure9 were selected to investigate the results.

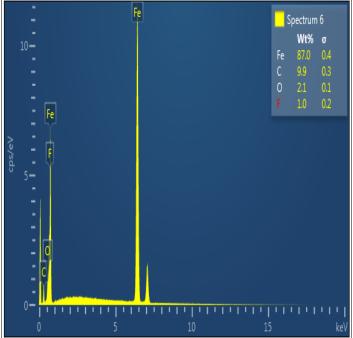
IJSER © 2020 http://www.ijser.org Figure-9: Spectrum-6 Results of the Clean surface sheet

Figure-9 specifies the spectrum-6 graphs of the clean surface of the steel sheet.

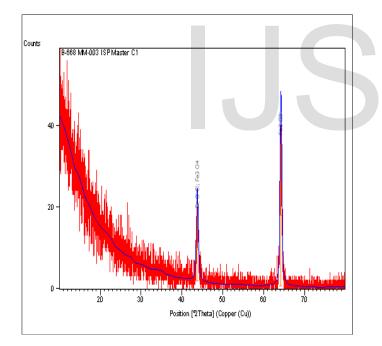
Figure-11: XRD Spectrum of Black Patch portion

A clear indication of FOCI compounds is visible in the spectrum of the defected portion. This indicates the possible activation of chloride ions carried by the sheet surface from the pickling or HCL cleaning process.

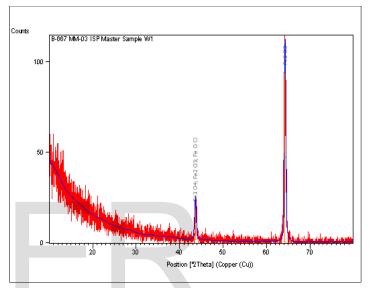
Figure-12: XRD Spectrum of Defect Free portion

Compared with the above results Shown in Figure-11 and Table-6, the defect free portion of the sheet was also tested and results were obtained as defined in Figure-12 and Table-7;
