Conservation and Restoration Research on 2nd BCE Murals of Ajanta

Abstract

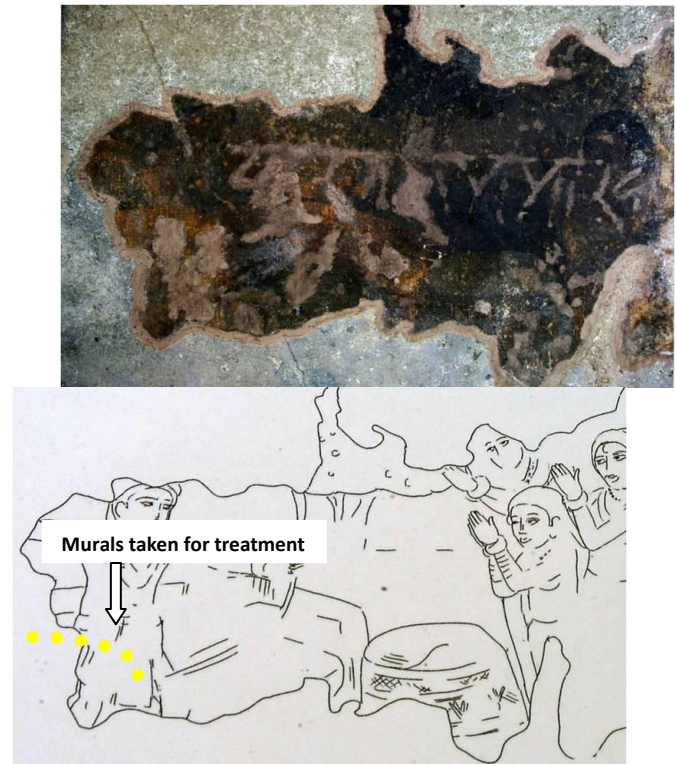
Figure-3 showing the original painted plaster and its outlines.

As this part of the paintings were repeatedly applied with varnish coating for copying under the light of oil lamp in 19th century, the whole painted figure were totally covered under varnish layers accompanied with dirt, dust, smoke etc. Large expanses of bats dropping have made the painted surface further illegible by naked eye. Before undertaking any cleaning operation, it is essential to have at least a primary knowledge about the design and shape of the painted figures for ease in treatment. The panel painting was observed under an adjustable illuminated magnifier. The paintings were observed by this process though the thick layer of varnishes. Figure- 3 shows the original condition of painted plaster and outlines drawn after examining the painted surface

through thick varnish layer under magnifying lenses. As from the outside no figures are visible to naked eye due to thick varnish coats, the outlines helped the conservators in planning the conservation operation.

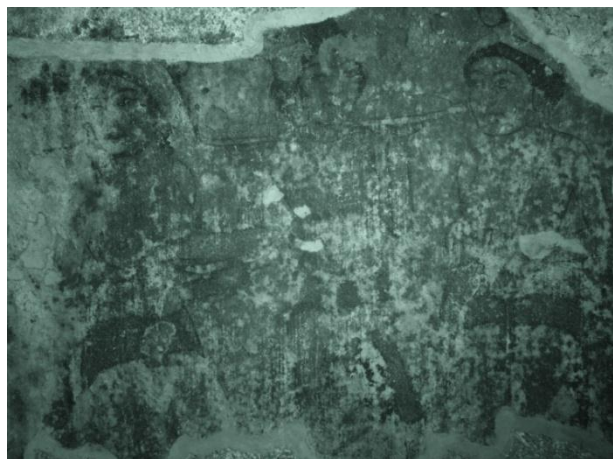
Figure-4 showing painting under IR light source

The painted surface was also observed under infra red light to visualize the painted surface and its condition. Figure-4 shows the view of the painting under IR light source. The outlines of the figures are very clearly visible under the IR light which is very thin and sharp, an essential characteristic of 2nd BCE painting. The missing part of the painting can now be easily seen. The bat excreta and soluble salts accretions over the painted surface is clearly visible. This has clearly given primary information about the painted figures, varnish layers and accretions present on the historic surfaces.

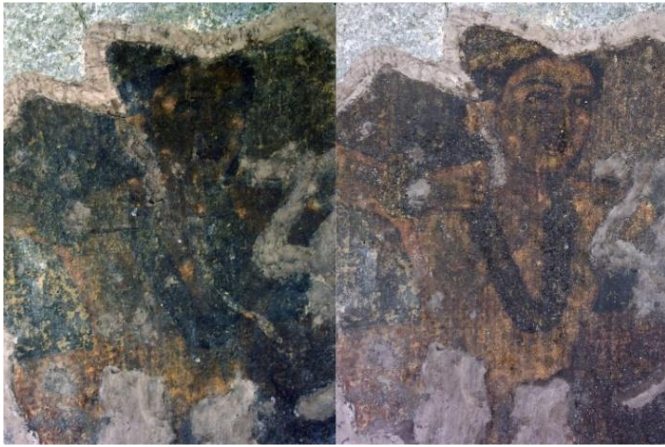
Figure-10 showing before/after conservation photographs Cave no 10, Ajanta.

For scientific cleaning of the paintings two different technique were applied. In the first technique, the mixture of organic solvents, two component system as described elsewhere¹⁰ was used to clean the surface with the help of cotton buds. In this process, it was ensured that the minimum quantity of cleaning solvent mixture was used for removing acceratory deposits of varnishes, dust, dirt, smoke etc. without giving any chance for the chemical mixture to seep into the ground of painting. The process is very delicate and exclusively depends on the dexterity and precision of the conservators. As the pigment layer in this panel is too thin, during cleaning operation it was not possible to reach up to the pigment surface with human eye due to great fear of losing any grain of pigment during the process of chemical treatment. Hence, the cleaning operation was carried out for superficial removal of 75-80% of varnish layer leaving 20-25% margin for cleaning by other sophisticated technique in future. The main purpose of the treatment was to reduce the thickness of varnish layer to render

the underlying surface to breath. Highest dexterity and precision was taken during the operation and figure-10 shows the before/after conservation work of the painting executed through this technique.

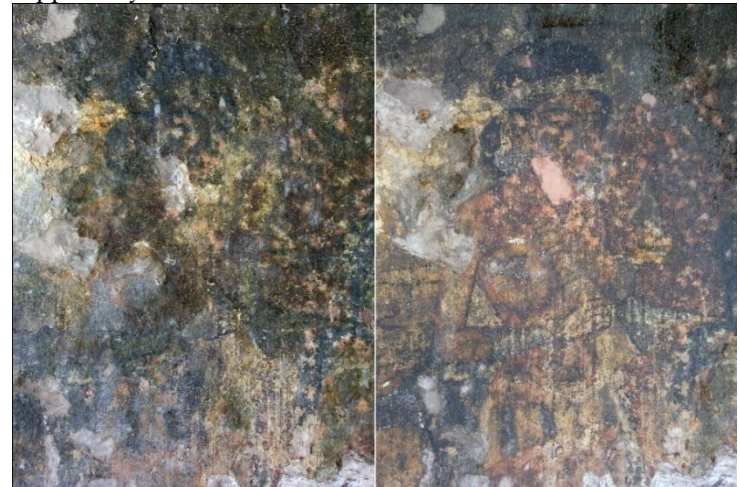
Figure-11 showing before/after conservation Photographs Cave no 10, Ajanta.

On the specific area, the Japanese tissue paper is stick with the appropriate concerned solution. The solvent gel chelante and concerned solution mixed properly is applied on Japanese tissue paper with fine brushes very gently. The solution is spread equally on the tissue paper and kept for 5, 10, 15 & 20 minutes as per thickness of the varnish layers. After this the tissue

paper was removed and the surface cleaned slowly with concerned solution with very soft brush with great precision and dexterity. Again precaution was taken not to reach up to the pigment layer and 15-20% of varnishes were left as such due to fear of losing any grain of pigment layer. Figure -11 shows the painting cleaned by this technique in this panel. All the chemicals used in the cleaning are the AR grade chemicals as supplied by the firm.
