# BUILDING COLLAPSE IN GEIDAM AND ENVIRONS: CAUSES, EFFECTS AND REMEDIES

<sup>1</sup>Kabiru, B., G.

<sup>1</sup>Department of Architectural Technology, Mai Idris Alooma Polytechnic, Geidam Yobe State, Nigeria

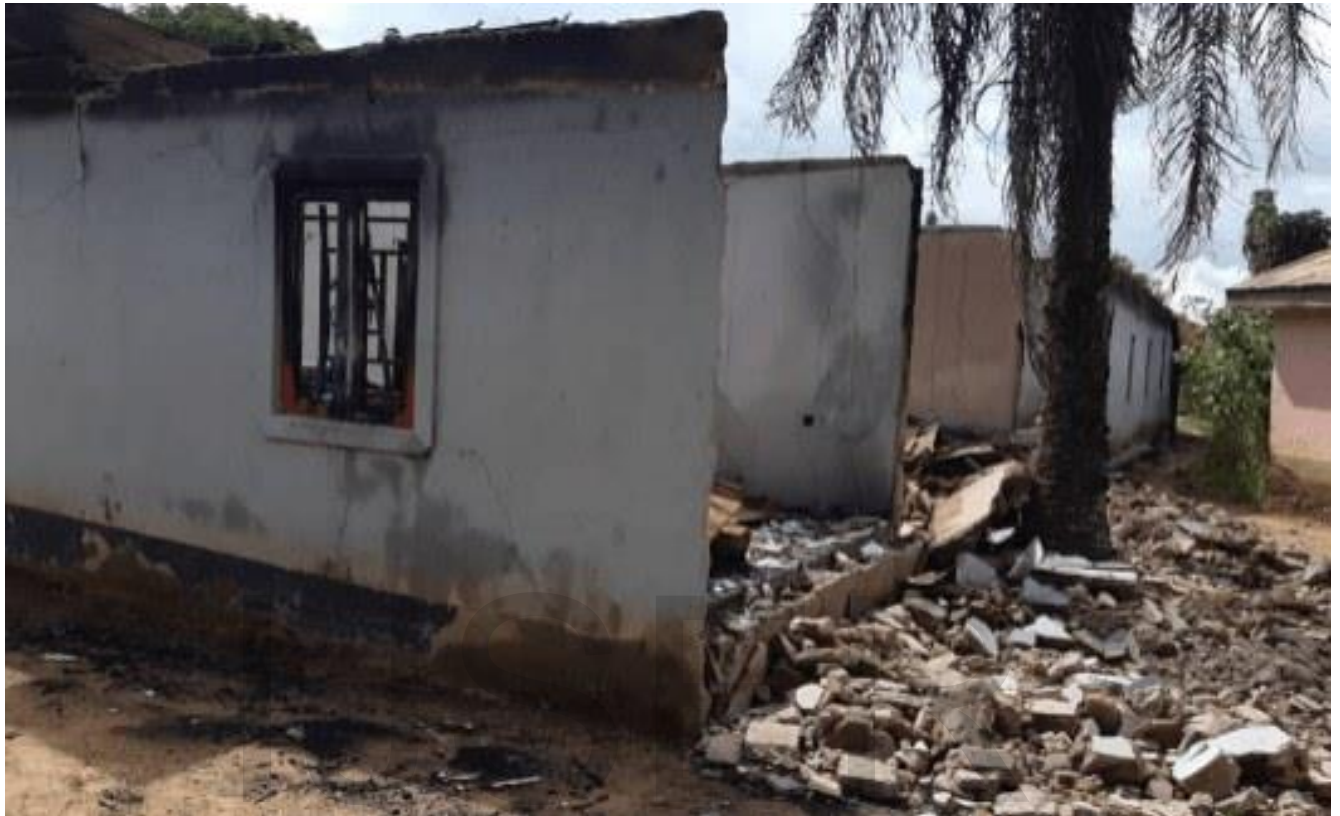
**Figure 1: Picture involving case study number 1; A collapsed 2 block of 3 bedroom flat at No. 45 along Kusurmari Street, Hausari, Geidam, Yobe State, Nigeria.**

Table 5 show the effect of building collapse from the economic point of view. Findings show a case study of a 2 blocks of 3 bedrooms flat that collapsed at No. 45 along Kusurmari Street, Hausari Ward Geidam, Yobe State. On the spot assessment revealed that the cost of the collapsed building was estimated as Ten million one hundred and forty seven thousand, three hundred and eighty four naira only (#10,147,384), which is about twenty five thousand five hundred and eighty nine dollars (\$ 25,589) at three hundred and ninety six naira to one U.S dollar exchange rate according to CBN as at Tuesday 16th February, 2021.

In the first case study (A case involving 2 blocks of 3bedrooms flat), findings revealed that an estimated cost of Ten million one hundred and forty seven thousand, three hundred and eighty four naira (#10,147,384) which is about twenty five thousand five hundred and eighty nine dollars (\$ 25,589) was a direct loss to the building owner. In the second case study (A collapse building of 3 bedroom bungalow), an estimated cost of twenty eighty million two hundred and thirty eight thousand, three hundred and thirty seven naira ( #28,238,337) which is about seventy one thousand three hundred and eight dollars (#71,308) inclusive of cost of demolition and cart away debris offsite was a direct loss to the building owner.

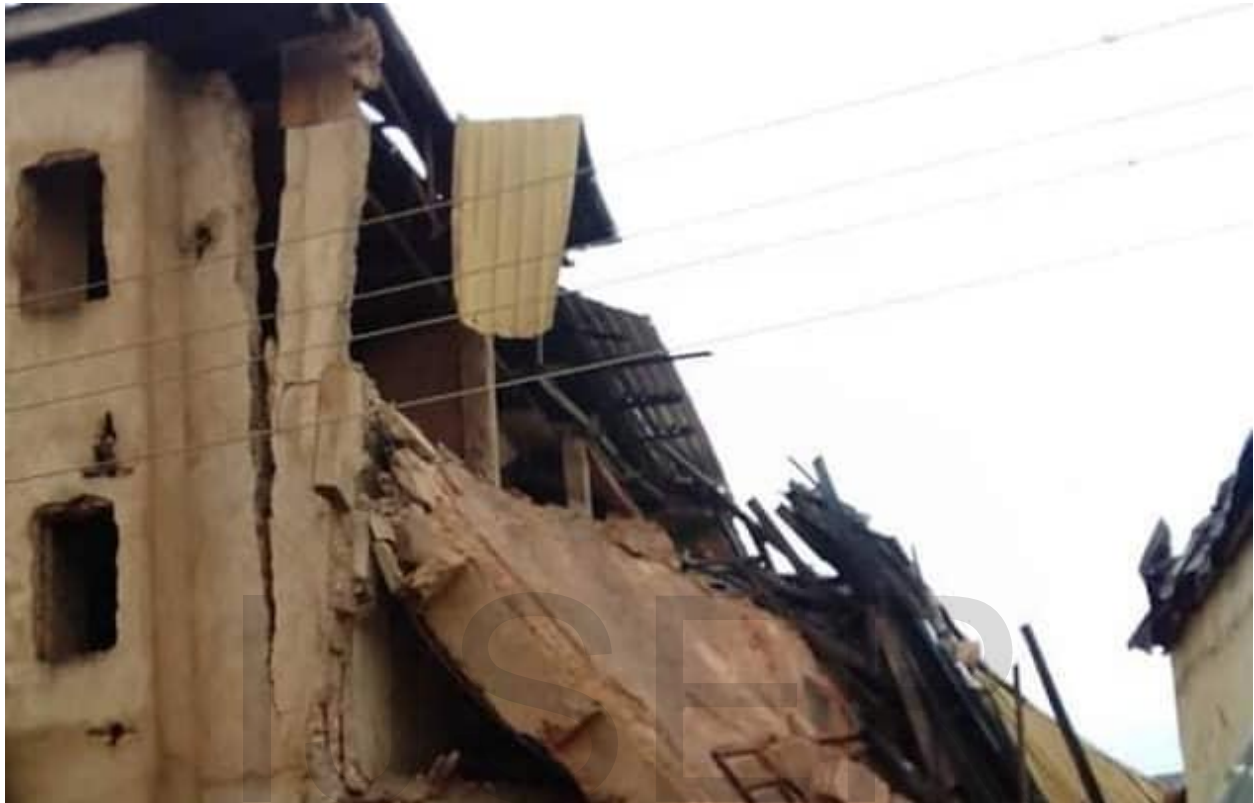
**Figure 2: Picture involving case study number 2; Collapsed 3 bedroom bungalow at no. 23 along Kolori Street, Geidam, Yobe State, Nigeria.**

Table 6 show a case study of three bedroom bungalow that collapsed at no. 23 along Kolori Street, Geidam while the building was already in use. On the spot findings show that the estimated cost of the collapsed building to the client was twenty eight million two hundred and thirty eight thousand, three hundred and thirty seven naira (#28,238,337) which is about seventy one thousand three hundred and eight dollars (#71,308) at three hundred and ninety six naira to one U.S dollar exchange rate according to CBN as at Tuesday 16th February, 2021. This is inclusive of cost of demolition and cart away debris offsite.
