Effect of Corrosion on Bond between Steel and Concrete of Corroded and Inhibitive Reinforcement Embedded in Reinforced Concrete Structures in Accelerated Corrosive medium

Charles Kennedy¹, Latam Leelee Prince³, Ugo Kingsley³,

¹Faculty of Engineering, Department of Civil Engineering, Rivers State University, Nkpolu, Port Harcourt, Nigeria.

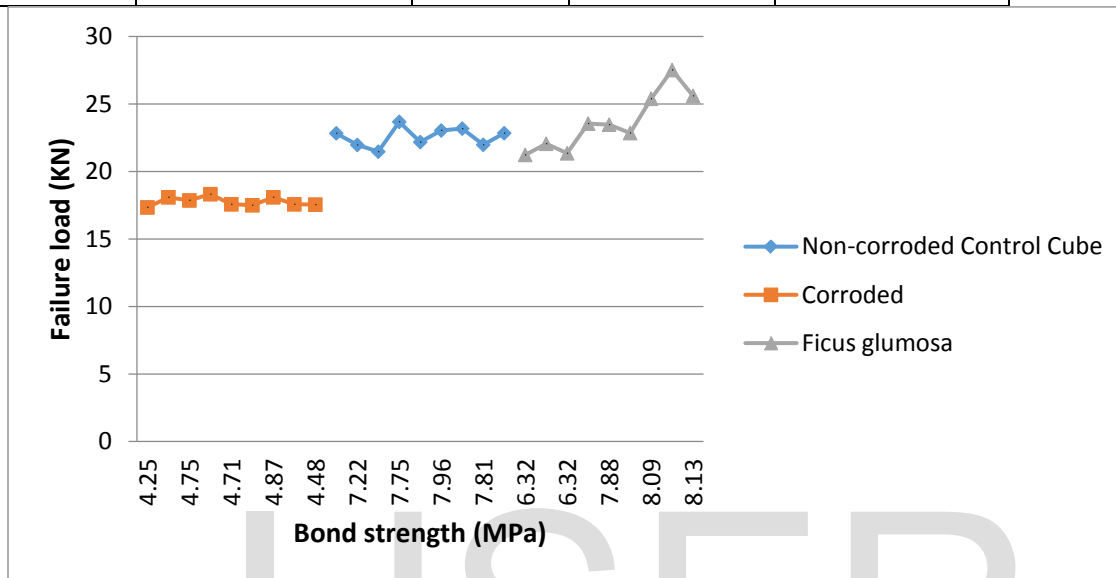
Figure 3.1: Summary Results of Pull-out Bond Strength Test (τ) (MPa) (Failure loads versus Bond Strengths)

Figures 3.1 and 3.3 are the plot of failure bond load versus bond strength and figures 3.2 and 3.4 are the plots of bond strength versus maximum slips. The plots of 3.1 – 3.4 explained the behavior of the steel reinforcement effect due to corrosion potential.

Tables 3.1 and 3.4 and figures 3.1 – 3.4 shows failure bond load, bond strength and maximum slip of 27.08%, 55.90% and 47.14% respectively.

Tables 3.2 and 3.5, figures 3.1 – 3.4 shows the results of pullout load bond, bond strength and maximum slip of 21.30%, 36.80%, 32.00%. When compared to results of non-corroded, corroded members have lower values.

Tables 3.3, 3.6, form the entire and average derive values of the results, figure 3.1 – 3.6 represented the plotted values of failure bond load versus bond strength and bond strength versus maximum slip. Observations from

experimental work showed the results of coated when compared to corroded has tremendous increasing values of failure bond load, bond strength and maximum slip of 33.60%, 62.40%, 88.2% against 21.30%, 36.80%, 32.00% of corroded respectively. This shows decreased in values in corroded members.

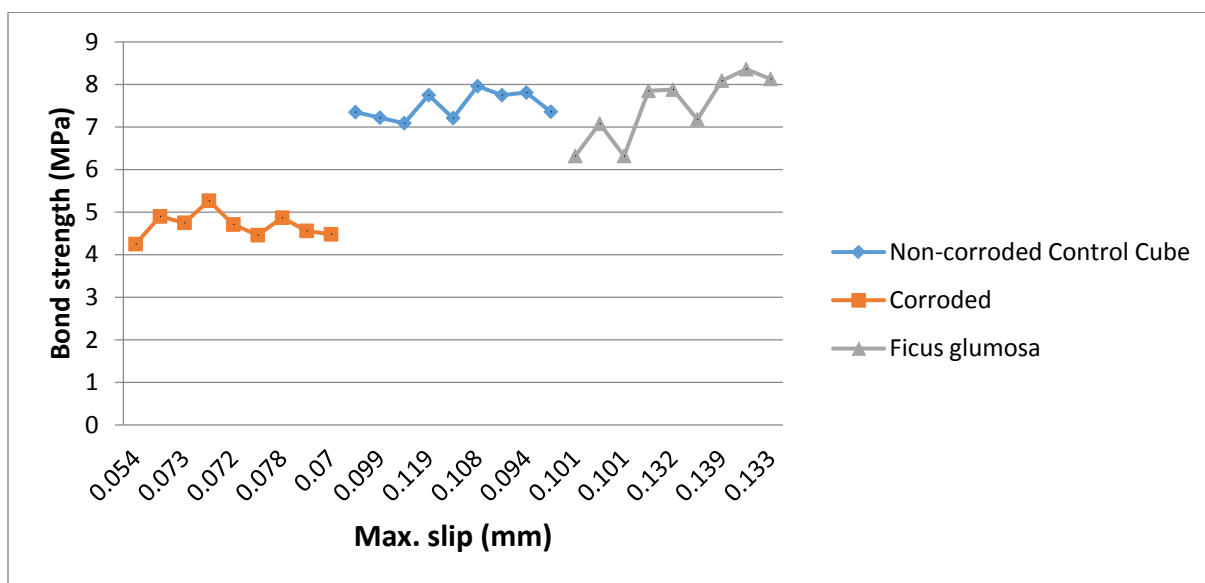
Figure 3.2: Summary Results of Pull-out Bond Strength Test (τ) (MPa)

(Bond Strength versus Maximum Slip)

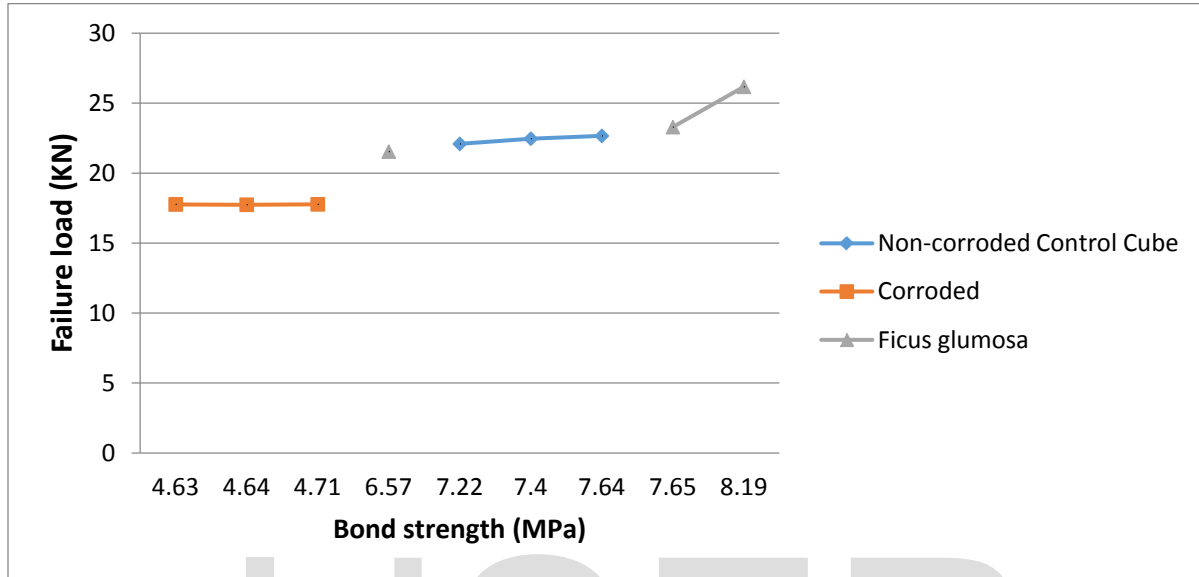
**Figure 3.3: Average Results of Pull-out Bond Strength Test (τ_u) (MPa)
(Failure loads versus Bond Strengths)**

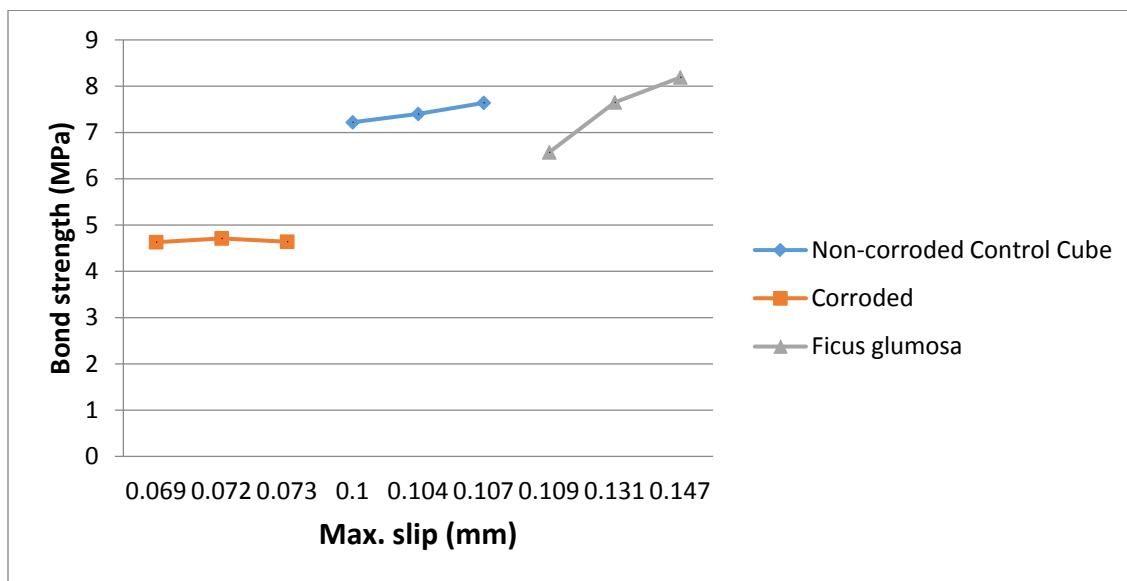
Figure 3.4: Average Results of Pull-out Bond Strength Test (τ_u) (MPa)

(Bond Strength versus Maximum Slip)
