Investigation of Existing Steel Bridges in Ho Chi Minh City

Dang Dang Tung¹

Index Terms— Steel bridges, deterioration, corrosion, inspection

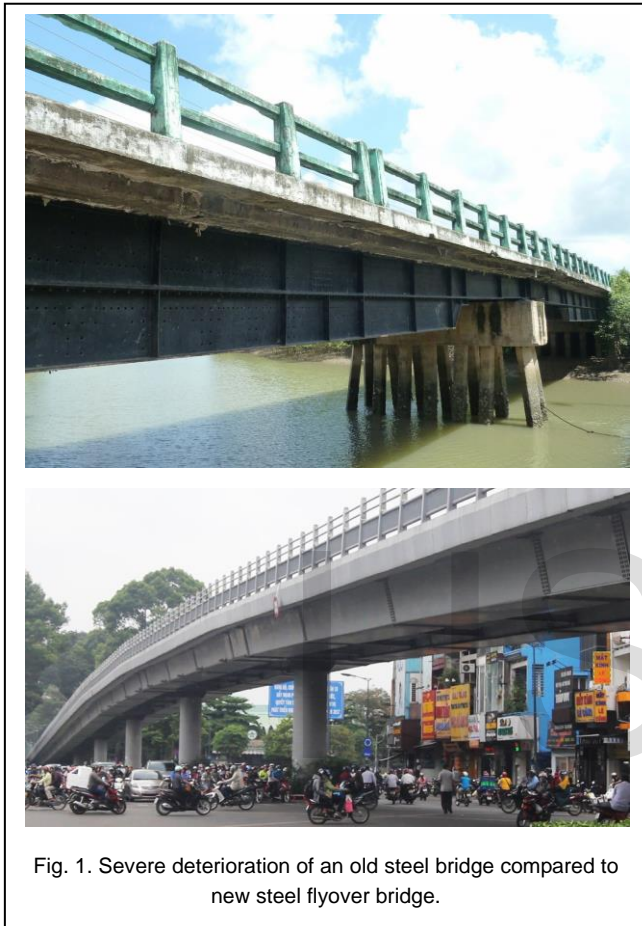
Fig. 1. Severe deterioration of an old steel bridge compared to new steel flyover bridge.

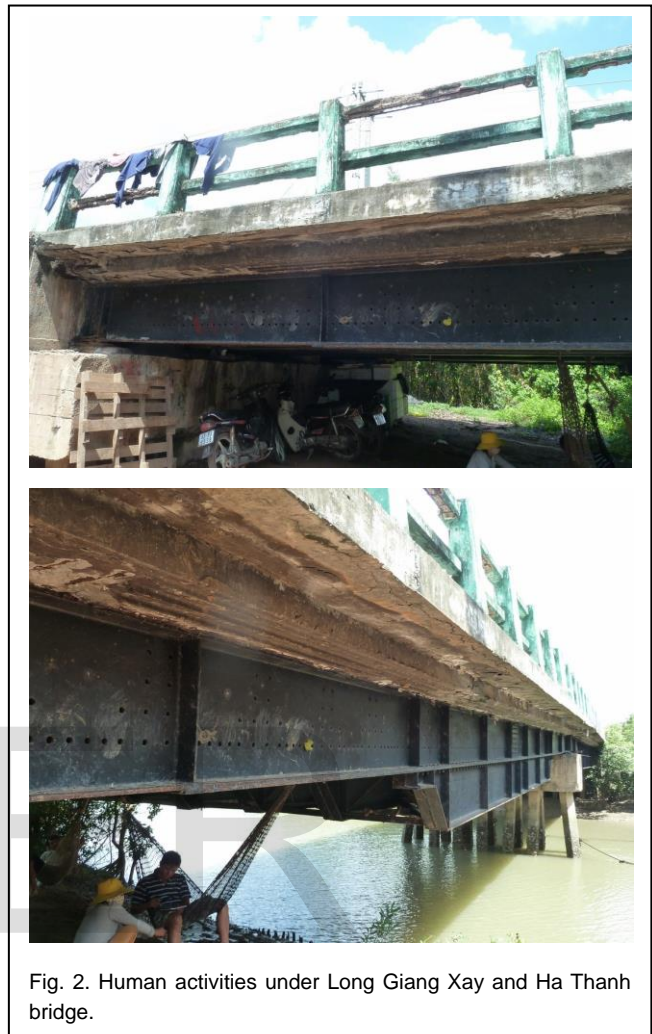
Bridge clearance spaces are used generally as flea-markets or street-front shops while their abutments can be used for anchoring vessels and barges as shown in Fig.2. There are many bridges that had pedestrian lanes invaded by residential sellers and pass-over buyers. These practices have created many problems such as narrowing of traffic lanes, creating congestions, and imposing extra loads to create unsafe conditions for traffic operations.

Fig. 2. Human activities under Long Giang Xay and Ha Thanh bridge.

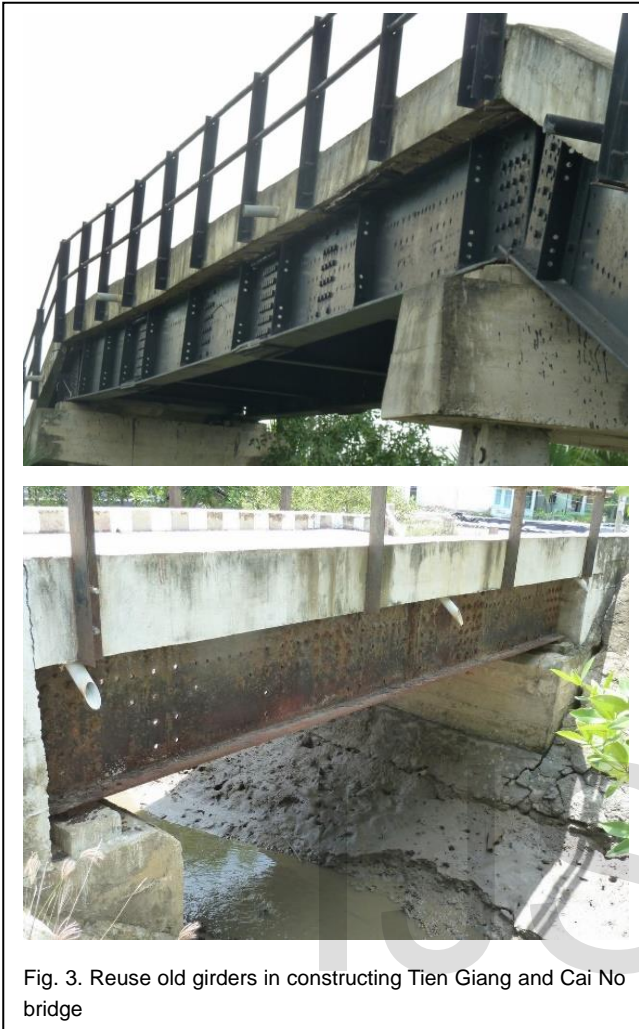
Fig. 3. Reuse old girders in constructing Tien Giang and Cai No bridge

The ability to reclaim old steel girders is an important advantage. This is represented clearly in case of HCMC. Fig. 3 shows the two bridges that were built of steel girders dismantled from other old steel bridges. With a limited budget for constructing new bridges, this solution really does the trick.
