PERFORMANCE ASSESSMENT OF URBAN DRAINAGE SYSTEMS OF HOLETA TOWN USING STORMWATER MANAGEMENT MODEL (SWMM).

^{a*} *Water Resources Engineering (Thesis: Performance Assessment of Urban Drainage Systems of Holeta Town Using Stormwater Management Model (SWMM)), Bule Hora University, College of Engineering, Water Resources and Irrigation Engineering Department, Ethiopia.*

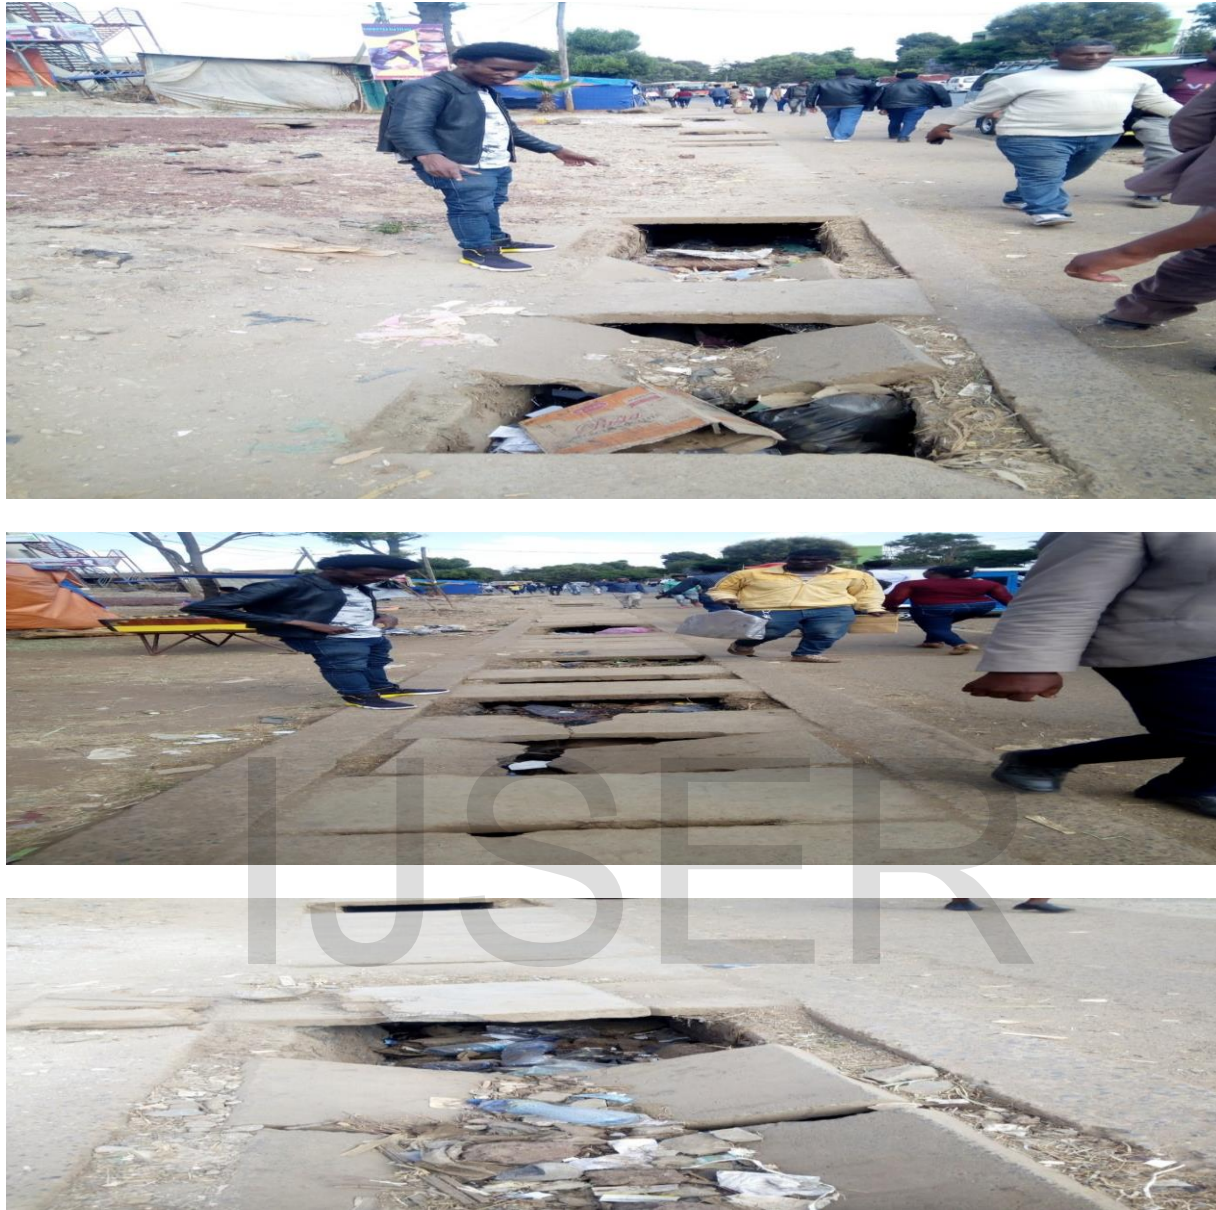
Dumping solid waste materials into the drainage system was the other challenge of the stormwater drainage system in Holeta town. Urban litter (alternatively called trash, debris, junk, floatables, gross pollutants, rubbish or solid waste) has become a major problem through the town. It typically consists of manufactured materials such as bottles, cans, plastic and paper wrappings, newspapers, shopping bags, cigarette packets and remains of chat. As a result of dumping such solid wastes into drains the drainage systems have been clogged and cause flooding over streets and drainage failures, as shown (Fig. 2).

Figure 2: Dumping of solid wastes

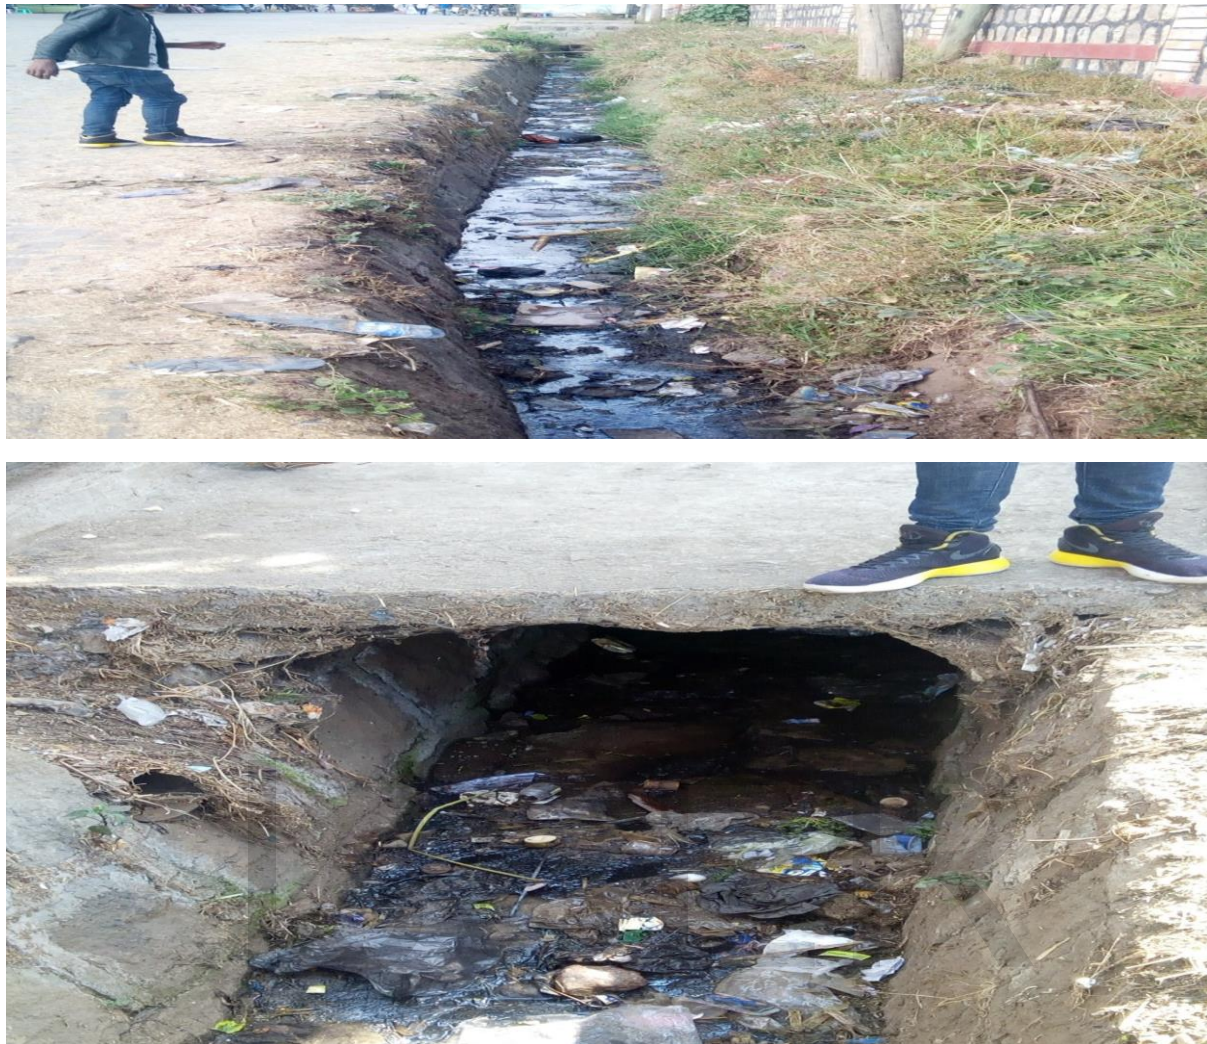
The liquid released directly into the drainage systems were gathering up pollutants along the way including motor oils and gasoline that leak from vehicles, waste from sewer lines and anything also that would float or dissolve in water. Prohibited joining of sewerage system into existing drains was one of the challenges which have been observed in this town. Most of the drainage lines in town accommodate as waste disposal and blocked by liquid and solid wastes. Aside from its' challenge to the drainage system, it could also cause a health problem and also it degrades the visual value of the environment, as shown (Fig .3).

Figure 3: Liquid wastes into storm drainages

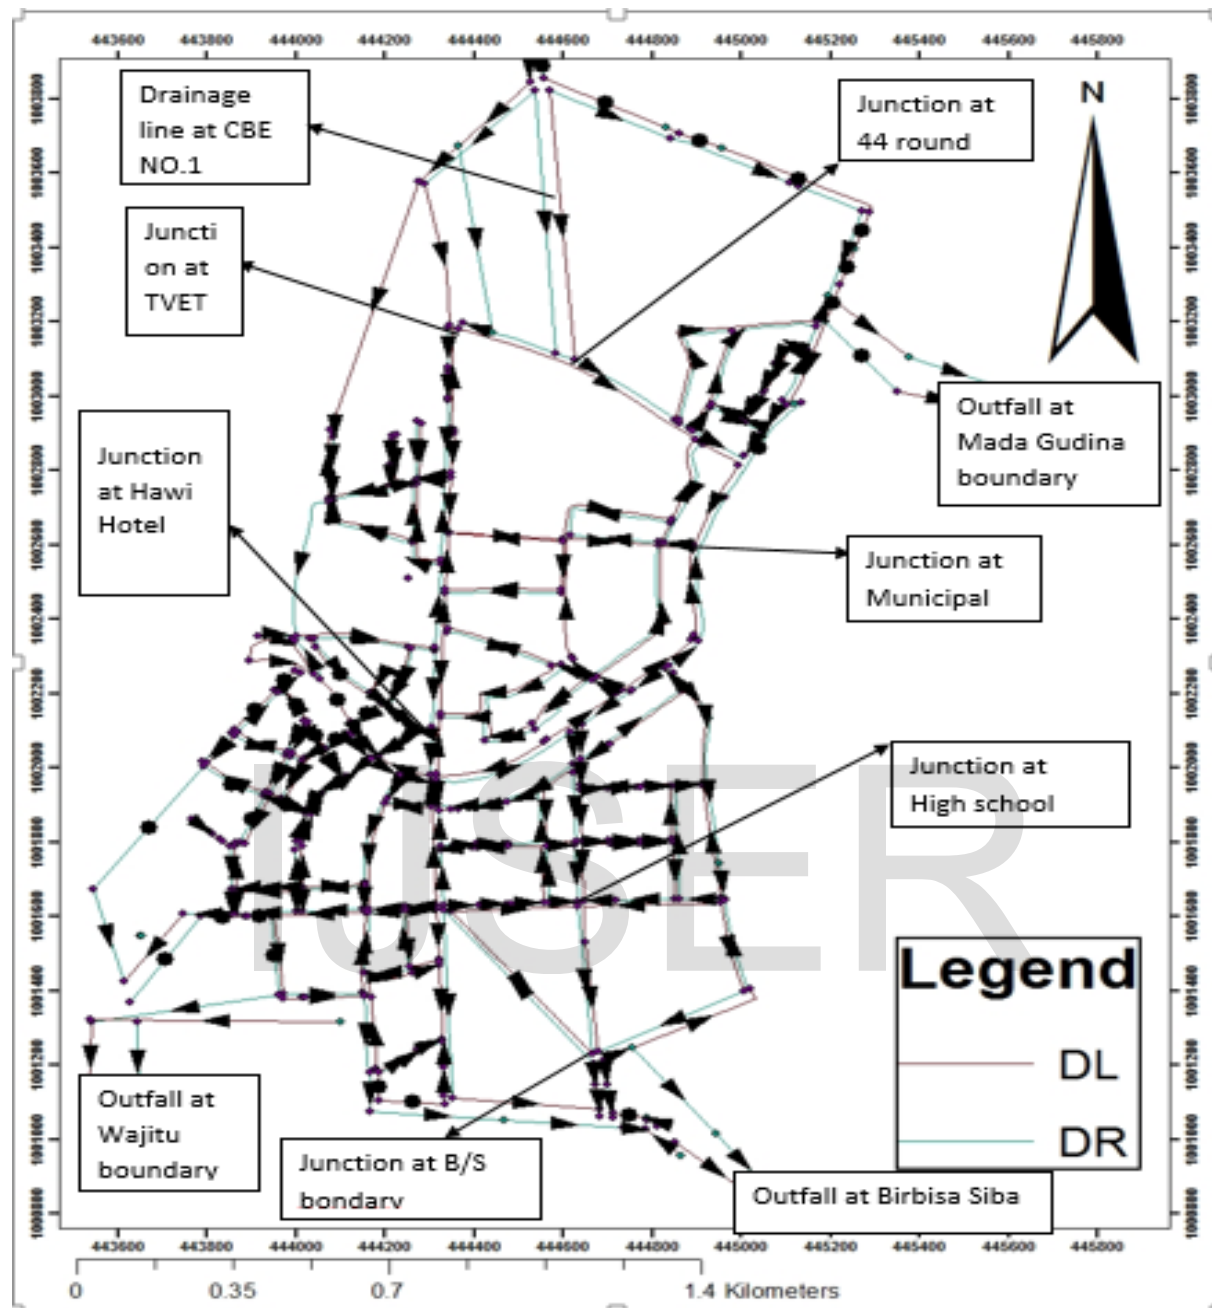
All runoff generated from the catchment would not flow towards the outlet. Because of the limitation that in urban environment runoff flows not only on surface but it also flows through manmade drainage structures such as roadside ditches. With the limitations in mind the catchment delineation can be taken as worst case scenario. So the proposed and existing drainage facility resulted based on the possible out flow direction. As a result the whole catchment of Holeta town has three outfalls boundary; Outfall at Wajitu boundary, Birbirs Siba and Mada Gudina boundary presented in (Fig. 4). Sub catchments were delineated based on the flow direction of the drainage structures of both right and left directions.

Figure 4: Drainage Network

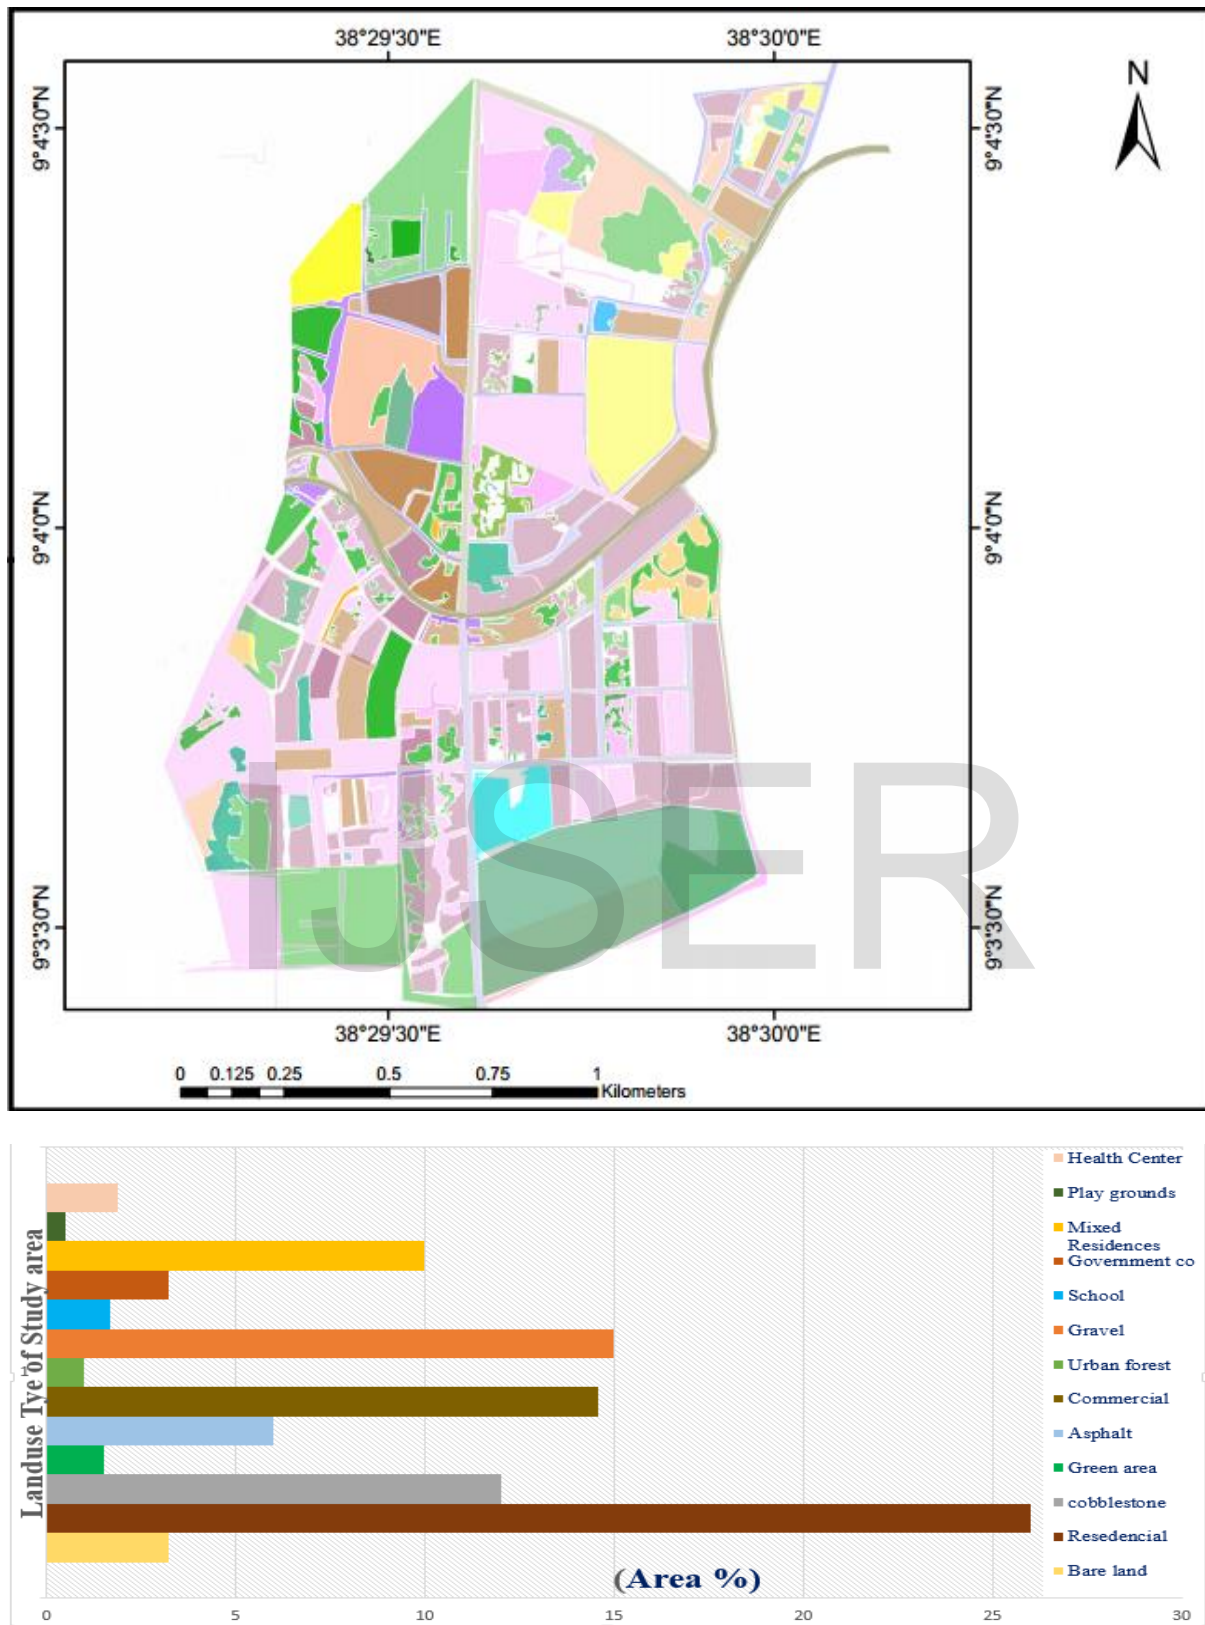
pervious and impervious surfaces who's dividing into many polygons. And these polygons classification of land features in Kml are too large to express the spatial distribution of rainfall-runoff production. Then the polygons with Kml are converted to layers by (ArcGIS 10.3) and are continued to divide into much more cells according to the separate social units. The cells are the sub-catchments for calculating rainfall-runoff. Then the total sewer shed can be divided into many polygons. The runoff contribution area of existing drainage canals was delineated based on the flow direction map by indicating the outfall boundary of the study area. The main result from sub-catchment area delineation was weighted runoff coefficient of each landuse those contribute the catchment of study area shown as (Fig.5).

Figure 5: Land-use type of study area

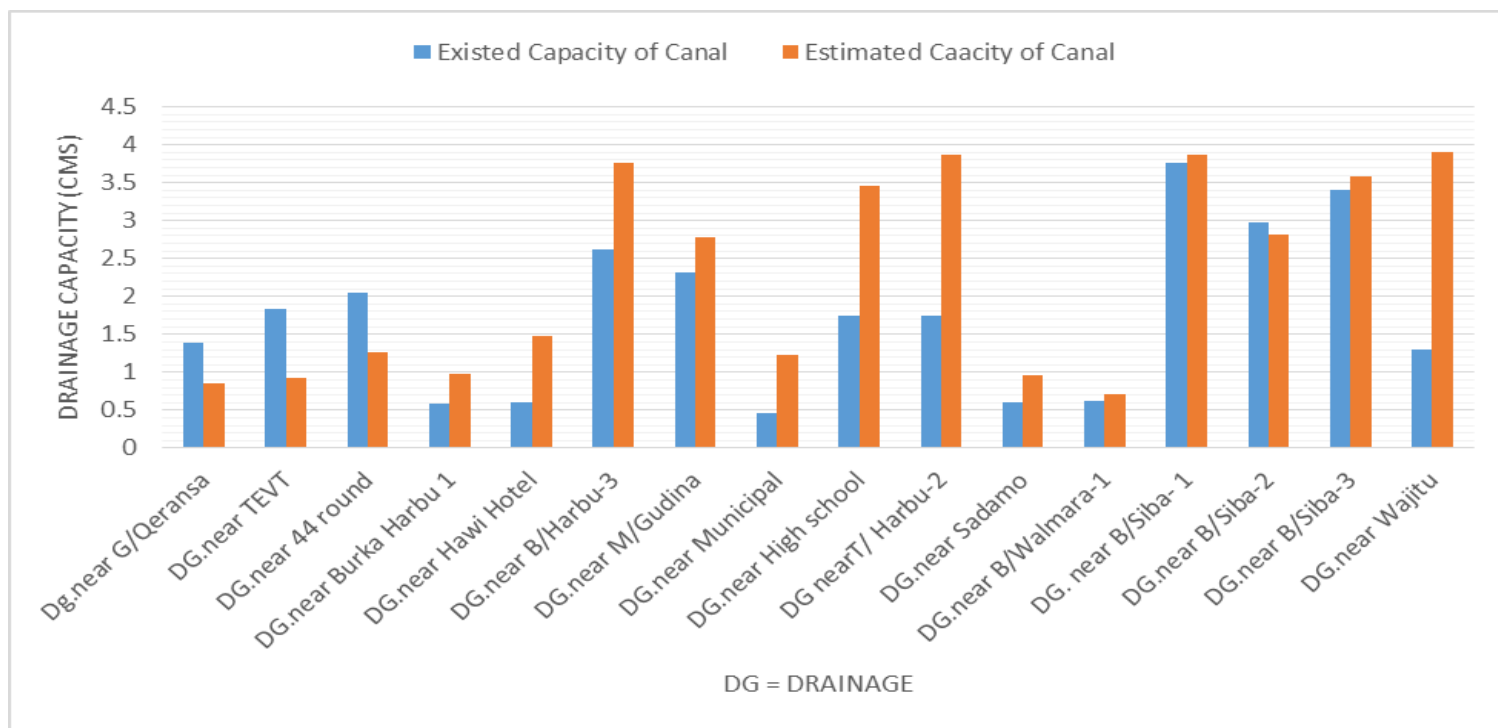
Figure 6: Capacity of Canal existed and estimated

The result obtained for a design period of 10 years as in (Fig.6), indicated that the capacity of existing drainage at Goro qerrensa, around 44 and at TVET were adequate. Whereas at Hawi Hotel, Municipal, Burka Harbu, Burka Walmara, Tulu Harbu, Wajitu outfall, High school, Sadamo and at Mada Guddina outfall, Birbirs Siba outfall the estimated drainage capacity of current runoff was higher than the existing one. That means overflow has happened in this area.

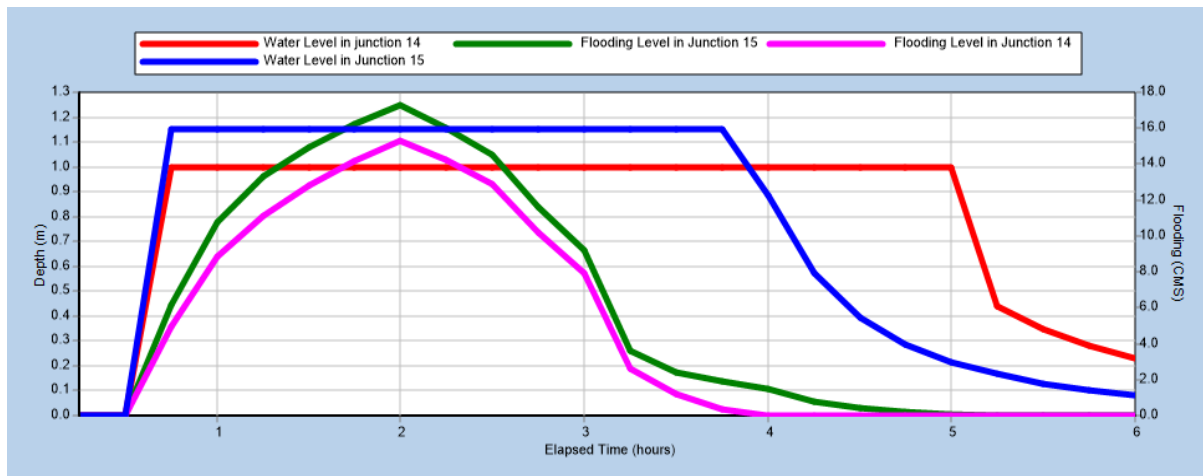
The maximum designed water level of drainage canal of junctions 14 and 15 near to high school were 1 m and 1.15 m respectively. The flooding level attained with 3hrs rainfall intensity in junction 14 is 1.1 m and in junction 15, 1.25m. Based on the simulation result of the model for the current land use condition, the designed canal depth was insufficient. Therefore there is the overflow of the water at junctions 14 and 15 due to inefficient canal capacity (Fig.7).

Figure 7: Designed water level and flood in junction-around High School

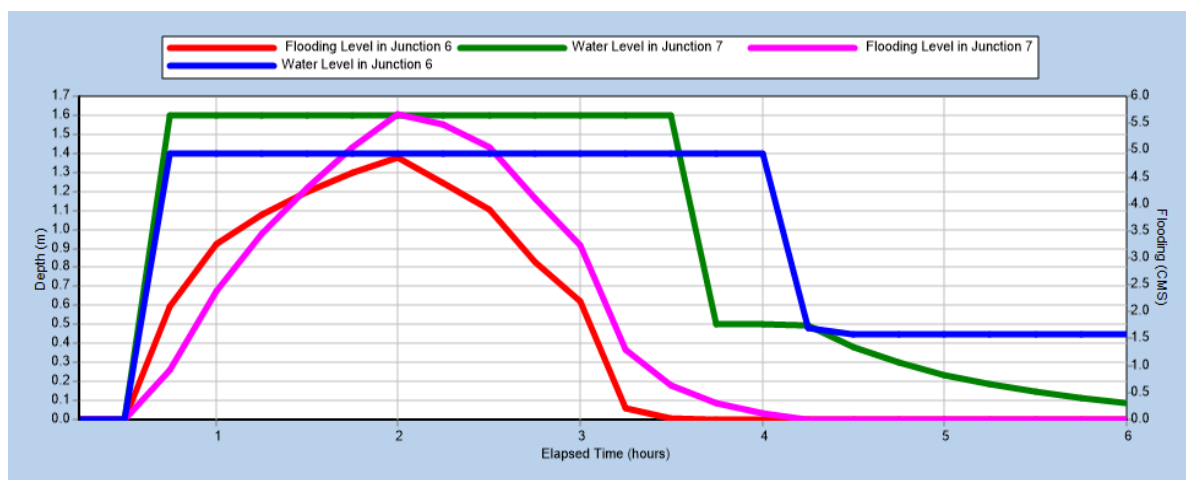
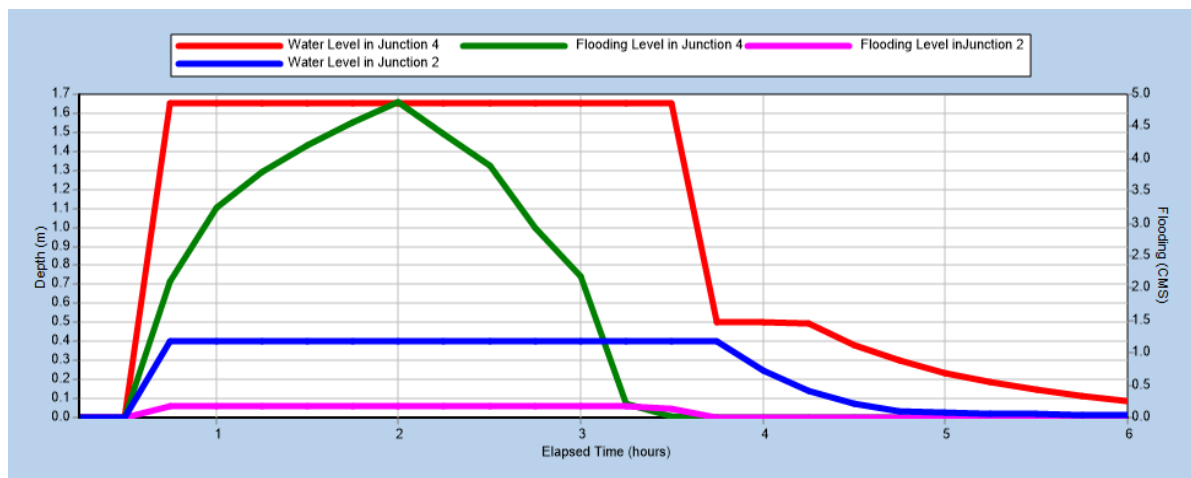
At around 44 areas the maximum designed water level of drainage canal of junction 6 and junction 7 were 1.4 m and 1.6 m and the flooding level attained with 3hrs rainfall intensity of each junction was equal to the maximum designed water level. As a result of simulation indicates the designed canal depth was sufficient and show that there is no flood at this location. Also near to TVET College, the designed water level of junction 2 and 4 were 0.4 and 1.65 m whereas the flooding level at the same junctions were 0.98 and 1.65 m respectively. That means the designed canal depth is sufficient. The simulation result shows that there is no flood around the area (Fig. 8).

Figure 8: Designed water level and flood injunction around 44 areas and TVET College

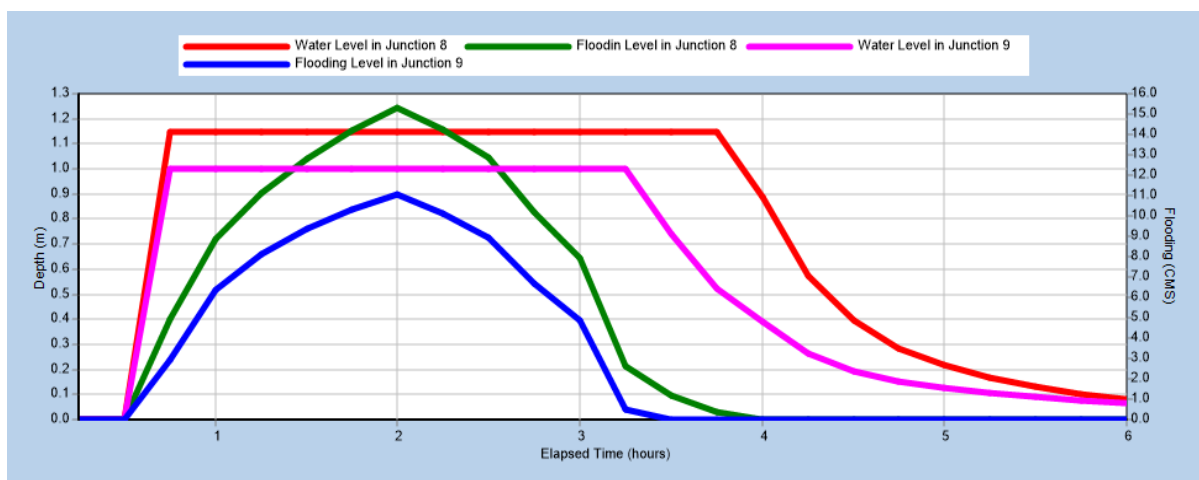
At in front of Holeta Municipal, the designed Water level of drainage canal of junction 8 and 9 is 1.15 and 1m respectively and the maximum flooding level for the 3hrs of rainfall intensity is greater than the maximum designed water level of junction 8 which is 1.25 m. The result of simulation indicates the maximum designed water level drainage canal of junction 8 was insufficient and the occurrence of overflow. Additionally, the maximum flooding level of junction 9 is less than of the maximum designed water level. That is the designed water level of drainage canal of junction 9 is sufficient and there is no overflow as the result of the model, but from the area of junction, the overflow was happened due to lack of management (Fig.9).

Figure 9: Designed water level and flood injunction around Municipal

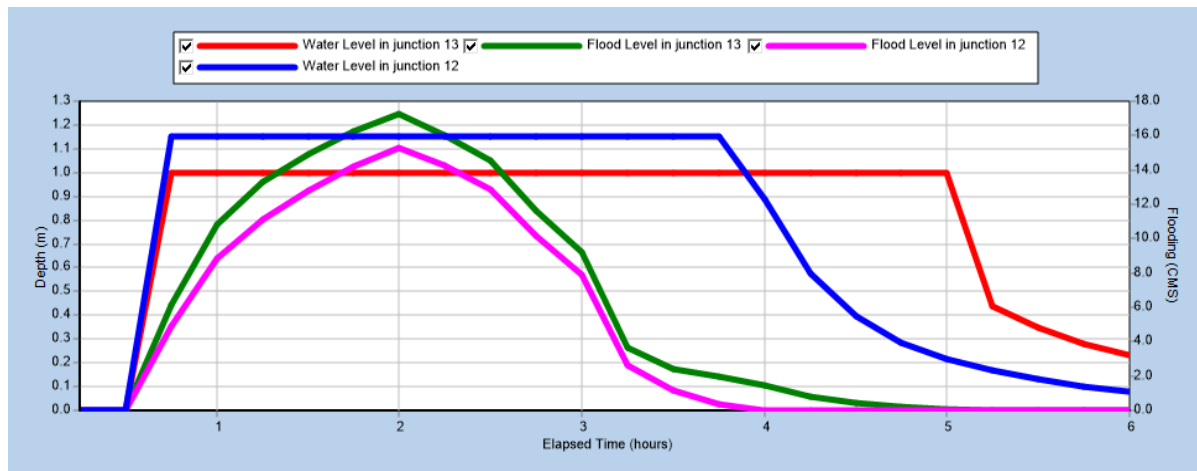
The maximum designed water level of drainage canal near to Hawi Hotel of junction 12 and 13 was less than the flooding level attained with 3hrs rainfall intensity. And the result shows that there is the overflow of water due to insufficient capacity of designed drainage canal of junctions 12 and 13 around Hawi Hotel (Fig. 10).

Figure 10: Designed water level and flood injunction around Hawi Hotel

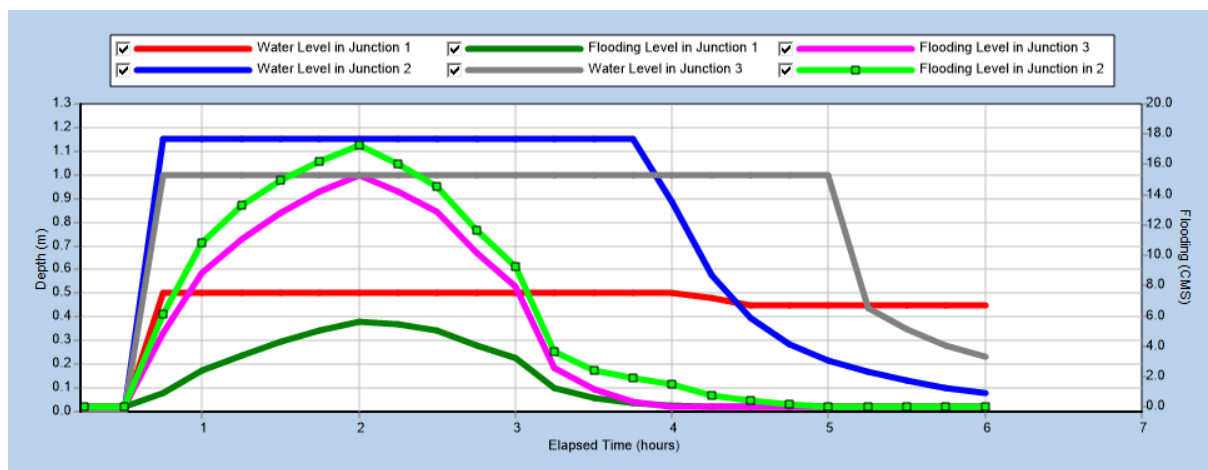
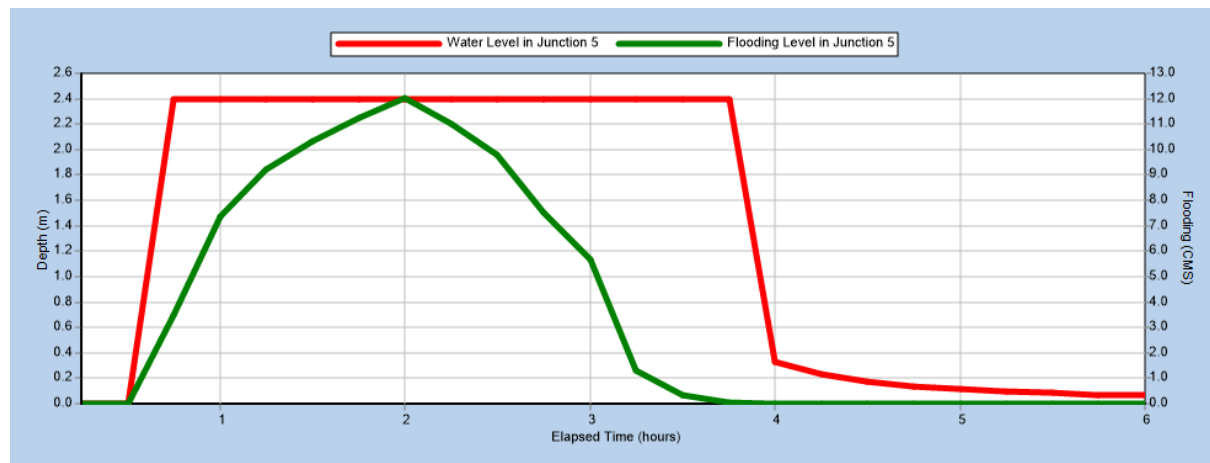
The designed water level drainage canal of junctions 1, 2, 3 and 5 were 0.5, 1.15, 1 and 2.4 m respectively. The maximum flood level of each junction is less than the maximum designed water level of the drainage canal. So that the designed water level of drainage canal depth around Goro Qeransa is sufficient, the simulation result shows that there is no flood (Fig.11).

Figure 11: Water level and flood inundation at Goro Qerransa

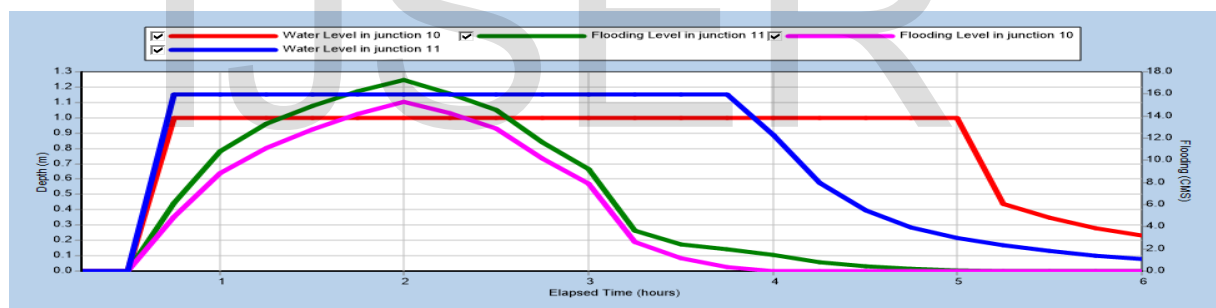
Figure 30 shows the designed water level of drainage canal of junctions 10 and 11 were 1 and 1.15 m respectively. And the maximum flooding level of each junction is greater than the designed water level of drainage canal depth. So that the designed canal depth of junction 10 and 11 near to Burka Harbu is insufficient and the simulation result shows that there is the overflow of the water around the area (Fig.12).

Figure 12: Water level and flood inundation at Burka Harbu

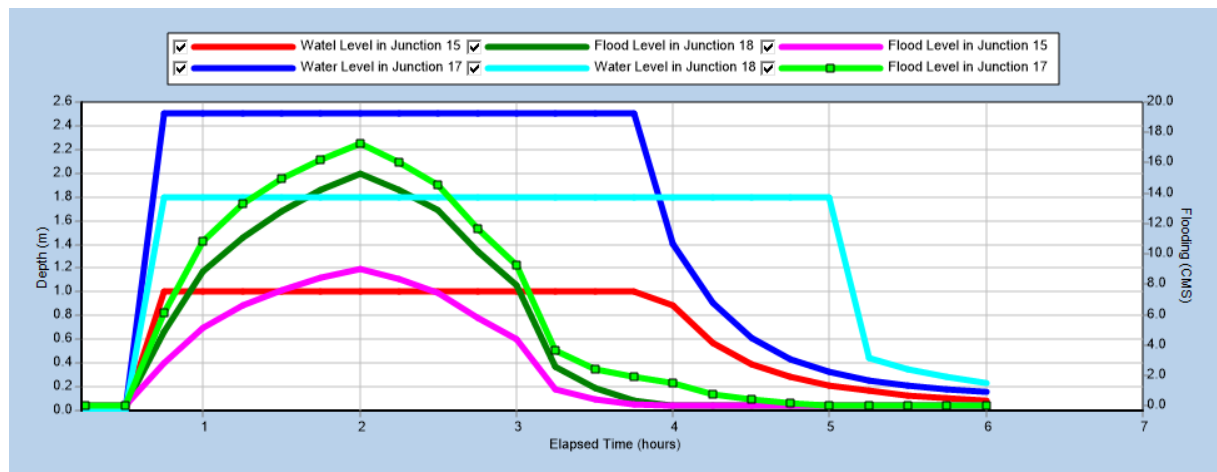
The maximum designed water level drainage canal of junctions 15,17 and 18 were 1,2.5 and 1.8 m and the flooding level of each junction 1.2,2.23 and 2m respectively. The designed canal depth of junctions 15 and 18 was insufficient and the simulation result shows that there is overflow. And the flooding level in junction 17 is less than the designed water level. So that the simulation result shows there is no overflow of the water around the drainage canal of junction 17 Tulu Harbu area. But from the area that we have seen of junction 17 filled by sediment and other rubbish materials and result overflow of the water around the area.

Figure 13: Water level and flood inundation at Tulu Harbu

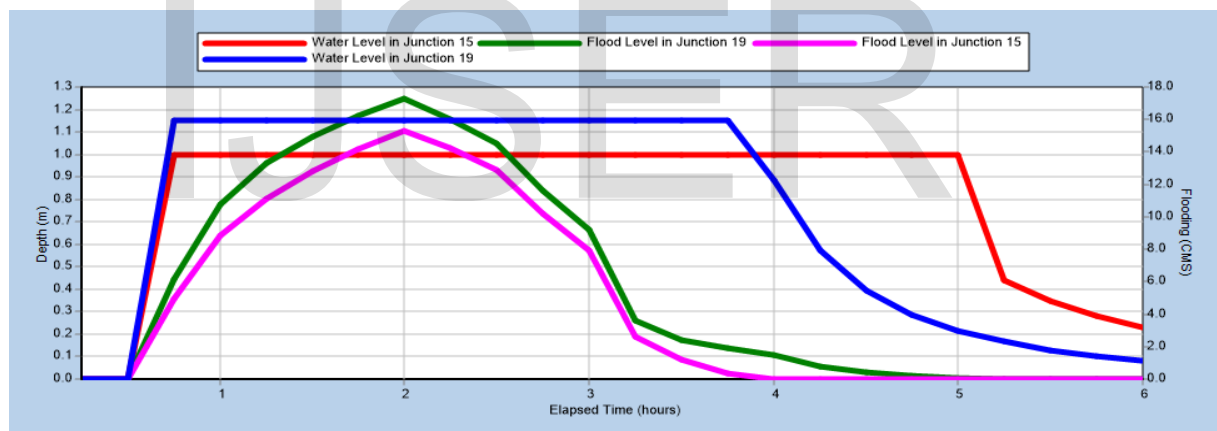
The designed water level drainage canal of junctions 15 and 19 were 1 and 1.1 m respectively. The designed canal depth of each junction was insufficient and the simulation result shows that there was a flood occurrence around the Sadamo drainage canal area (Fig.14).

Figure 14: Water level and flood level inundation at Sadamo

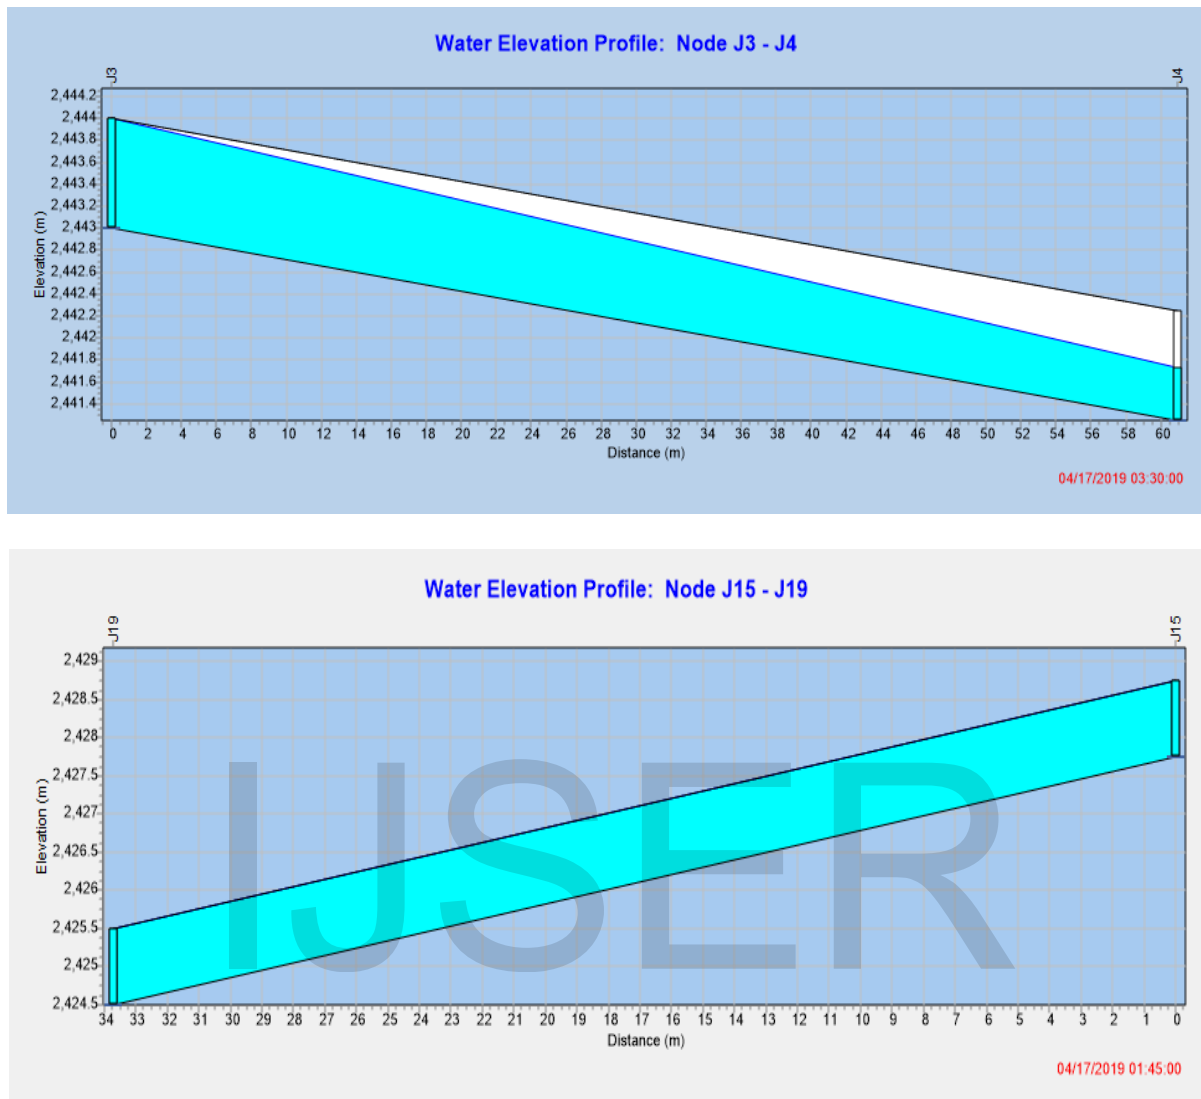
Figure 15 shows that the flow within the link and nodes at Birbisa Siba Outfall. The simulation result indicates that both junctions (15 and 19) are flooded due to insufficient design water depth. Consequently, the link (C21) is also busy at this time and the overflow of runoff has happened. And the drainage canal that found at the downstream part of Birbisa Siba Outfall (link C3 and Junction 4) are sufficient to carry the generated runoff and also there is no flooding in the Junction 4.

Figure 15: Water Elevation Profile at Birbisa Siba Outfall

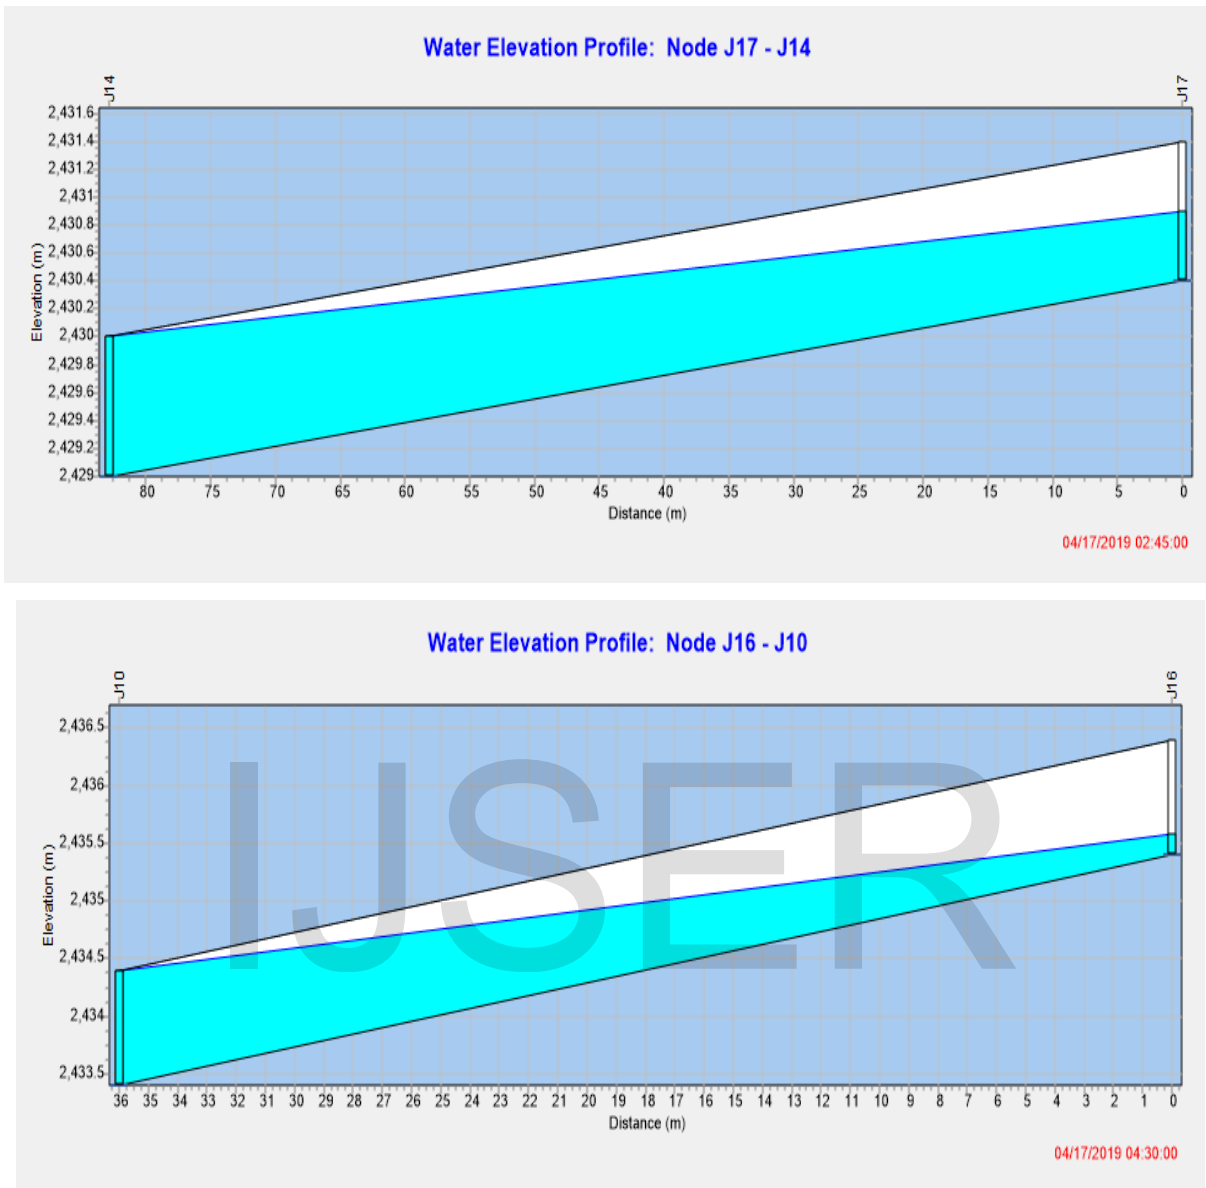
The drainage canal found an upstream part of the Mada Gudina outfall link (C15, C16) as the simulation result indicates the junctions (16 and 17) are sufficient to carry the generated runoff and also there is no flooding as shown figure 30. But the downstream of the link (C15 and C16) means junctions (10 and 14) are also insufficient for this condition of land use (Fig.16). That means overflow has happened in the area.

Figure 16: Water Elevation profile at Burka Harbu Outfall

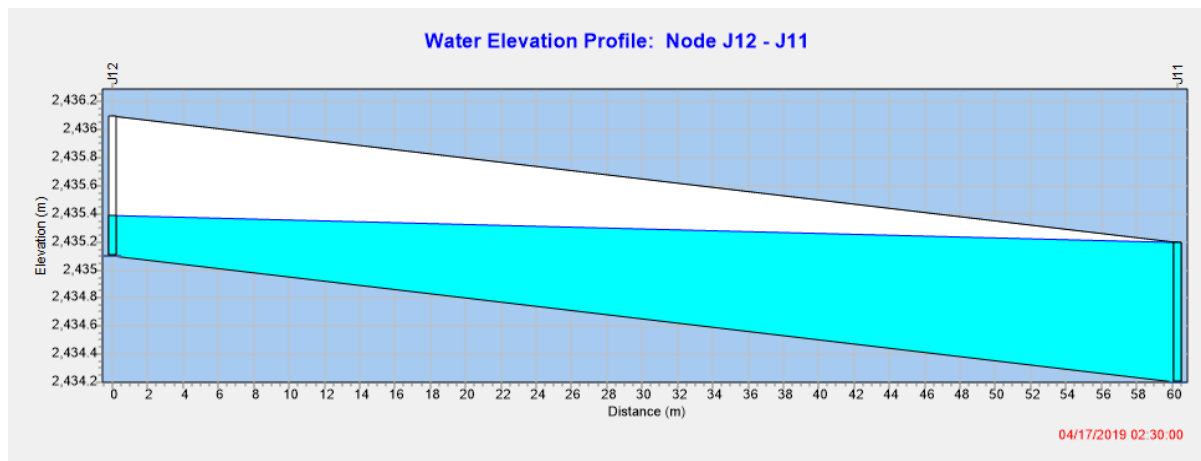
The drainage canal that found an upstream part of Wajitu outfall (link C18) as the simulation result indicates Junction J12 is sufficient to carry the generated runoff and also there is no flooding as shown in figure 17. But the downstream of the link Junction J11 is insufficient. That means overflow has happened in this area. That is at Wajitu Outfall the drainage canals are busy and insufficient to carry with 3hrs rainfall intensity.

Figure 17: Water Elevation profile at Wajitu outfall

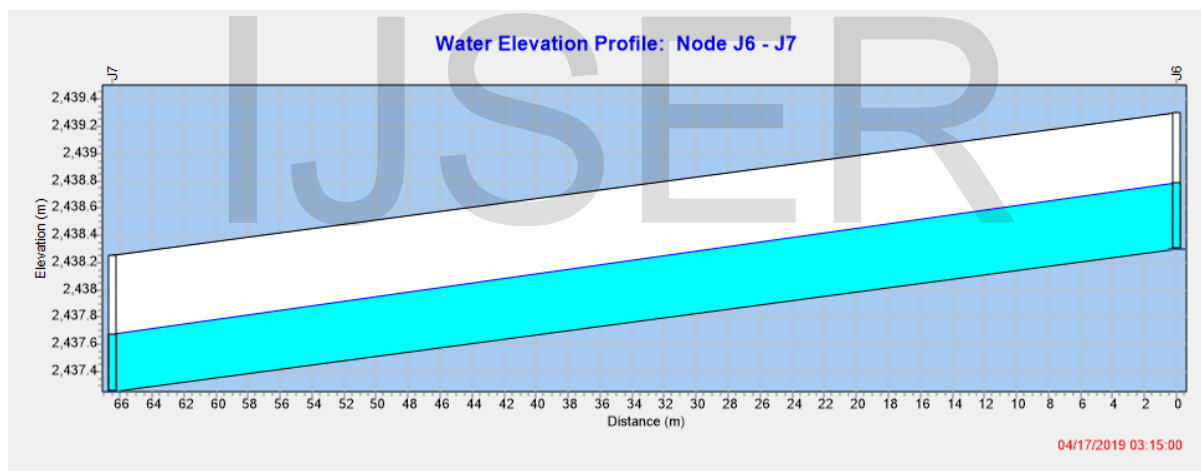
The drainage canal that found at the upstream and downstream part of around 44 (link C8) as the simulation result indicates Junction J6 and Junction 7 is sufficient to carry the generated runoff and also there is no flooding (Fig.18).

Figure 18: Water Elevation profile at around 44

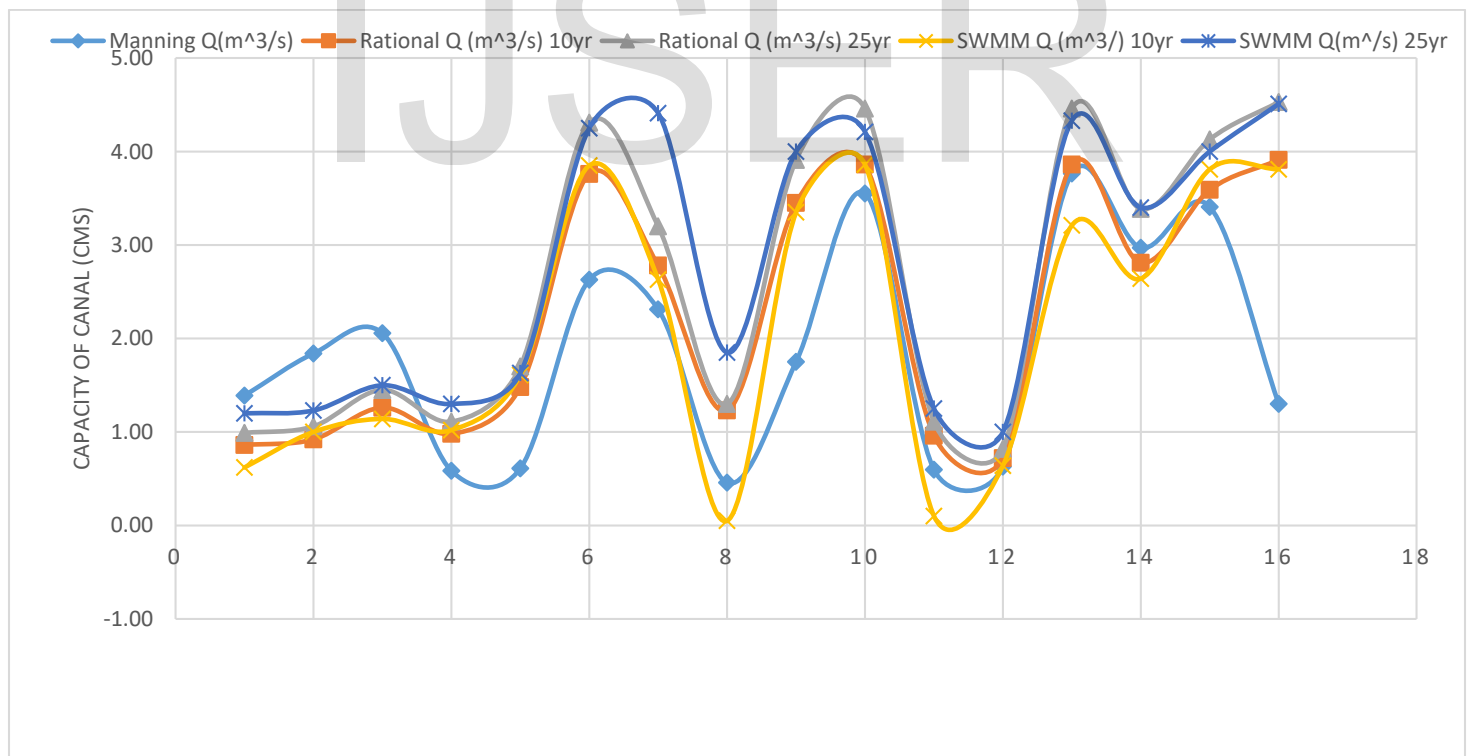
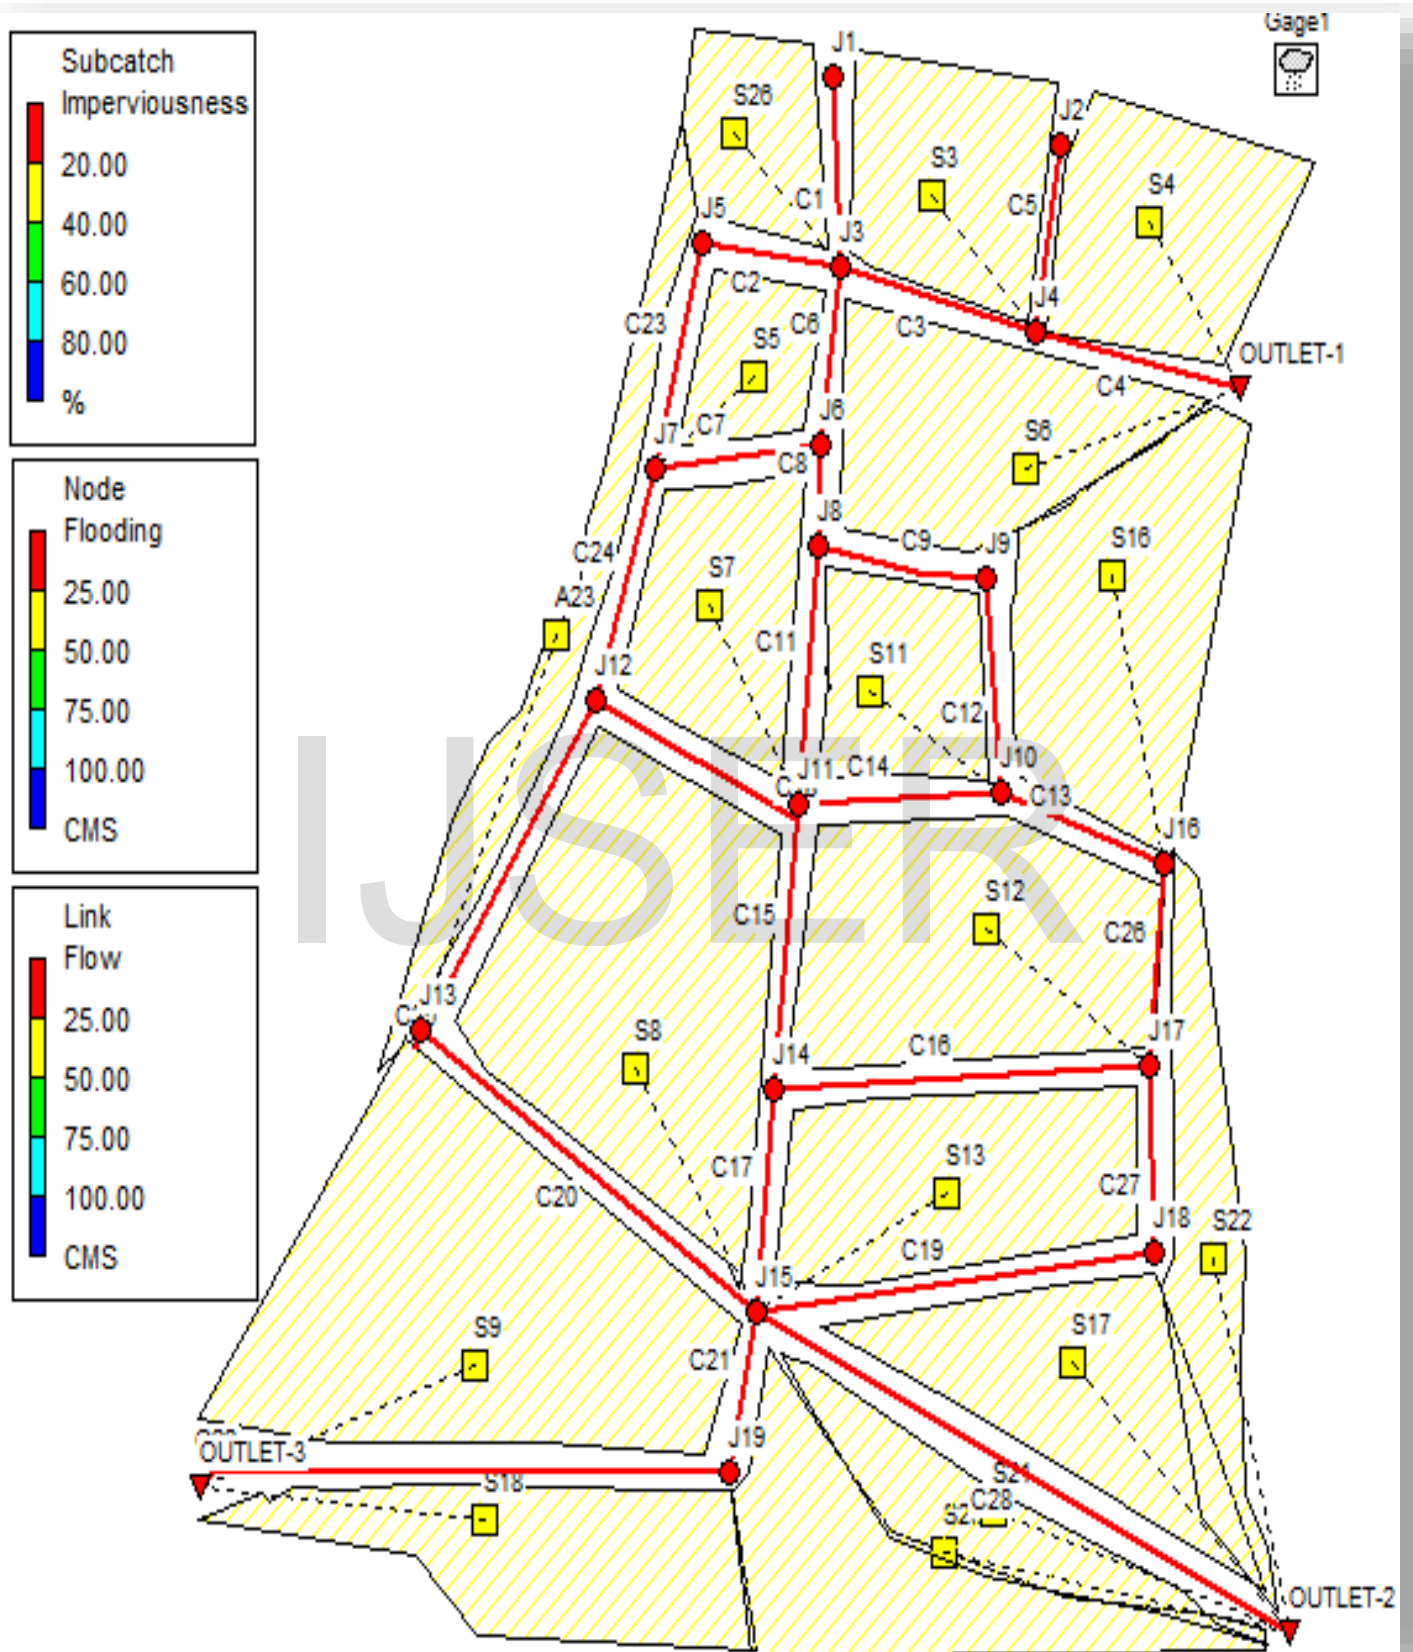
Table 2 show that, the result of discharge by SWMM 5.1 and rational method with in design period of 10 year were 36.43 and 35.34 m³/s, were as for check 25 year were 41.927 and 44.07 m³/s with R² value of 0.65 and 0.63 respectively. It show that, the performance of the SWMM Model 5.1 with Rational method was well match and acceptable in this study.
