Structural Behavior of Brick Walls with Openings Rehabilitated With Steel Plates Box-Section and Steel Angles

Elsamny, M.K.¹, Ezz-Eldeen, H.A.¹ and Mahmoud, M.H.¹

¹Al Azhar University, Faculty of Engineering, Egypt

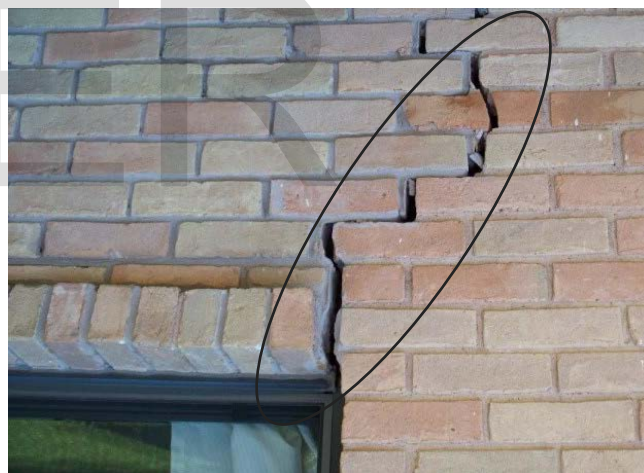
Figure (1) The cracks in brick wall with openings at filed

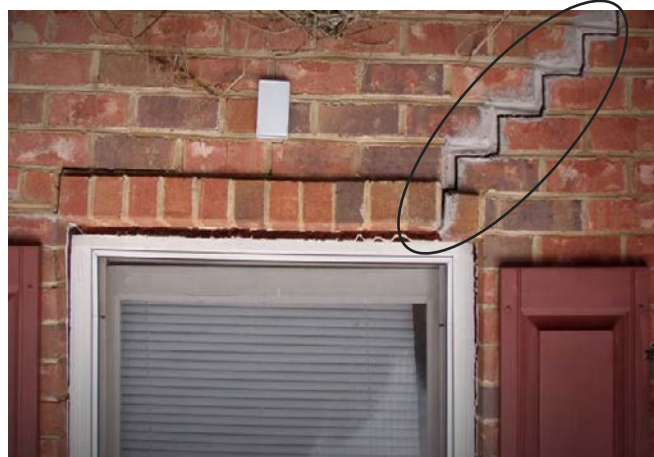
Figure (2) Diagonal cracks in brick wall.

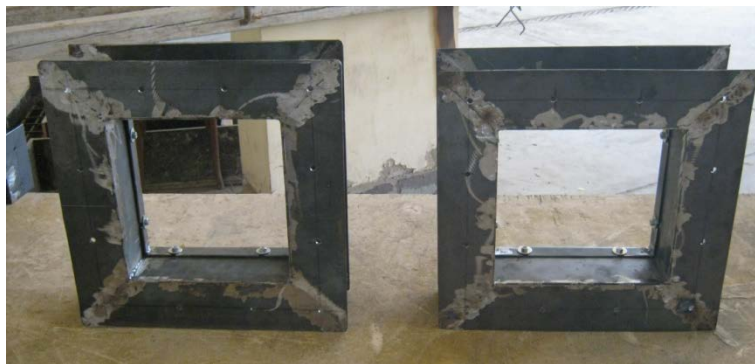
Figure (7) The used steel plate box-section.

Figure (7) shows the used steel plate box-section for rehabilitation technique.

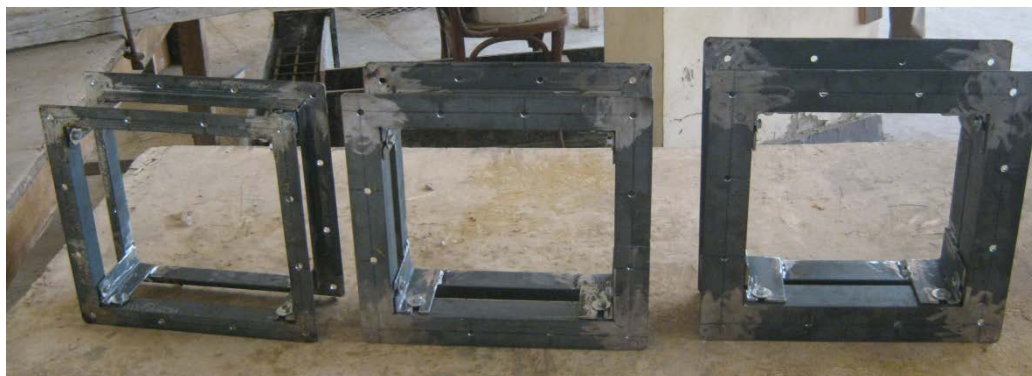
Figure (8) The used steel angle.

Figure (8) shows the used steel angle for rehabilitation technique.

All specimens were constructed using solid cement brick units with nominal dimensions 205 mm long, 100 mm wide and 57 mm high. Six standard brick units have been tested after 7 days from the date of curing. The average strength test result for brick was 20.87 N/mm². Graded sand having sizes in the range of (0.075 - 0.3 mm) was used as the fine aggregate in the mix of the mortar. Ordinary Portland cement was used in all the experimental work. Clean drinking fresh water was used for mixing and curing the specimens. The mix proportions of the mortar used for all wall specimens were designed according to the Egyptian code of practice as shown in table (2). Mild steel plate grade B with thickness 2&3 mm were used in Rehabilitation. Hot-rolled sections equal angle with thickness 3 mm were used in Rehabilitation.

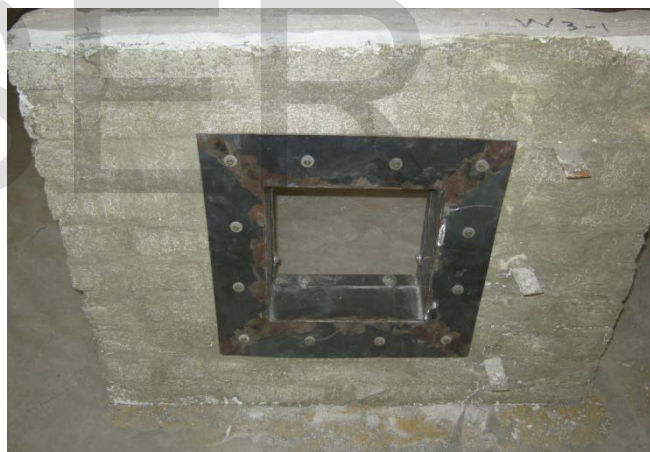
Figure (9) Details of the used rehabilitation technique using steel plate box-section (2x100 mm, 3x100 mm) inside opening welded with square-shaped steel plate at both sides.

Figure (9) shows details of the used rehabilitation technique using steel plate box-section (2x100 mm, 3x100 mm) inside opening welded with square-shaped steel plate at both sides.

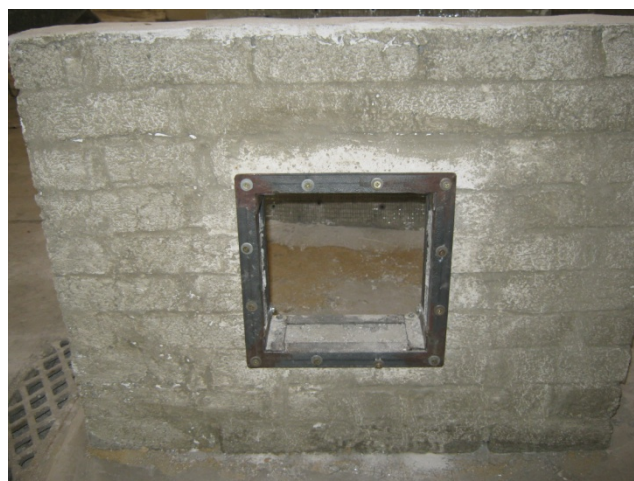
Figure (10) Details of the used rehabilitation technique using steel angle 3x30 mm around opening at both sides welded with steel angle inside opening corners.

Figure (10) shows details of the used rehabilitation technique using steel angle 3x30 mm around opening at both sides welded with steel angle inside opening corners.

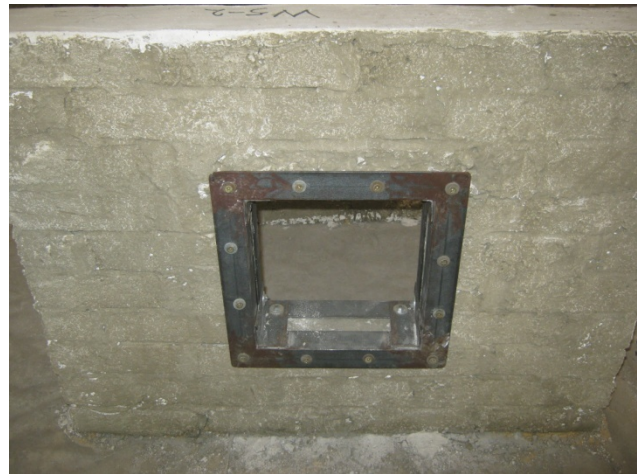
Figure (11) Details of the used rehabilitation technique using steel angle 3x40 mm around opening at both sides welded with steel angle inside opening corners.

Figure (11) shows details of the used rehabilitation technique using steel angle 3x40 mm around opening at both sides welded with steel angle inside opening corners.

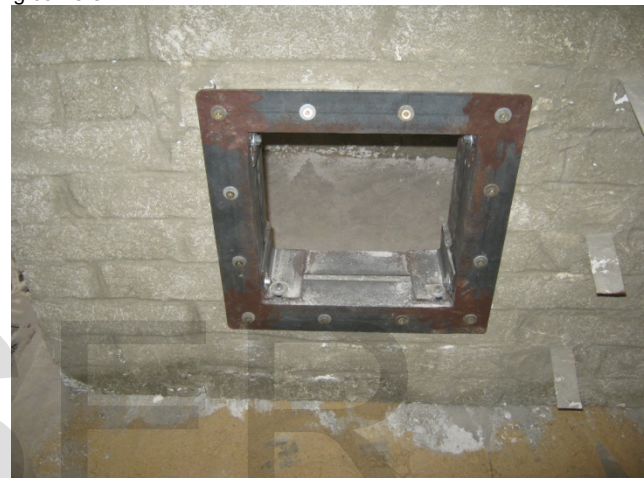
Figure (12) Details of the used rehabilitation technique using steel angle 3x50 mm around opening at both sides welded with steel angle inside opening corners.

Figure (12) shows details of the used rehabilitation technique using steel angle 3x50 mm around opening at both sides welded with steel angle inside opening corners.

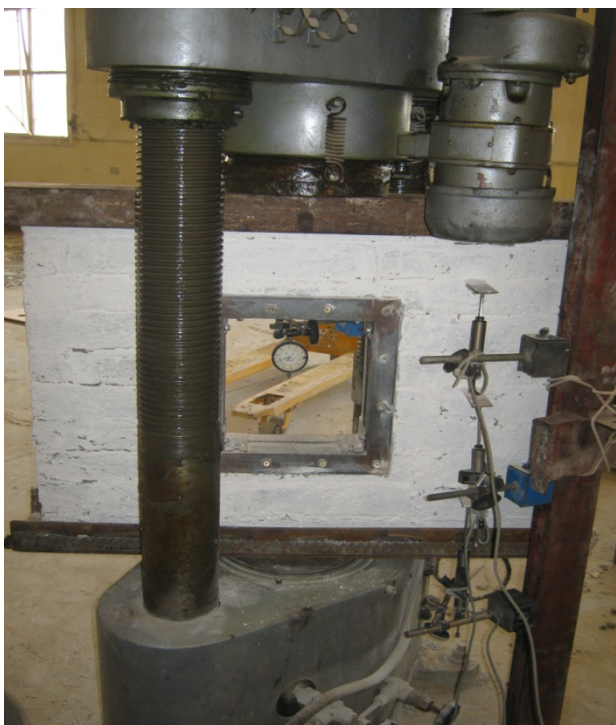
Figure (13) The test setup

All wall specimens were tested under uniform loading using the testing machine mounted on the Material laboratory of Al-Azhar University, which has an ultimate compressive load capacity of 2000 kN. The data acquisition system used in the present study consisted of a Laptop computer, a Keithley-500A Data Acquisition System. Three LVDT were used for measuring vertical deformation and one dial gauge was used for measuring deflection at mid span of lintel.

Figure (13) shows the test setup.

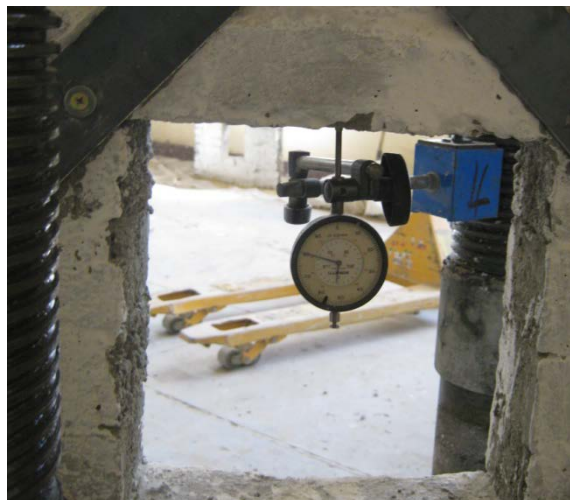
Figure (14) The used dial gauges for measuring lintel deflection.

Figure (14) shows the used dial gauge for measuring lintel deflection.

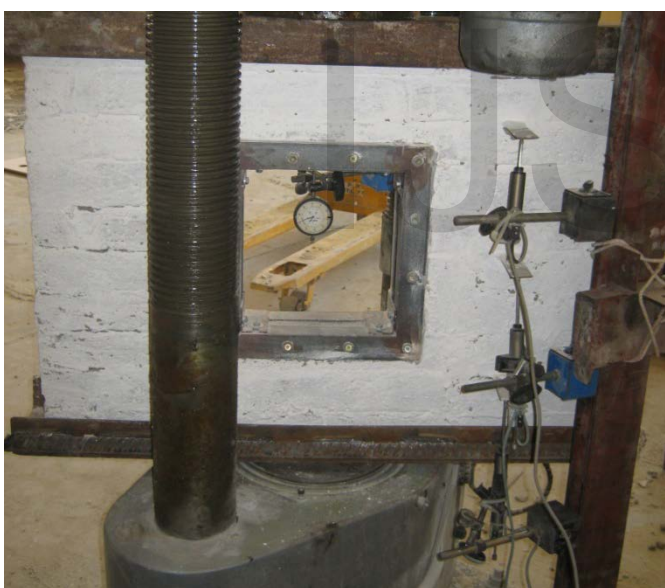
Figure (15) The used LVDT for measuring vertical strain.

Figure (15) shows the used LVDT for measuring vertical strain.

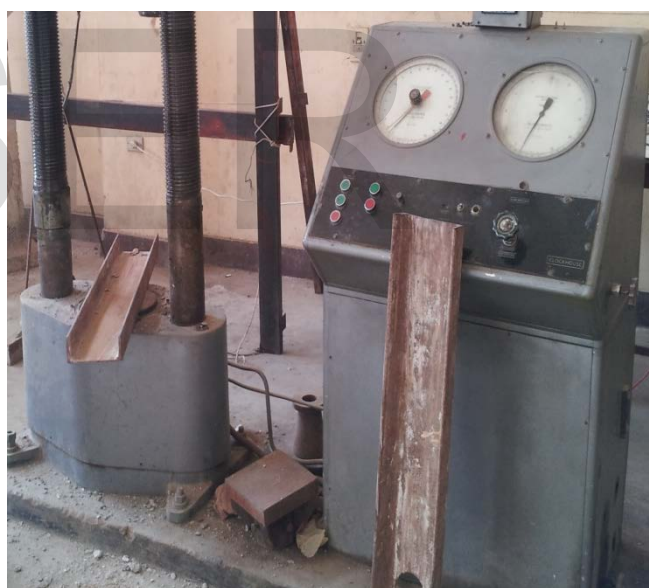
Figure (16) A steel beam as C-channel for transfer the load to wall.

Figure (16) shows a steel beam as C-channel for transfer the uniform load to wall. However, there is another steel beam as C-channel at the bottom of the wall.

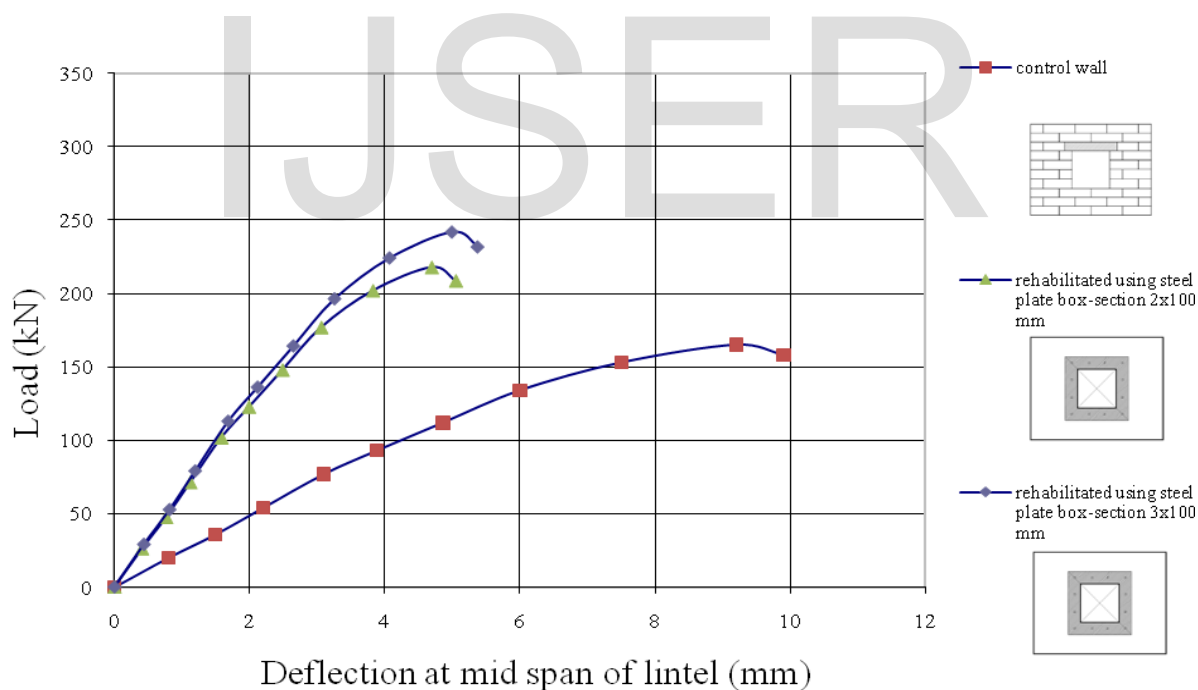
Figure (20) The relationship between load and deflection at mid span of lintel for walls rehabilitated using (2 and 3 mm) thicknesses of steel plate box-section inside opening welded with square-shaped steel plate at both sides.

Figure (20) and (21) show the relationship between load and deflection at mid span of lintel for walls rehabilitated using (2 and 3 mm thickness) steel plate box-section and walls rehabilitated using (30, 40 and 50mm) steel angle around opening.

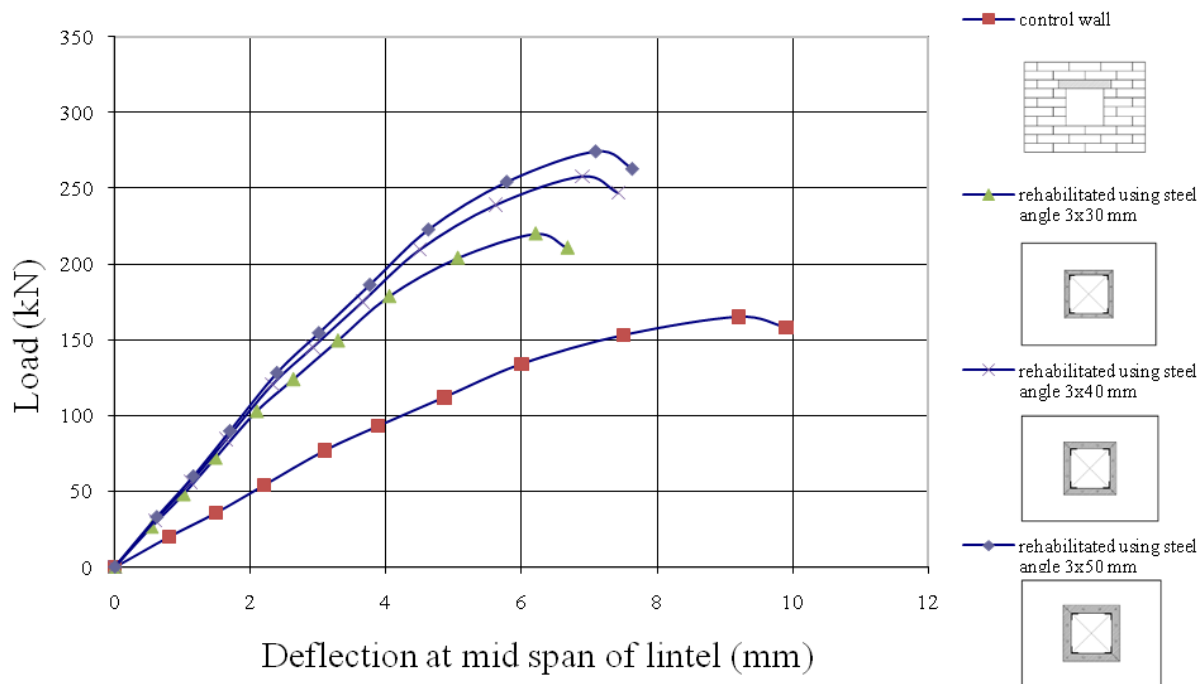
Figure (21) The relationship between load and deflection at mid span of lintel for walls rehabilitated using (3x30, 3x40, 3x50mm) cross-sections of steel angle around opening at both sides welded with steel angle inside opening corners.

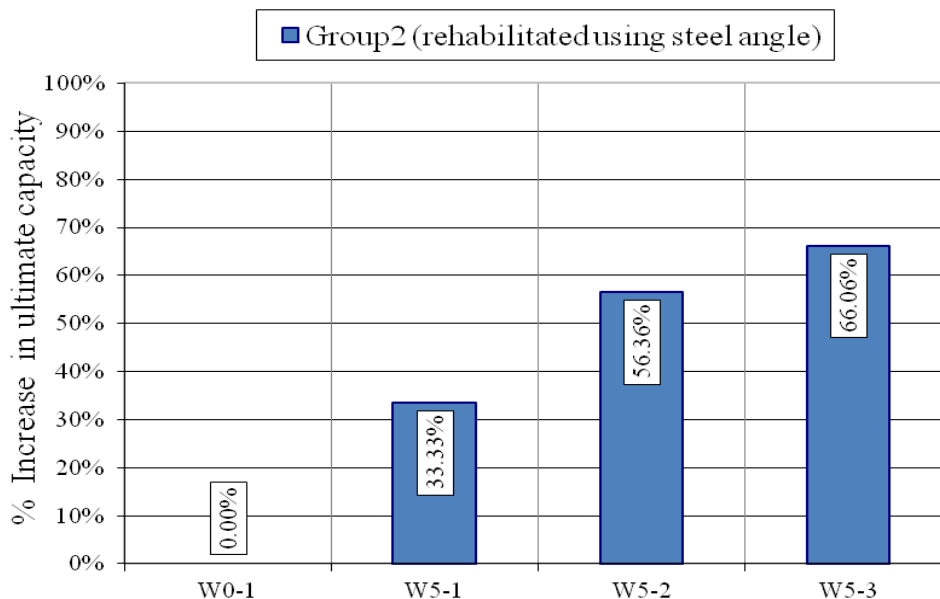
Figure (23) The percentage of increase in capacity for walls rehabilitated using (3x30, 3x40, 3x50mm) cross-sections of steel angle around opening at both sides welded with steel angle inside opening corners.

Figure (22) and (23) show the percentage of increase in capacity for walls rehabilitated using (2 and 3 mm thickness) steel plate box-section and walls rehabilitated using (30, 40 and 50mm) steel angle around opening.
