ASSESSMENT OF GROUNDWATER PHYSICO-CHEMICAL PARAMETERS NEAR WASTE DUMPSITES IN THE WESTERN NIGER DELTA, NIGERIA

Irunkwor, T. C¹, Abam, T. K. S² and Amechi, B. U³

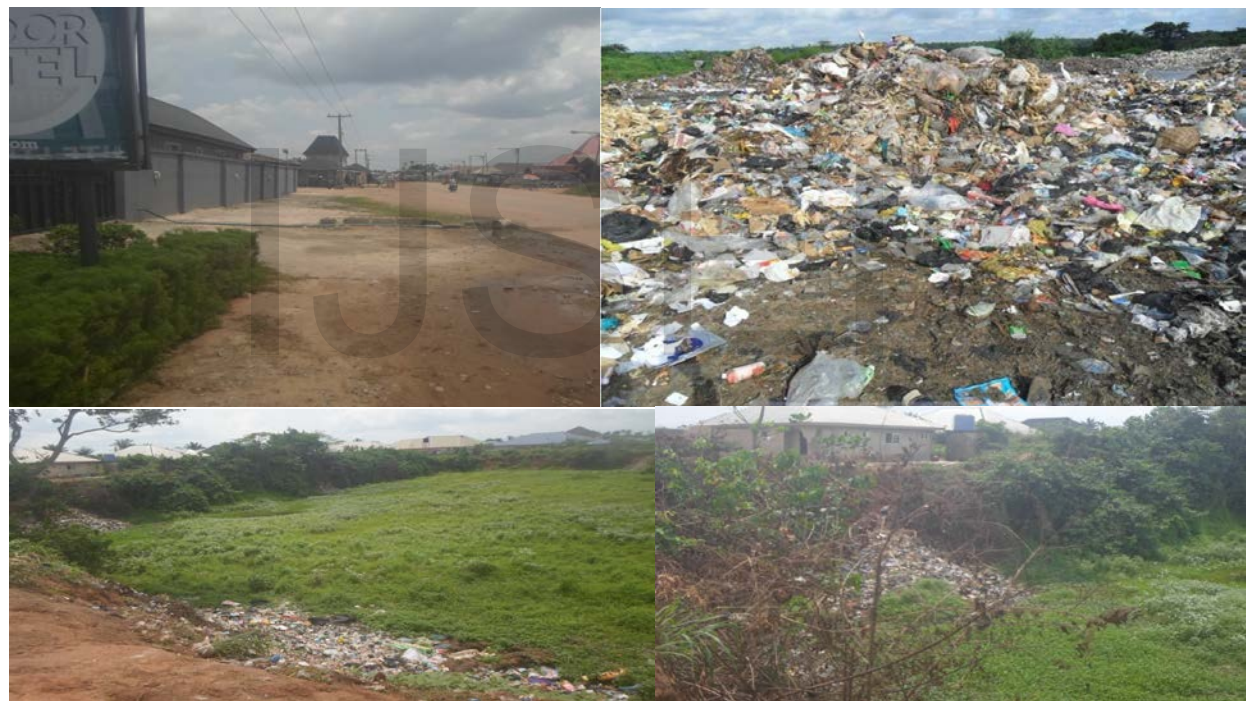
Figure 2b: Burrow Pit dumpsite opposite Keldor Hotel along Ibori Road

Solid and liquid wastes are indiscriminately deposited in Ogharefe municipality in open dumpsites without regard to proximity of inhabited homes/houses, the nature of soil, and the hydrogeology of the area. The study investigated 2 dumpsites at Ogharefe community in Oghara town. One of the dumpsites is a burrow pit that lies within $5^{\circ} 56' 50.10''N$ and $5^{\circ} 39' 34.12''E$ located opposite Keldor hotel along Ibori road, Ogharefe. The dimension of the burrow pit is 20m by 40m and the age is conservatively between 20 and 30 years. The burrow pit is where the residents in the area dump their domestic and liquid wastes. The attendants of Keldor hotel also empty the liquid wastes from swimming pool, dirty dishes and laundry into the burrow pit which they channel through underground waste pipe (Fig. 2a and 2b). The second dumpsite is located within the residential area enclosed by Scot road and Sakponba road in Ogharefe which lies on on co-

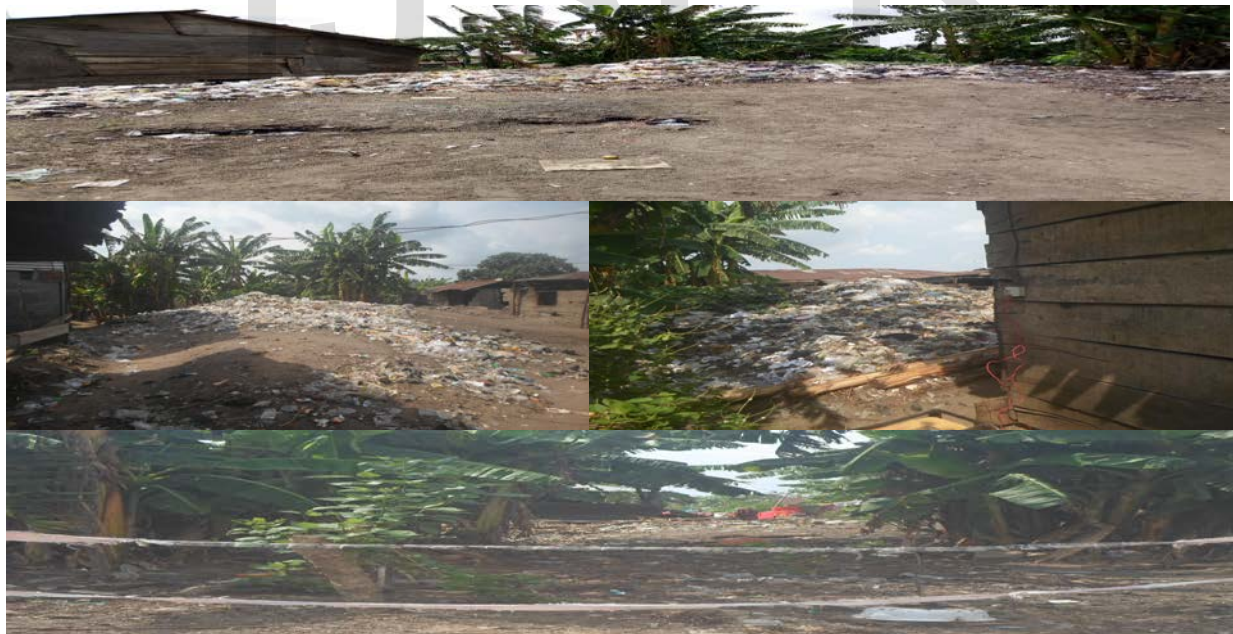
Figure 3b: Dumpsite Enclosed within Scot Road and Sakponba Road (Residential Area)

ordinates $5^{\circ} 56' 52.58''N$ and $5^{\circ} 39' 34.45''E$. The dumpsite covers a total length of about 632m from Otorho road by Scot road junction to Sakponba road. It is the belief of the local inhabitants that this dumpsite has been in existence for over 50 years (Fig. 3a and 3b).
