BEHAVIOR OF STRENGTHENED RC COLUMNS BY MEANS OF FERRO CEMENT JACKET

**Serag Ahmed Mohamed¹ , Mohamed Zakaria Abdelhamid²,
Osama Al-heweiry³**

Civil. Eng. Dept., Aswan Univ., Aswan, Egypt

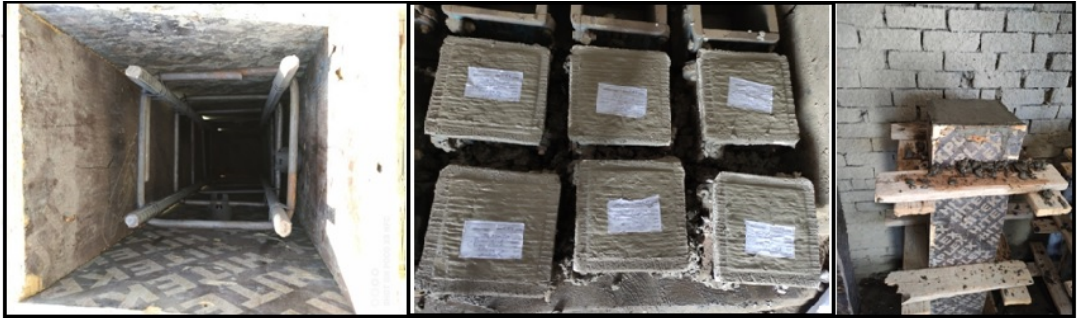
Fig. 3. Preparing of steel cage, casting, and curing of the tested columns.

Rectangular steel moulds of 250 × 200 mm, 200 × 200 mm and 150 × 200 mm cross-section and 1200 mm in height were used for casting of concrete specimens. Before casting, their inner sides were coated with oil. After that, the concrete mix was prepared according to the mix design and placed into the moulds. Ten square reinforced concrete columns were cast. All columns were cast in a vertical position using steel moulds for the formwork. The prepared reinforcement cage was held carefully in the moulds. Concrete spacers of 15 mm size were used to maintain a 15 mm concrete cover to the main reinforcement. The concrete was poured in three layers and compaction of each layer was carried out using a vibration device, See Fig 3.

After 24 hours of casting, all columns and cubes were de-moulded and cured under tapestry sheets until two days before testing to prepare the specimens for the test. **Fig 3** shows the Preparing of steel cage, casting and curing of the tested columns.

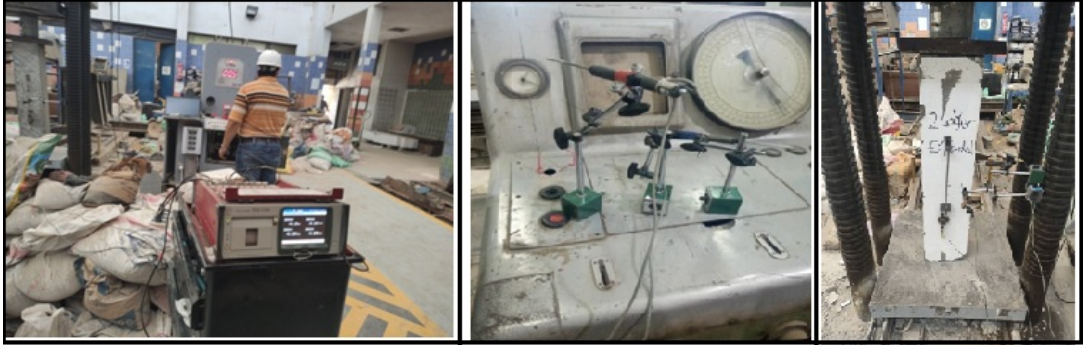
Fig. 5. Testing Machine, Data logger device and the positions of axial and lateral LVDTs on tested column

Control and jacketed columns were tested under axial compressive loading in a 250 T hydraulic column testing machine. The test set-up is shown. Vertically of the column was ensured during the test to obtain a central loading on the column. A thin layer of cement paste was applied at the top and bottom of the column. Plates of the column-testing machine were ensured to be horizontal to eliminate the column to frame relative displacement. The axial and lateral displacements were recorded using linear variable differential transformers (LVDT). Ultimate load, axial and lateral deformation were recorded using data logger and failure modes of specimens were observed, See Fig 5.

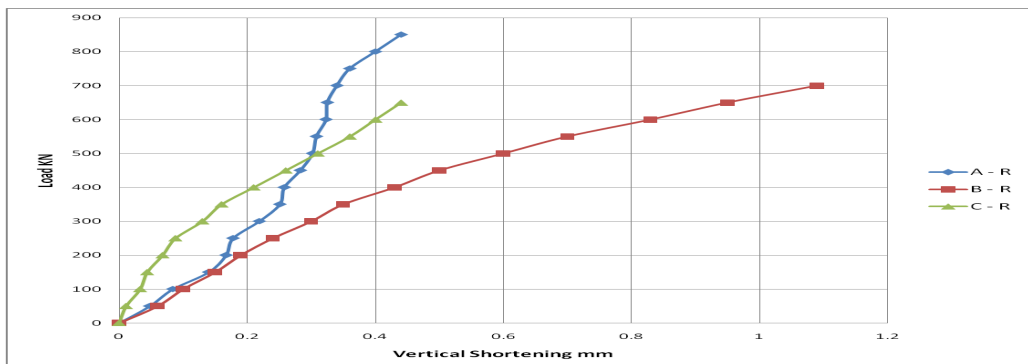
Fig. 7. Variation of load with respect to vertical shortening in columns (A0, B4, C8)

From **Figs. 7–9** and **Table 6** it is seen that the axial load, carrying capacity of all Ferro cement jacketed columns specimens is higher than those obtained from the non-jacketed specimens.

The load – vertical displacement curves for the square jacketed reinforced columns are shown in **Figs. 7 to 10**, respectively. It can be observed that the columns with three-layer wire mesh performed better. Also using two layers of expanded wire mesh with 30 MPa mortar strength gives a good performance in load – vertical displacement behaviour. This may be due to the column was previously loaded up to its failure. It is observed that the use of expanded wire mesh is better than using square wire mesh to strengthen the square reinforced concrete columns.

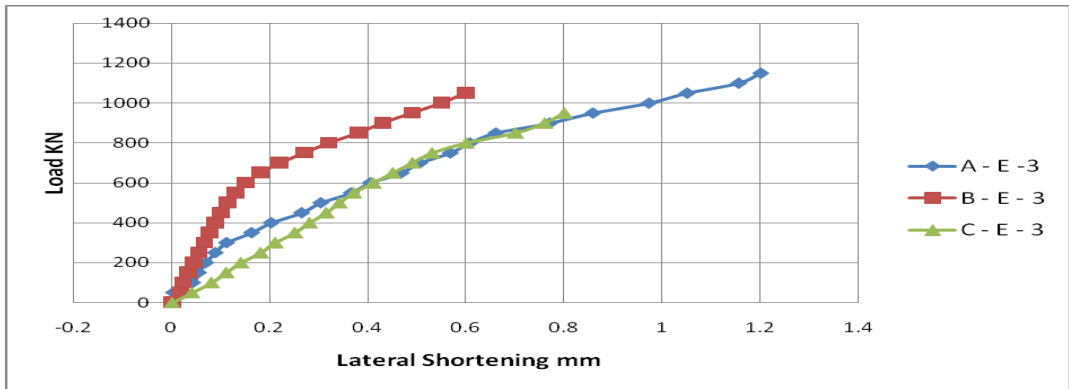
Fig. 13. Variation of load with respect to lateral displacement in columns (A2,B6,C10)

. In columns (A3, B7) and (C11) increased from 0.74 to 0.88 and then dropped to 0.85. This decreased or dropped in the ductility due to using four layers of mesh. A comparison between lateral displacement for column with two or three layers of expanded and square wire mesh were shown in **Figs 11 and 13.**

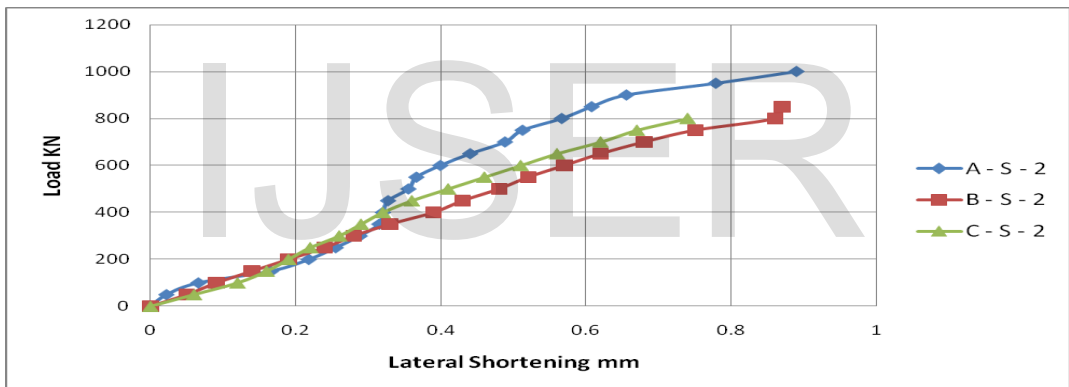
Fig. 14. Variation of load with respect to lateral displacement in columns (A3,B7,C11)
