Causes and Prevention of Flooding and Erosion in Urban Centres: A Study of Kube-Atenda Community, Ibadan North Local Government Area, Oyo State, Nigeria.

Joseph Sunday Onyemesim, M. K. C. Sridhar and A.O. Coker

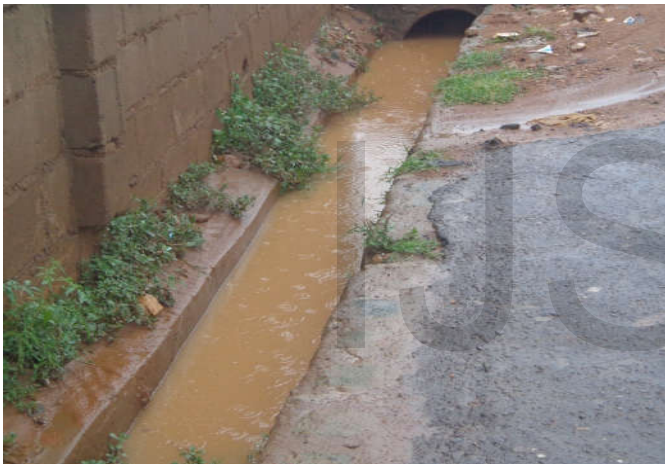
Plate 1. Section of a Road in Kube-Atenda showing blocked Drainage/Culvert

Despite the fact that few of the residents have drainages at the front of their buildings, yet flood disaster is a prevalent environmental problem in the Community. This is because of the blockage of drainage channel with solid wastes as indicated by some of the residents. Flood in the study area also causes damage to properties, land degradation, loss of income to the residents as well as loss of lives. Lack of proper waste management may also contaminate the water sources (most especially the Kube spring water which is used by the community for drinking and other purposes) to transmit environment related communicable diseases such as typhoid, dysentery, while the stagnant water also breed mosquitoes which cause malaria fever through the anopheles mosquitoes.

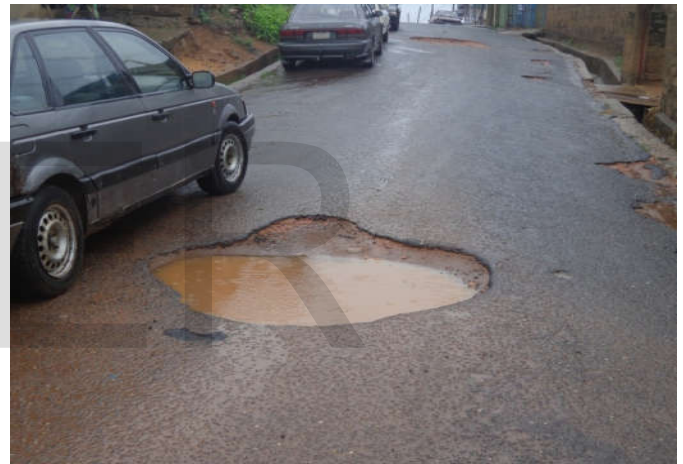
Plate 2. Pot Hole - a devastating effect of flood on a tarred road in Kube-Atenda

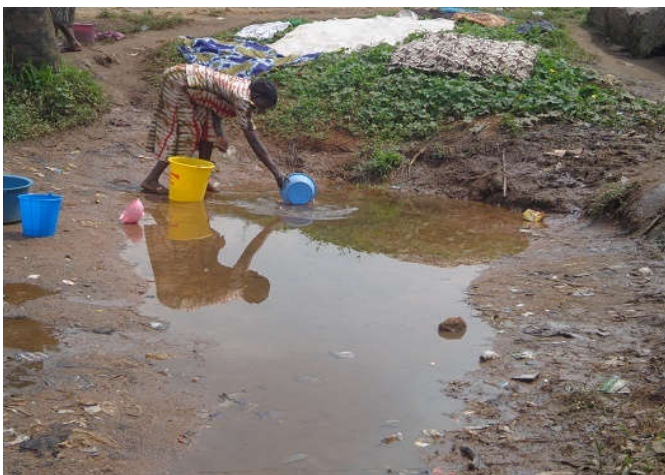
Plate 3. Contaminated Spring Water - a devastating effect of flood in Kube-Atenda

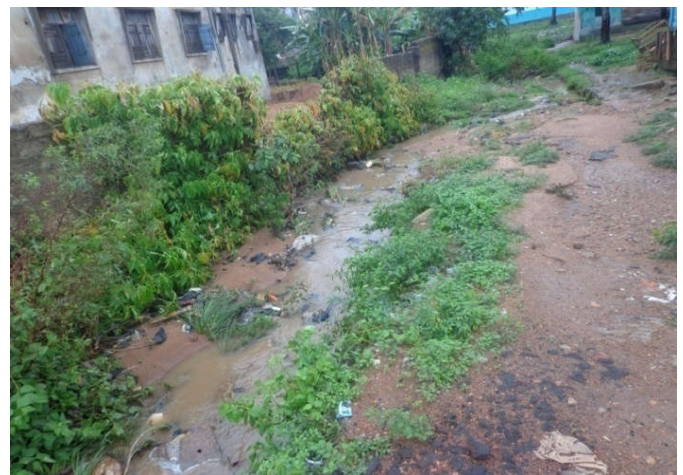
Plate 4. One of the Buildings constructed on River bed in Kube-Atenda

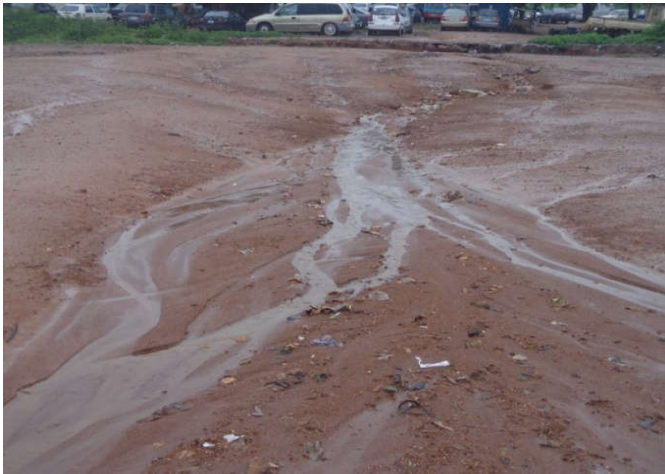
Plate 5. Rill Erosion at Kube Football field after the rain on Tuesday morning (2-6-2015)

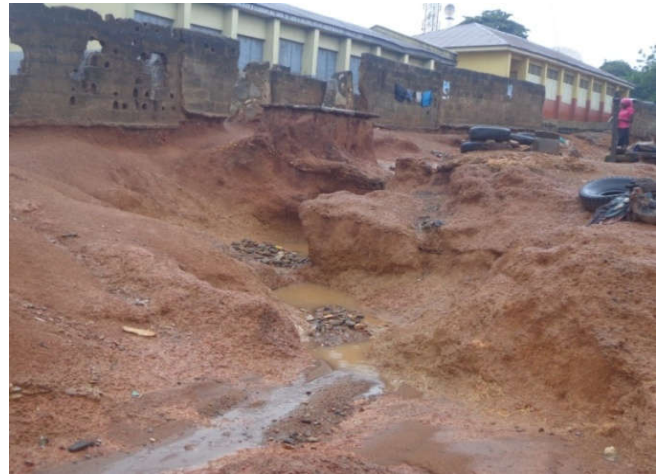
Plate 6. Gully erosion formed after Tuesday morning rain in Kube-Atenda (2-6-2015)

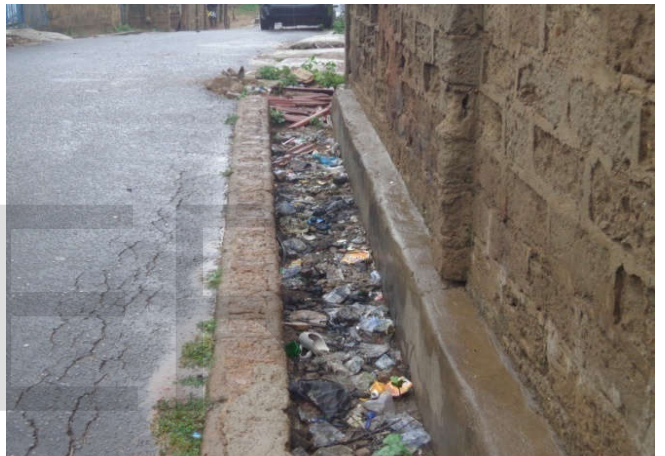
Plate 8. Refuse found inside an existing Drainage in Kube-Atenda
