Criticalities encountered in Construction of (HRT) Head Race Tunnel of Kameng Hydro Electric Project (600MW), In Arunachal Pradesh, India.

Abstract: This paper presents some of the criticalities encountered in construction of (14.45 Km) head race Tunnel of (600MW) Kameng hydroelectric project in Arunachal Pradesh, India located in North East Himalayan Region. As the region has complex geological formations and is considered to be the best field laboratory to learn Rock Mechanics and Tunneling Technology for weak rockmass. The ongoing excavation of HRT in Kameng H.E Project encountered various criticalities and geological problems thereby hindering the overall progress. The rock class encountered during the excavation of HRT varied from good to fair quality (class II to VIA & VIB as per Q system of rock classification). The HRT support system was designed for different classes of rock mass and the same was implemented with some modification as per the site conditions and some additional strengthening work also taken up in the crown portion of erected steel rib (ISMB200X100) in the squeezing zones. The Rock mass encountered along the excavated tunnel profile, mainly comprised of fau

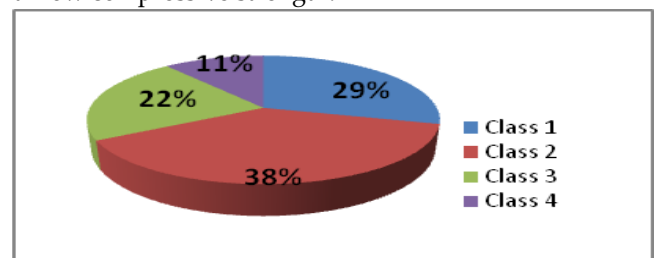
Fig. 1: Original % of Rock Classification of HRT Face-III

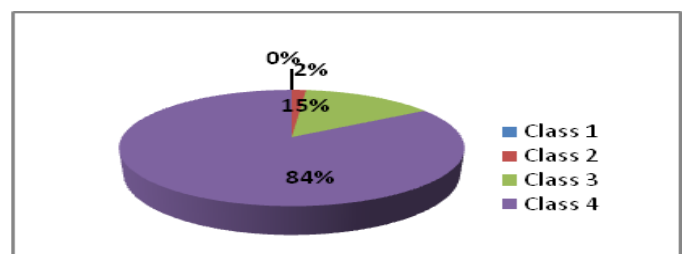
Fig. 2: Actual % of Rock Classification of HRT Face-III

The ongoing construction of 4.80Km HRT Face-III of Kameng H.E project it was found so far that 84% rockmass encountered come under poor rock category and supported by Class-IV support system. The HRT passes through Gondwana formation comprising weak sedimentary rocks mainly consist of thinly laminated carbonaceous shale/siltstone with graphitic coaly bands, Quartzitic sandstone and Precambrian metasedimentary rocks such as Quartzite, phyllite, Quartzitic phyllite, Gneiss, Carbonaceous schist/slate. These metamorphic rocks are highly folded, sheared, crushed, pulverized, jointed, foliated, banded and fractured in nature. In some stretches clay gouge has also been observed along with shear zones. Which have resulted in slow progress and difficult tunneling media, the rockmass such as phyllites and quartzites are found to be closely jointed, folded and fractured having several shear zones, rendering the rock mass into poor category. In some critical stretches where the carbonaceous rockmass encountered, major cavities have been occurred along with water ingress.

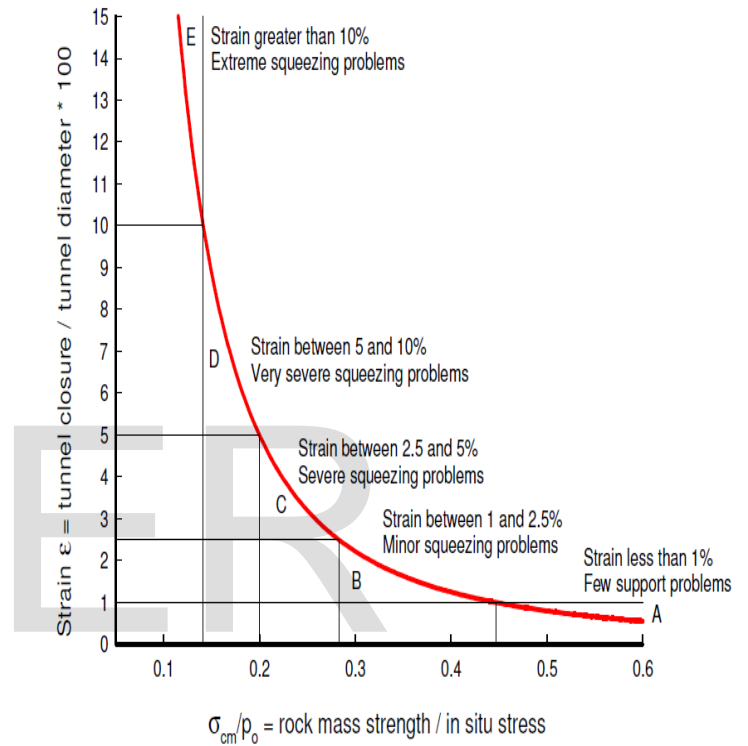
Fig: 3 Relationship between tunnel strain and ratio of rock mass strength to in situ stress (Proposed by Dr. Evert Hoek and Marinos, 2000)

by (Hoek and Marinos, 2000) (Fig: 3) is found to be **20.56MPa** (209.71Kgf/cm²) (Approx. 210.00 Kilogram per square centimeter) in HRT Face-III with about 800m-1000m overburden.

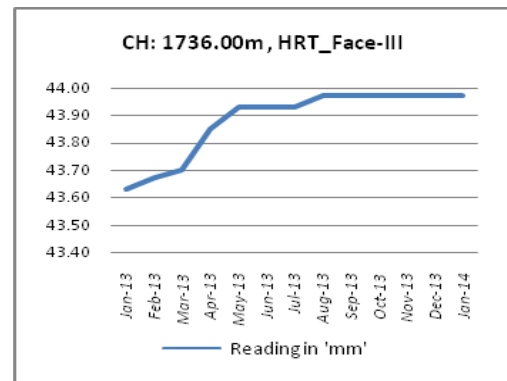
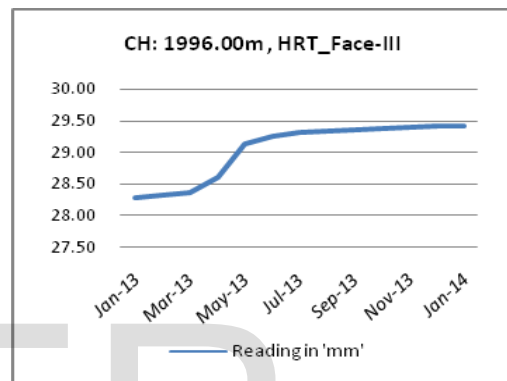
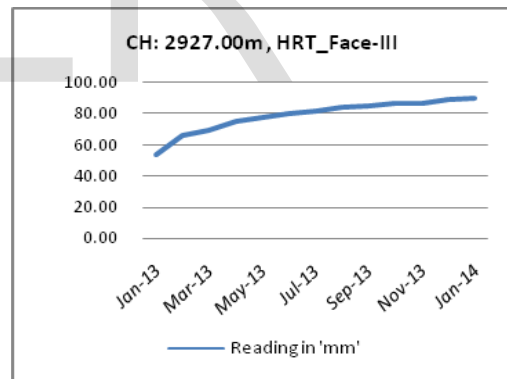
Fig:4: HRT Clouser of Face-III at various changes 1736.00m, 1996.00m and 2927.00mm (MPBX reading)

The strain in the rockmass is calculated by MPBX (Multi-Point Borehole Extensometers) and its reading clearly shows the rock movements in HRT Face-III (Fig:4) and same is recorded by 0.5m, 1.50m and 3.00m length anchors in the rockmass. The convergence readings are also taken by plastic survey reflectors of the Geodata Bireflex type. It was found that the average time taken to stabilize the rockmass is around 6 to 7 months after the excavation for HRT Face-III & VI. In rocks where the loads and deformations do not attain stable values, it is recommended that the lining work should not be taken up for safety measures. If the final lining is installed after the tunnel has been stabilized by initial support, the final lining will undergo very little additional loadings.

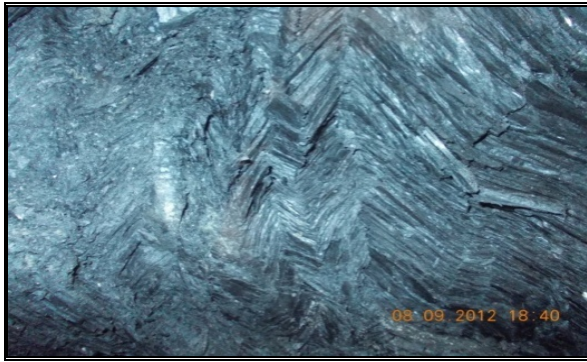
Photo: 1 Anticline in HRT ch: 2922.85m Face-III

The photographs (1 & 2) shown below is the face rock condition of HRT face-III where the deformation in the steel ribs occurred after fixing the support system due to very high active stresses in rockmass and the compressive strength of rockmass was found to be below 7.00MPa (71.40Kgf/cm²). The rockmass shows very complicated joint patterns and bedding plane.

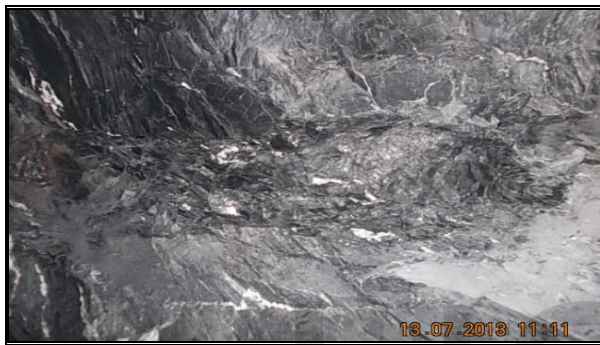
Photo: 2 Shear zone in HRT ch: 3275.15m Face-III

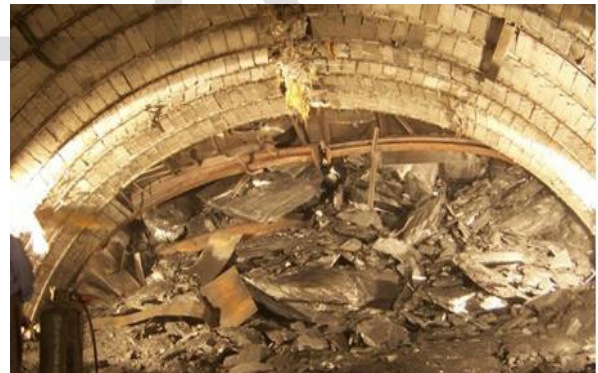
Photo: 3 Cavity formations in HRT Face-VI

As the (Photo-3) above is of HRT Face-VI, where the rock was not sufficiently strong enough, the strength of rock (UCS) found to be below 7.00MPa, the induced stress due to rock load was more than the rock strength resulting rock failure thereby forming the cavity in the crown portion. It was observed that when tunnels is excavated in jointed rock mass at relatively shallow depth with lower overburden, the most common types of failure are those involving wedges falling from the roof or sliding out of the sidewalls of the openings. These wedges are formed by intersecting structural features, such as bedding planes and joints, which separate the rock

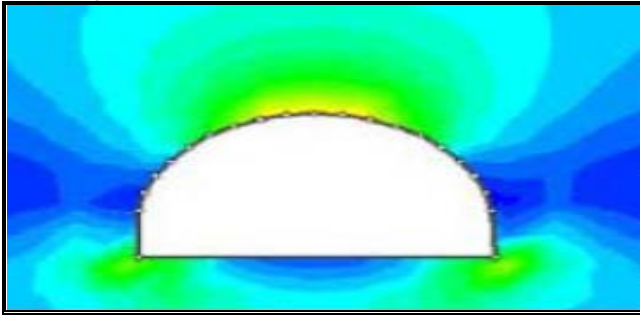
Fig: 5: Predicted bulb of Rock load on the steel support.

Most failures in tunnel face are initiated at the crown portion, when the highly fractured rockmass that wants to loosen and come out, which do not possess the inherent resistive strength. This can continue until the formation of cavity in tunnel or completely collapses or until the geometry and stress conditions come to equilibrium. It was observed that the tunnel excavation causes a disturbance of the initial state of stress in the ground and creates a three-dimensional stress regime in the form of a bulb around the advancing tunnel face. The failure mechanism depends on the in-situ stress level and characteristics of the given rock mass. Such a stress regime is indicatively displayed in Figure (5).

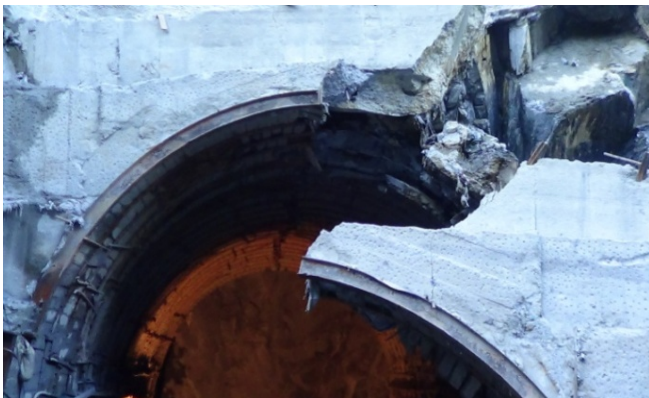
Photos: 4: Shear failure of steel rib due to developed stresses in cut and cover portion above the flash portal & cavity formation.

Thus a higher cavity/ chimney formation along the thick shear zone are common phenomenon in HRT Face-III, unless the face is protected at crown prior to blasting. It was also observed in HRT Face-VI where the chimney formation occurred in water-charge rockmass, where seepage out of excavated rock susceptible to erosion and dissolution. The rock load acting on the tunnel varies depending upon the type and mechanical characteristics of rock mass pre-existing stresses in the rock mass, the nature and strength of rock. Thus rock at depth is subjected to stresses resulting from the weight of the overlying strata and the excavation in the rockmass causes the stress field to disrupt and a new set of stresses are induced in the rockmass surrounding the opening. Failure occurs if the strength of the rock is less than the induced stress (Photo-4).

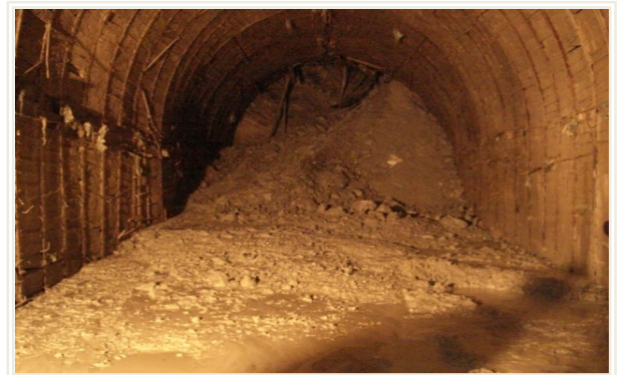
Photo: 5: Cavity /blowout ch: 422.6m in HRT Face-II

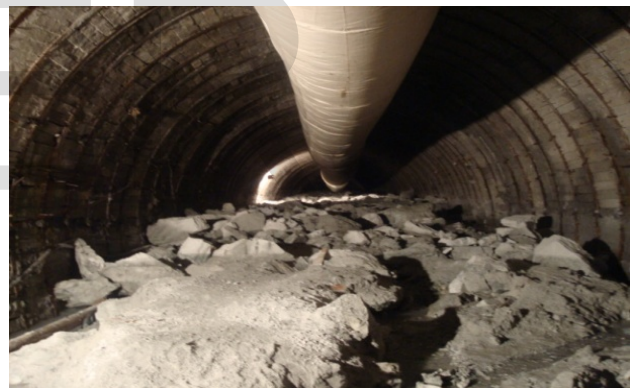
Photo:6: Cavity /blowout ch: 616.68m in HRT Face-II

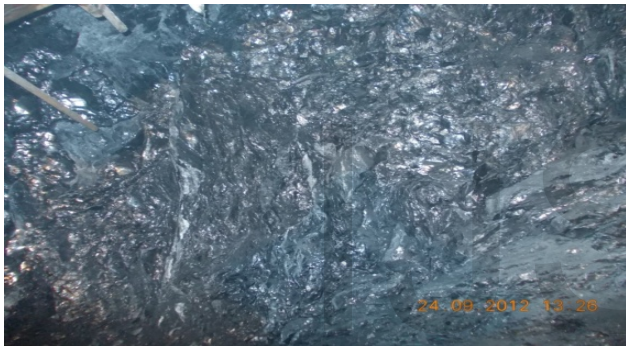
Photo: 7 Squeezing in crown portion in HRT Face-III

It was observed that the ground with low frictional strength the rate of squeeze depends on degree of overstress. At several places in HRT Face-III, the rock shows gradual squeezing tendency or deformations generally over period of about one month after excavation. This is manifested by development of cracks in the lagging and buckling of steel ribs and disjuncting of concrete slabs with steel ribs (Photo-8). The squeezing mainly occurred when the rockmass consists of shiny carbonaceous materials with very low compressive strength of below 2.00Mpa (Photo-7). The rock mass encountered in squeezing area was weak in nature and the uniaxial compressive strength was significantly low and presences of no definite joint patterns were observed. After the excavation immediately the steel support system were fixed and back-filled is done with M20 concrete but after 20 to 30 days the deformation in the rib was observed due to high stresses in the rock mass.

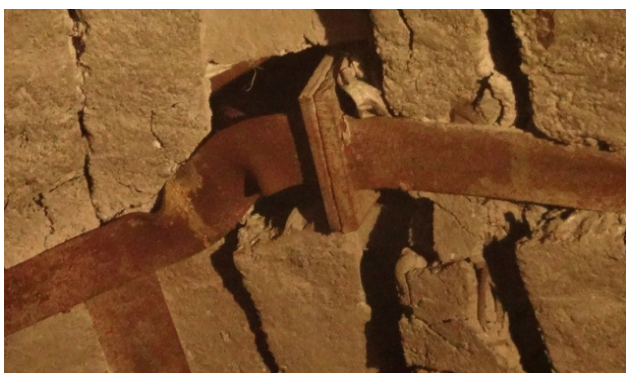
Photo: 8 Squeezing Rock strata in HRT Face-III

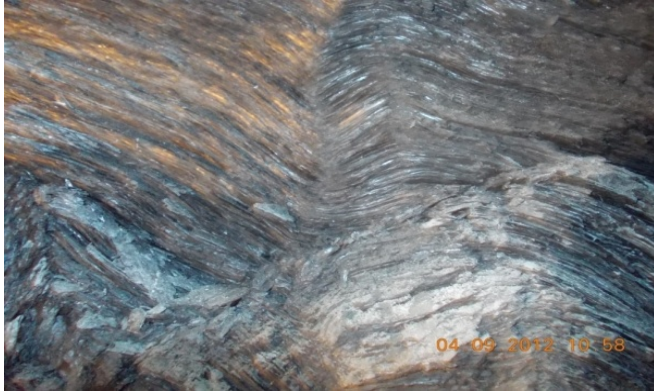
Photo: 9: The rock condition of face and the squeezing takes place the rock seems to experience high stress.

The following (Photograph-9) show the condition of rockmass before fixing of support system and the squeezing effect on support system were seen after laps of time period. The anticline and syncline in the rockmass indicates the presence of stresses and the significant signs of squeezing in the form of deformation in ribs are observed in the SPL.

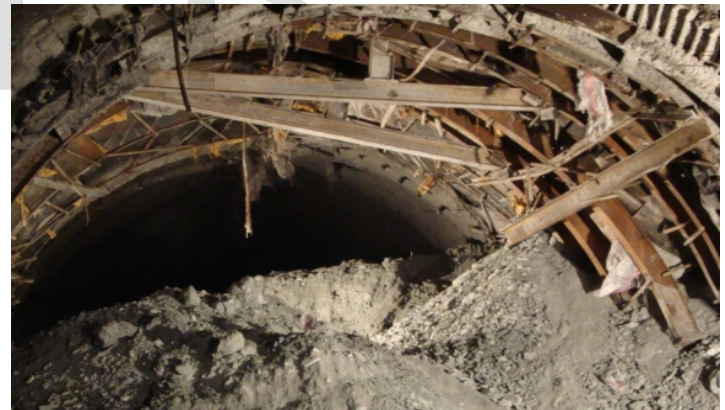
Photo:10 The face condition where the dry crushed sheared material suddenly comes out exerting high pressure in rib support. Ch: 1385.0m, HRT Face-III.

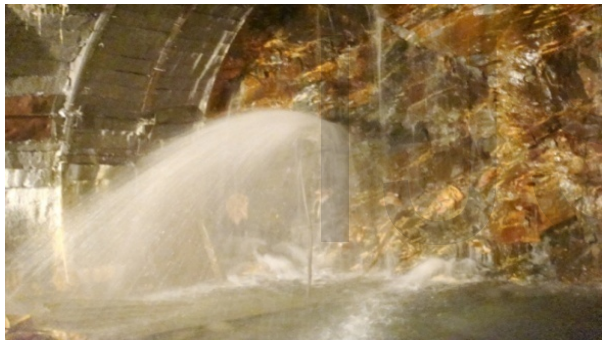
Photo: 11: The seepage water comes out at high pressure.

The highly folded rock strata encourage water entrapment and subsequent release on boring. Total length of HRT face-VI is 1684.00m and heavy seepage of underground water was encountered along with very poor geology from Ch. 331m to Ch. 343m, Ch. 532.00m to Ch.595.00 m, and from Ch. 750.75 to 781.15 m. The heavy ingress of water was first encountered on 17th Feb'2007 at Ch: 333.0m. The rate of seepage recorded in this stretches of tunnel varied from 6500 to 9000 liters/min. The progress during the year 2007-'08 was only 360 m due to the criticalities encountered. The tunnel alignment had also passed through three major shear zones, leading to collapse of face, formation of huge cavity and flow of loose muck/sludge accompanied by heavy seepage water from the face of HRT.

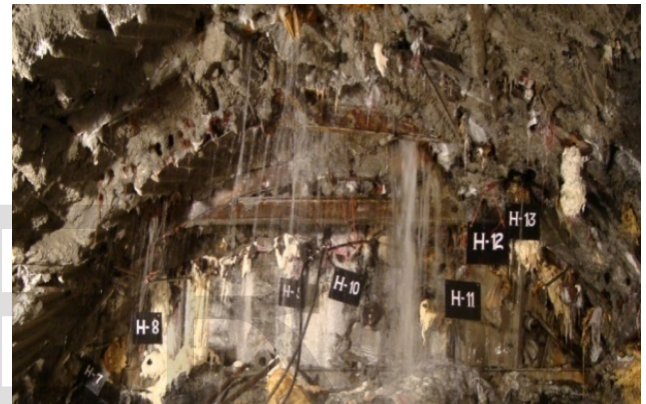
Photo: 12: PU (polyurethane) Grout, HRT Face-VI.

The PU Grouting was done under high pressure in HRT Face-VI, by drilling 45 mm dia, 5.00 m long holes all along the HRT periphery and in the face keeping an overlap of 2.00 m. The grout pressure up to (60 bar) was used to inject the PU grout into the fractured rockmass, which reacts chemically with seepage water. The PU grout stabilized, strengthen and seal the rockmass by diverting the huge seepage water from the tunnel face to adjoining area. The face condition was improved by injecting PU grout and further tunneling was possible in HRT Face-VI.
