Damage Evaluation and Partial Retrofitting of Old Steel Bridge

ABSTRACT

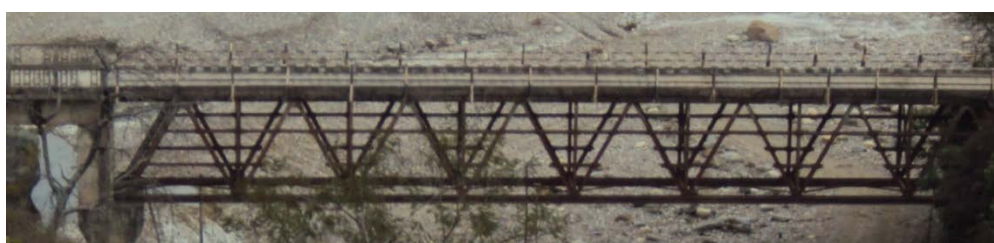
Figure 1: 40m span Steel truss bridge in HP India

schemes and bridge member replacement based on the extent and cost of the required upgrade. The present work presents salient features of the procedure as well as the results of an extensive study on a particular and characteristic deck-truss highway bridge (Fig. 1). .An extensive investigative program was chalked out comprising of preparation of as built drawings at the site, a brief FEM analysis and field tests. The sequential order of the investigative program detailed below was carried out between Oct,2010 and March 2011:

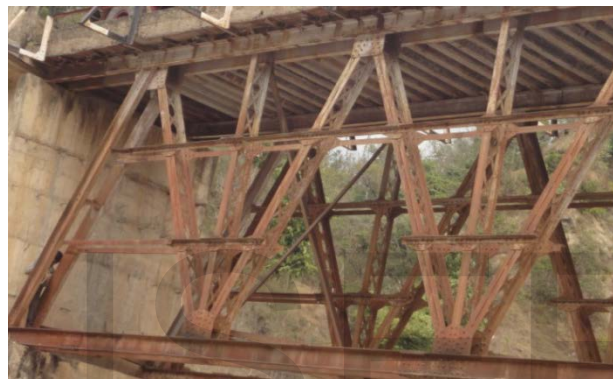
End members are made up of two Channels section 254x101.60 mm placed back to back and joined with 10mm thick plate. The top and bottom horizontal members are made of two channel member 254x101.6mm fabricated back to back and riveted with 10 mm thick plate. The members of the trusses have been joined with rivet connections.

Figure 2: Side View of 40 m steel truss bridge

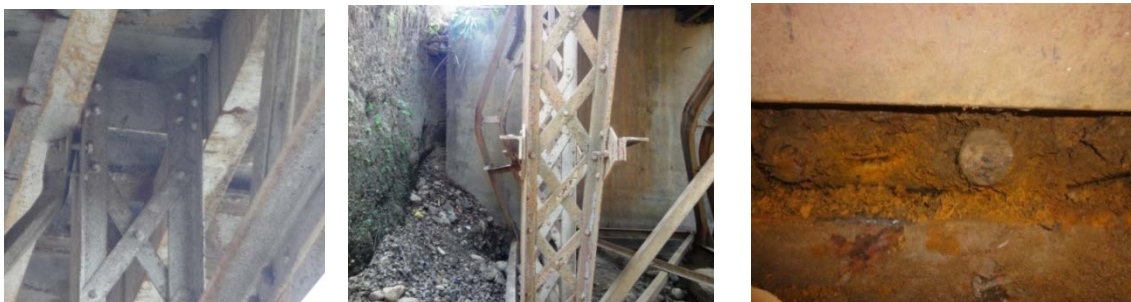
Figure3(a),(b),(c): Loose Rivets, Bearing Filled up with Soil, Roller filled with soil

the earthsoil has been filled up in the rollers and has changed the behavior of bearings and therefore members joining this node have been stressed and failed(Fig 3) at higher loads of 9.56 tone as checked with analytical model. The horizontal stiffener joining the end member was joined with 5mm thick plate in place of 75x75x10mm angle. The deck plates have been damaged as shown in fig. 5 and top surface of deck of the bridge was damaged and surface was uneven. Due to uneven surface the additional impact load had also been added to the structure. It has also been observed that one number bridge was under construction on the same road and this bridge was only approach to that bridge. The over Loaded trucks carrying the construction material were crossed over this bridge which was the main region of failure of the bridge.

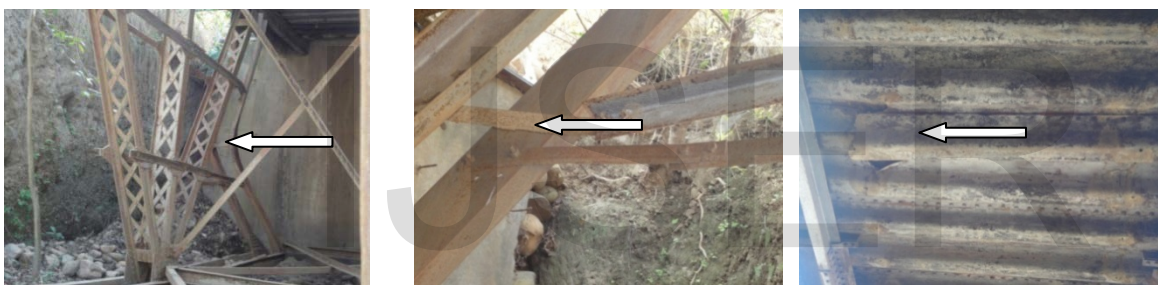
Figure 4 (a)End Member Buckled (b) Inadequate Horizontal stiffener (c) Corroded and damaged Deck

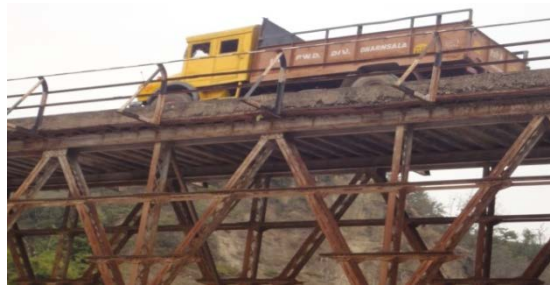
Fig.5 Truck placed to measure deflection

A visual inspection was carried out in order to know the reasons for failure. Serviceability or deflection, is very important in monitoring the health of not only a structural system, but also in analyzing the affects of a new technology applied in the field[6]. The full-bridge deflected shape in long-span bridges is an important parameter that evaluates the safety state of a structure[9] For measuring deflection, surveying equipment was employed in attempt to make serviceability measurement more practicable because of limited access for traditional monitoring equipment for bridges in the remote region. Until recently, surveying equipment would not have produced the accuracy required for structural monitoring use; however, manufacturers of this equipment have developed new technologies to increase the accuracy of the instrumentation. The major component used in this study, the total station, can measure deflection accurate to 0.2 millimeters[7]. This monitoring system useful because there is no site restriction, less labour and time requirement. A basic parameter such as displacement was selected for investigation of damage in bridge. Displacement was recorded at different nodes using firstly with dial gauges and after the bearings was cleared of the debris, the deflection was measured with Total station and dial gauges to know the behavior of bridge under static truck load of 9.56 Tone(Fig 6). The corrosion in the members has been obtained from the half cell potentiometer.

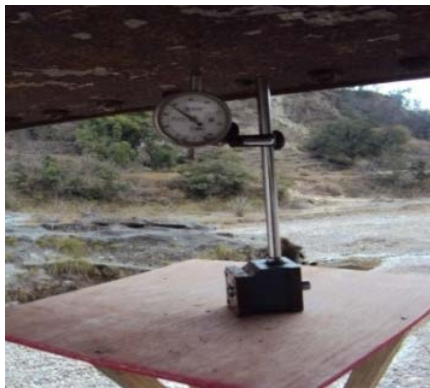
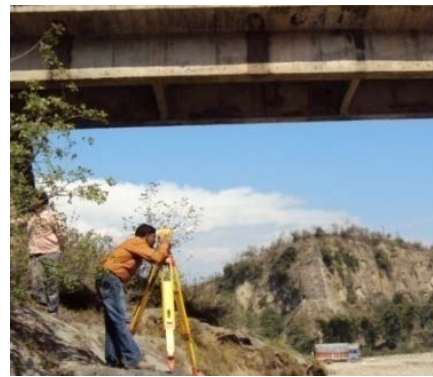
Figure6: Deflection measurement using Total Station and Dial Gauge

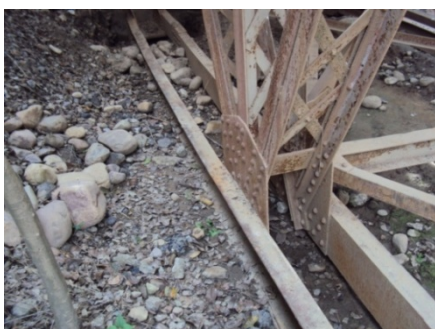
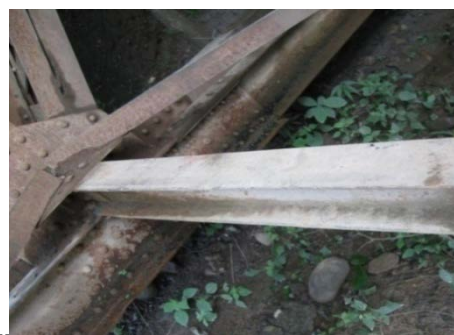
Fig. 7 Node 10 settles down & acted as support Fig. 8 The Support of Debris removed at Node 10

The debris was cleared off and the nodal point 10 was cleared off debris and support was also cleared off debris and load was transferred to roller support. The deflection was measured with same instrument set up and truck with load of 9.56tone placed at the centre (Fig.9). Maximum deflections were observed at nodes 8,9 and 10 and not at centre because end member(node 11) was not transferring load to support as it had already buckled and maximum load is being transferred through node 10.The node no 10 shows the maximum deflection and deflection at nodes 3, 8, 9 is appreciable due to the reason that these points are flexible and damaged as compared to other points. The governing difference between the damaged and undamaged portion is that the response of the damaged region is softer in nature than that of the undamaged region[4]. A primary cause for this softened response is illustrated in Figure 16, where the damaged region shows an increased level of lateral deformation than that of the undamaged region. The nodes of truss towards u/s side does not shows much deflection which shows that the deflection in D/S truss is much more than U/S truss. Thus the retrofitting is required to make the bridge workable

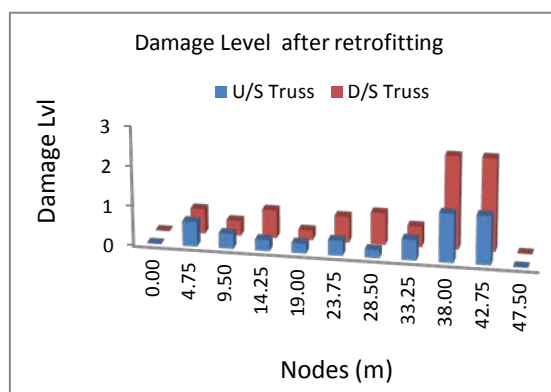
The damage level at span 38.0m and 42.75m was more than other nodes even after retrofitting and shows flexibility at these nodal points which is not evident from visual inspection. The damage level of downstream truss is higher than that of upstream truss both before and after strengthening and retrofitting (Fig. 12). However for both trusses of the bridge the damage level decreased drastically after retrofitting irrespectively of the damage level (Fig. 13).

Fig. 12 (a) Damage level before retrofitting (b) Damage Level after retrofitting

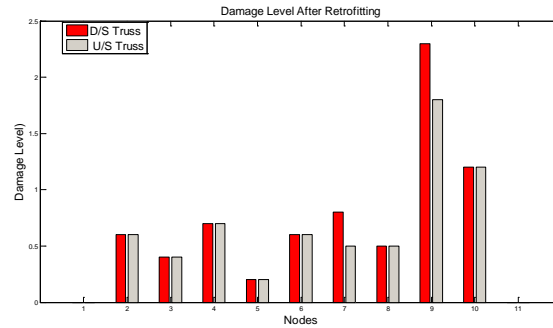
After the retrofitting damage level is as shown in fig.16. Damage level of node 10 was more than other nodes. Some damage has been observed in different nodes because the top longitudinal girder has not been strengthened as this will be retrofitted along with replacement of deck.

Fig.16 Damage Level of Different Nodes after Partial Retrofitting

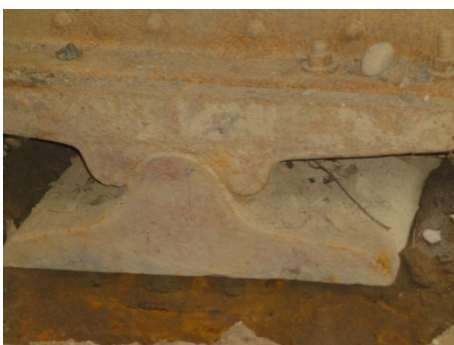
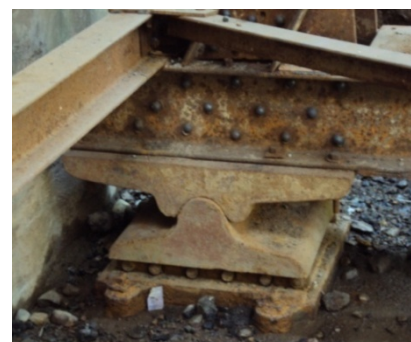
Fig.18(a)

Bearings before Retrofitting

Bearings after retrofitting

Figure 18(a) shows the status of bearings before and after retrofitting. The same bearings were used after clearing the soil deposits. Rocker and rollers were in good condition. The bottom longitudinal members were straightened and stiffened with same steel plate of 300x10mm size as shown in fig.18 (b) The End members were replaced with same section and stiffened with steel plate as shown in Fig.18(c). To avoid inconvenience to the local resident of the area, bridge was opened to traffic. However the replacement of damaged Deck plates and retrofitting of top longitudinal member is still pending and owner agency is on the Job.

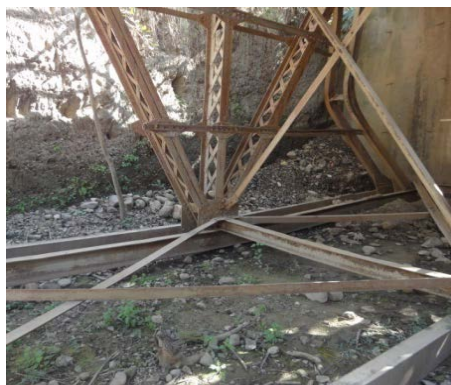
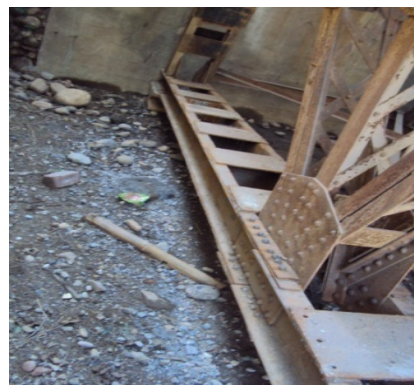
Figure 18(b)

Bottom members before Retrofitting

Bottom members after retrofitting

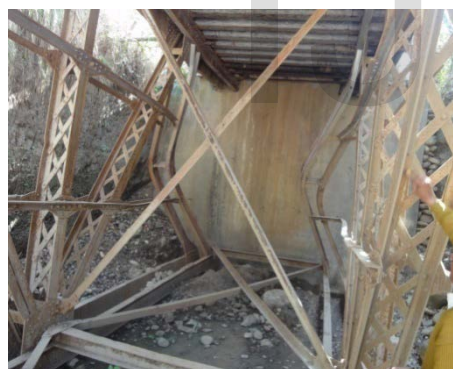
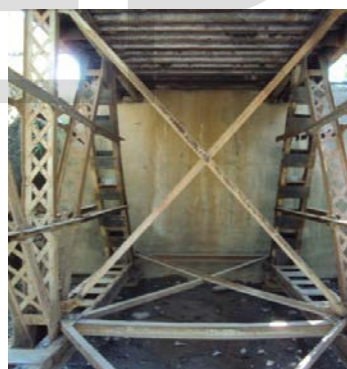
Figure 18(c)

End members before Retrofitting

End members after retrofitting
