Evaluation of Mechanical Defects in Power Transformer Windings Based on Frequency Response Analysis

ABSTRACT— In-depth evaluation of mechanical defects of a 150 MVA, 330/132 kV power transformers windings was investigated in this study based on Frequency Response Analysis (FRA). The FRA, short circuit impedance and insulation resistances measurements were performed to determine transformer windings deformation, mechanical defects, and insulation conditions of the transformer's windings using Frequency Response Analyzer and Megger insulation tester. The attenuation in decibel (dB) of the transmitted signal was measured over a frequency range from 20 Hz to 2 MHz.

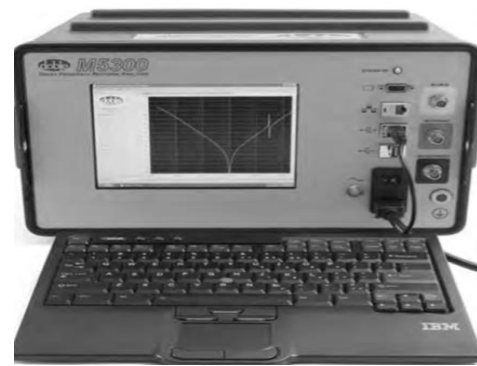
Fig. 3: Frequency Response Analysis Analyzer with application software

FRA tests performed for each phase LV winding of the transformer involves measuring the frequency response of each phase winding. The frequency was measured by injecting a sine wave signal of 10 V AC to the winding for all possible connections with respect to earth at one end of winding of the transformer under test and measuring the signal amplitude there and at other end of winding. The attenuation (in decibel dB) of the transmitted signal relative to reference signal at the input terminal was measured over a frequency range from 20 Hz to 2 MHz. Fig 3 shows the frequency response analyzer measurement equipment used in this study. The frequency response analyzer is a powerful tool, quality control and maintenance toolkit which enables to look inside the transformer to detect even subtle changes in the mechanical structure of the core and windings without costly detanking before testing. This is the most effective diagnostic tool generally used on large HV power transformers because it is sensitive tests to detect winding distortion and deformation in coils, layers, turns, and leads in power transformers [12, 19-20].

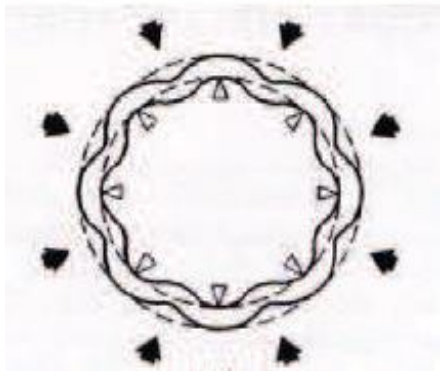
Figure 5: Radial forces due to axial field

Radial electro-dynamic forces cause winding buckling as illustrated in Fig.5 (a) and inward bending between axial strips as is shown in Fig.5 (b), leading to damage of conductor insulation and possible rupturing of conductors. The direction of the forces is perpendicular to the magnetic field lines which have components that cause both radial forces and axial forces. Due to the diversity of electro-dynamic forces acting on transformer active parts, only a number of defects related to these destructive forces are detectible.

(a) Buckling winding

(b) Inward bending between axial strips

Forced buckling occurs when the winding cylinder has significant stiffness as compared to winding conductors; conductors bulge inwards as well as outwards at one or more locations along the circumference as indicated in Figure 5. Severe radial deformations of transformer windings, known as hoop buckling leads to bent winding, but not broken. These deformations occurred in LV windings and show significant decrease (shift to left) of the medium frequency resonance points.

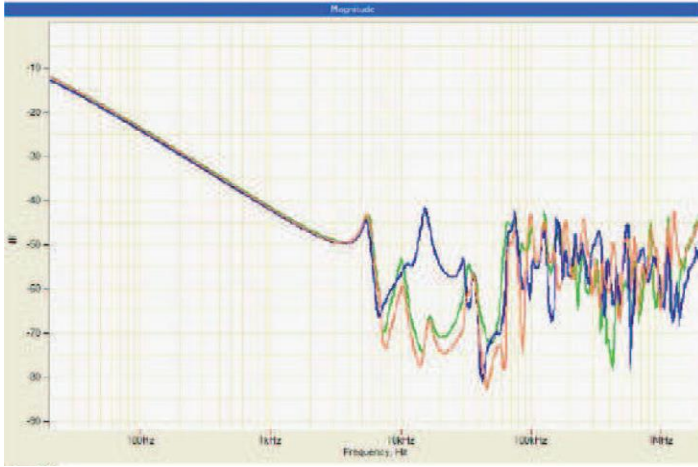
Fig. 6: Short circuit plot of LV winding with respect to HV due to Radial (buckling) deformation

However, the capacitances between the LV winding and a core rapidly increase depending on the deformation degree, showing about 19% and 58% changes for the deformation degrees 1 and 3 respectively. This was due to the LV winding buckling towards the core, which reduces the distances between the corresponding surfaces of the LV winding and the core. Figure 6 depict short circuit plots of LV windings; the logarithmic amplitude ratio in (dB) is in y-axis against the frequency (Hz) in x-axis representing simulation of hoop buckling of the LV winding three-phase faults of **a-n** (brown color) **b-n** (blue color) and **c-n** (green color) with the deformation degrees 1 and 3 respectively.

It can be seen that at low frequency the difference in dB is around 0.4 dB, which was not so critical. However, there were significant deviations of resonance appearances from the middle toward higher frequencies spectrum.

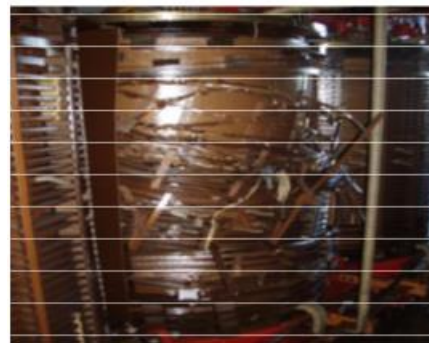
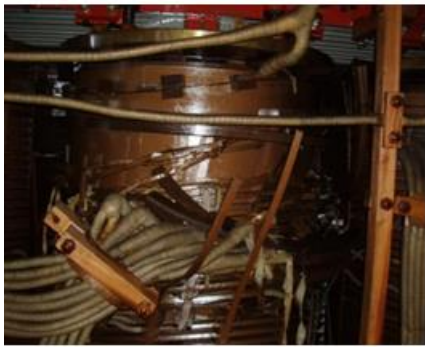
Fig. 8: Visual Inspection of Transformer Axial deformation at HV windings

In order to validate the tests, the transformer was de-tanked to examine the cores and windings physical appearance inside the transformer tank. De-tanking process is a procedure for taking out the core and winding from the main tank of transformer. This leads to the faults been identified more clearly. The de-tanking transformer was let uncovered until winding and core inspection was completed due to time constraint. From the visual inspection results shown in Figures 8(a) and (b), clearly indicates that the transformer had experienced axial winding deformation at HV windings. The HV winding move downward because of the large electromagnetic forces originated from short circuit current produced toward outer direction and make the upper layer of HV winding to disrupt downward.

(a) Normal winding position

(a) Axial defects of HV winding with H2-H3 phase moved downward

(b) Winding defects at H2-H3 phase affecting the tap leads winding

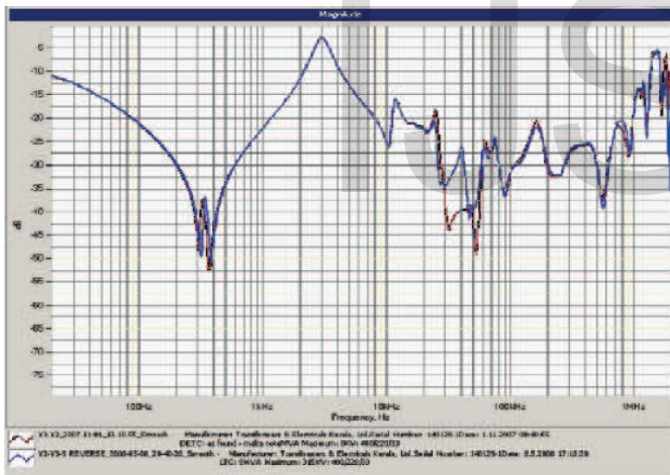
Fig. 9: Short circuit plot of LV winding with respect to HV showing major axial shift in winding movement

Figure 9 illustrate the transfer function responses simulating upward and downward shifts of the LV winding with respect to the HV winding respectively. As seen from the figure there is clear shifts to right in resonance frequencies in both curves, which supports the above classification hypothesis.
