# FAILURE MODES OF RC COLUMNS UNDER LOADING

G. Doğan, M. H. Arslan

**Abstract**—Failure of reinforced concrete (RC) columns has been a main cause of collapse of existing RC building frames so far. Similar failure patterns of buildings have been repeatedly observed in the investigation of past earthquake damages. As observed from these events, seven failure types cause completely failed buildings or partially damage the structural members. The names of them flexural failure, shear failure, shear failure of flat-plate construction (punching failure), bond splitting failure, splice failure of longitudinal reinforcement, creep failure and column-beam joint failure. The objectives of this paper are to highlight some of these observations, causes of failure and to find preventing method of these damages. Some analytical calculation is also given in this paper.

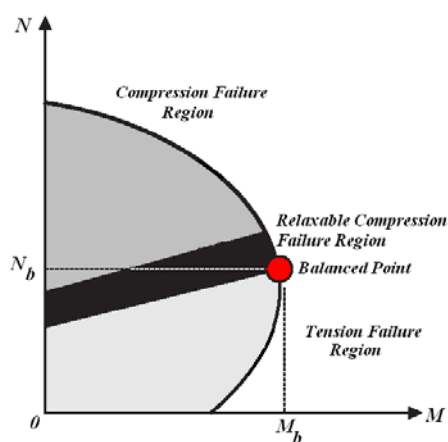
Fig. 1. Interaction curve of a column

With reference to the N-M interaction diagram given in Fig. 1, the design point on the compression axial load side should be made to lie at or below the balanced point, that is  $N < N_b$  so that the failure of column is by yielding of steel and not by crushing of concrete.

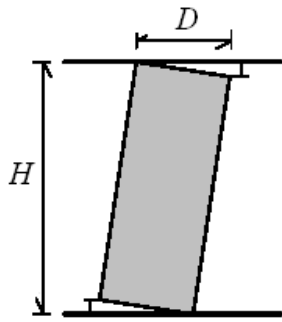
Fig. 2a. Deformation mode

If the column is idealized as a rigid body, the flexural deformation of the column can be represented by the rotation of the rigid body. Fig. 2.a shows this type of failure mode.

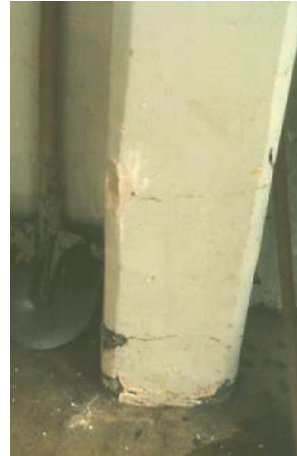
Fig. 2b. Bending cracks witnessed in a coffee-processing factory in Izmit

The bending cracks investigated at the socket level of the columns of a coffee-processing factory erected in 1996 in Izmit can be seen in Fig. 2.b. Formation of bending cracks at lower sections of the columns is a widespread failure type confronted. This type of failure is the indicator of column exceeding the ultimate elastic moment bearing strength at lower sections. The inadequacy of the column cross-sections especially in frame's orthogonal out-of-plane direction (the asymmetrical approach in column-design) and exceedingly ratio of the longitudinal reinforcement the total area of which reaches up to the ultimate value given in the building codes that a column might possess are the principal reasons for column lower section failures.

To compare concrete strength with code's requirement [12], six specimens were extracted from different axe's columns (one of them is shown in Fig. 2.b.). Core of constant diameter,  $d=8$  cm, and different lengths,  $l$ . The results are listed in Table 2 where the core strength is converted into that of the standard cylinder of 15-30 cm.

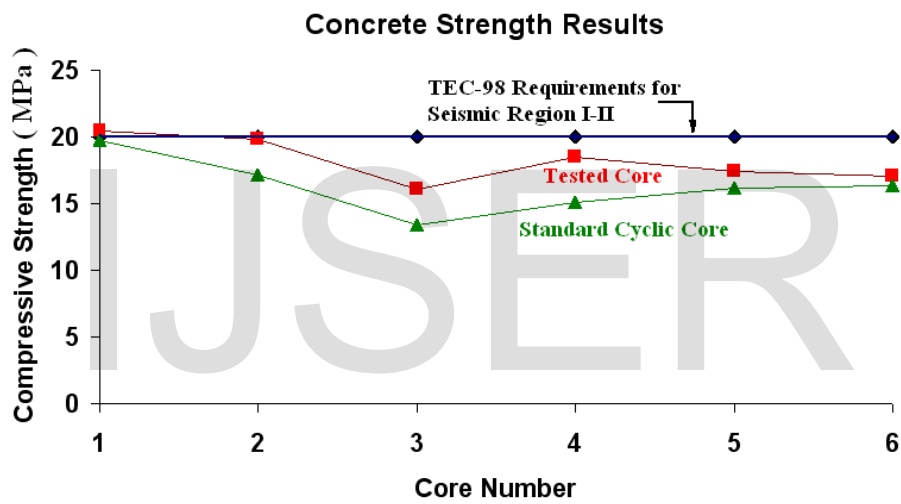
Fig. 3. Comparative experiment of concrete strength

Fig. 3 gives basic information about material strength. As illustrated in Fig. 3, even though the concrete strength must be emphasized upper than 30 MPa in the project, experimental study shows that real strength is lower.

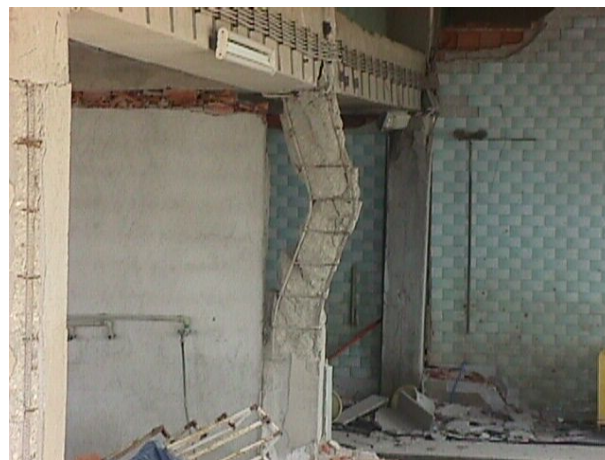
Fig. 4. Typical column failure

from TEC-2007 [12] and TBC-2000 [17] requirements. Fig. 4 was taken from a damaged column that was made low quality materials.

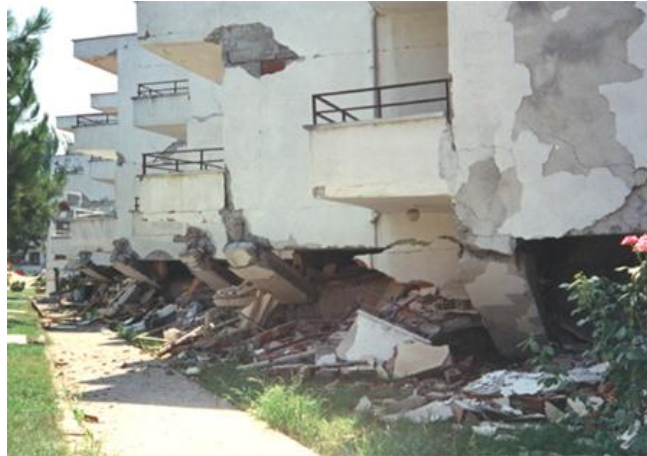
Fig. 5. Strong beam-weak column failure example

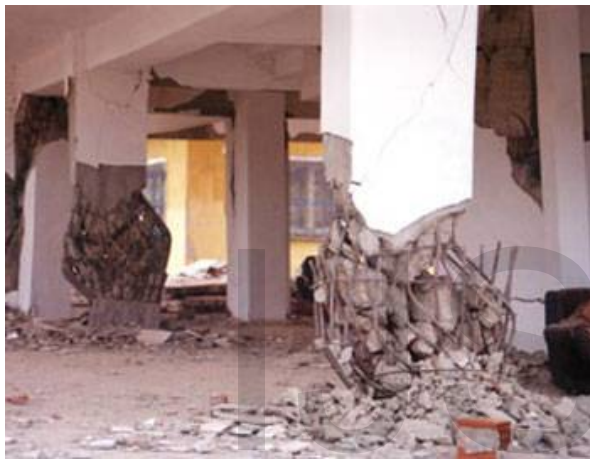
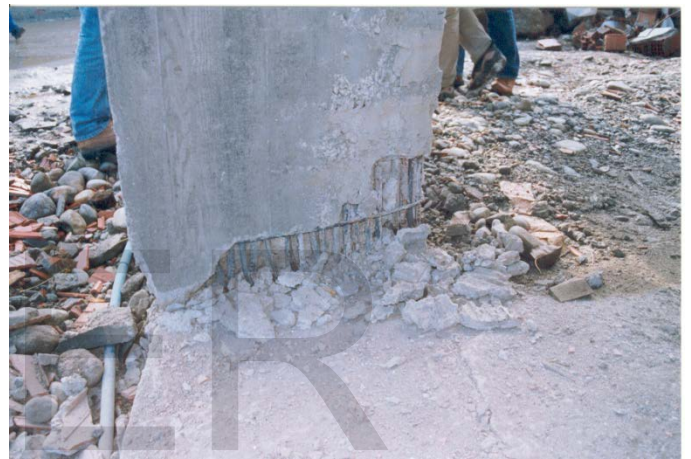
Fig. 6. Columns failure with buckled longitudinal bars

In buildings, the redundancy is higher and the bending moment due to lateral loads per column may be small. Further, the efforts of designers to reduce column sizes to increase architectural appeal pushes the design point more towards the apex of the N-M interaction diagram. This is not desirable owing to possible brittle compression failure. In addition, smaller column sizes relative to that of the beams suggest that the beams are likely to be stronger than columns. Under lateral loads, this strong-beam-weak-column system leads to catastrophic storey collapse mechanisms (or sway mechanisms). Typical strong beam-weak column failure type represents in Fig. 5. According to all seismic codes, columns must be stronger 1.2 times than beams. In example buildings given in Figure, beams are 1.65 times stronger than columns. From these points of view, it may be required to the design point to a level marginally above the balanced axial load, if not at or below the balanced axial load. Fig. 6 shows column with buckled longitudinal bars that experienced high axial load.

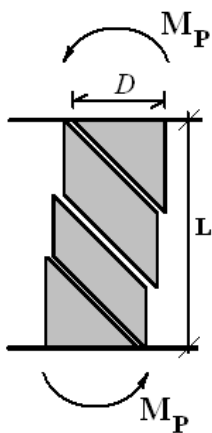
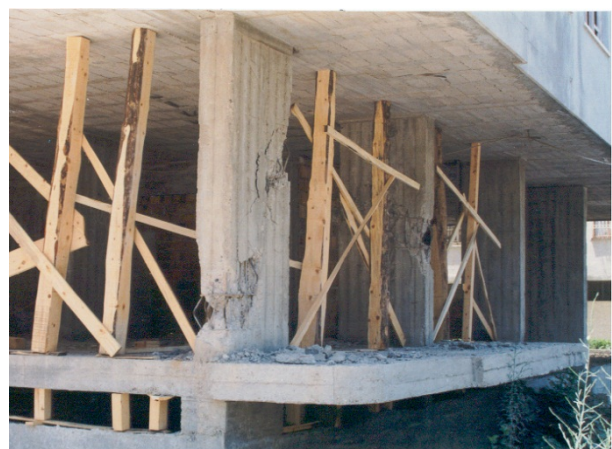
Fig. 7. Shear failure mechanism

The main reason of the shear failure is exceeding tension stress of the concrete tension strength. If shear deformation due to shear cracks is idealized as shown in Fig. 7.

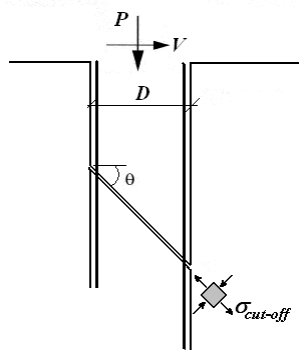
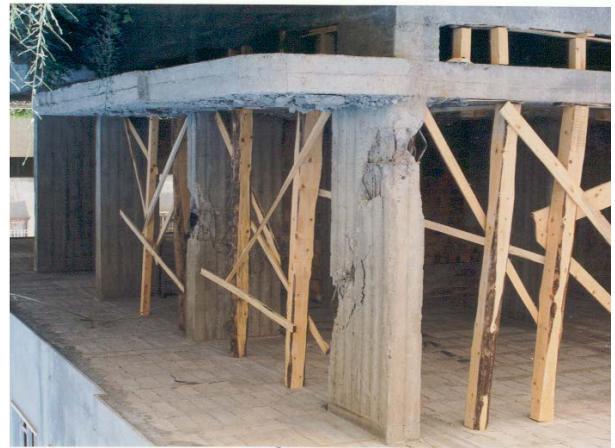
Fig. 8.A damaged column by shear effect

After the concrete cracks under the tensile stress, the stress must be transferred to the lateral reinforcement. Brittle shear failure occurs in the diagonal tension mode when the minimum amount of lateral reinforcement is not provided in the member. Fig. 8 illustrated shear effect on a

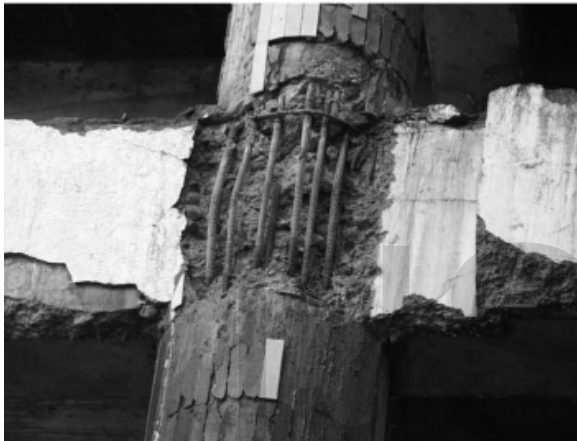
Fig. 9a. The Lack of Shear reinforcement failure of the column [22]

The lack of shear reinforcement was one of the main causes of collapse of the buildings and it is shown Fig. 9a [22]. Some RC columns failed due to its shortening because of the effect of the masonry wall (short column effect) (Fig. 9b)

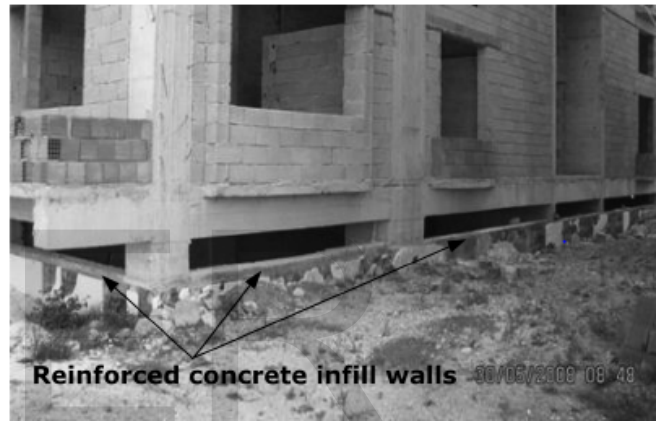
Fig.9b. Short column effect [23]

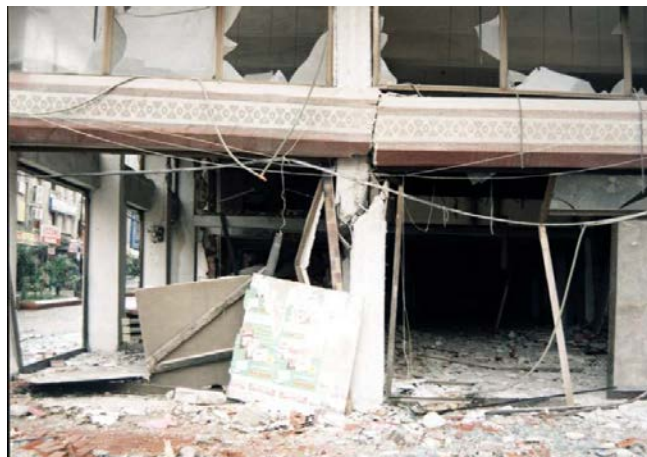
Fig. 10. Shear failure at column Top [24]

Fig. 10 is represents a shear failure type occurred after 1999 Marmara earthquake [24]. As well as ACI-318, during the last few decades several shear strength model have been proposed and used for the design and evaluation of RC columns. A short brief of this model is given in Table 3 for a sample column. In the Table 3, only concrete contribution and transverse reinforcement is given. According to the ASCE-ACI Committee 426 Proposals [25], the most critical mechanism were identified as the shear transfer by the transverse reinforcement and concrete. Shear transfer by uncracked concrete, interface shear transfer in the cracked concrete, aggregate interlock, dowel shear carried by the longitudinal reinforcement and arch action in deep members is commonly neglected.

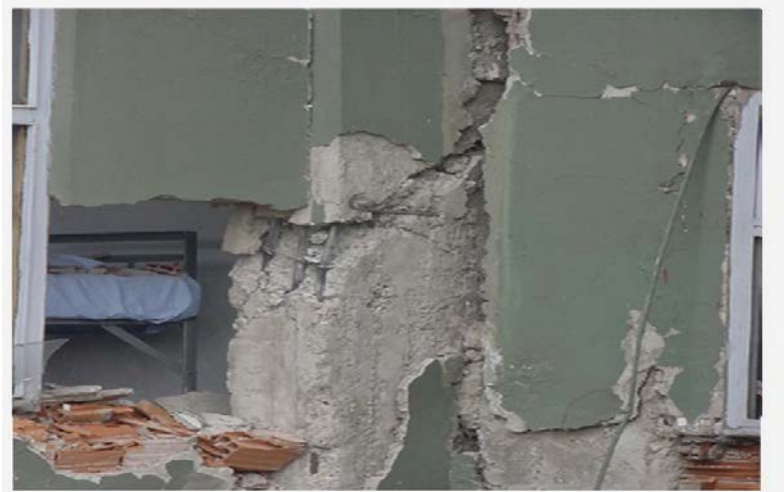
Fig.11. Shear failure of column [26]

In lightly reinforced columns after the shear failure degradation of the core concrete may lead to loss of gravity-load-carrying capacity. A sudden loss of column axial capacity will lead to transfer of column gravity loads to neighboring frame members with ensuing dynamic redistribution of forces within those members and a possible subsequent building collapse. Fig.11 shows shear failure effect in a lightly reinforced column [26].

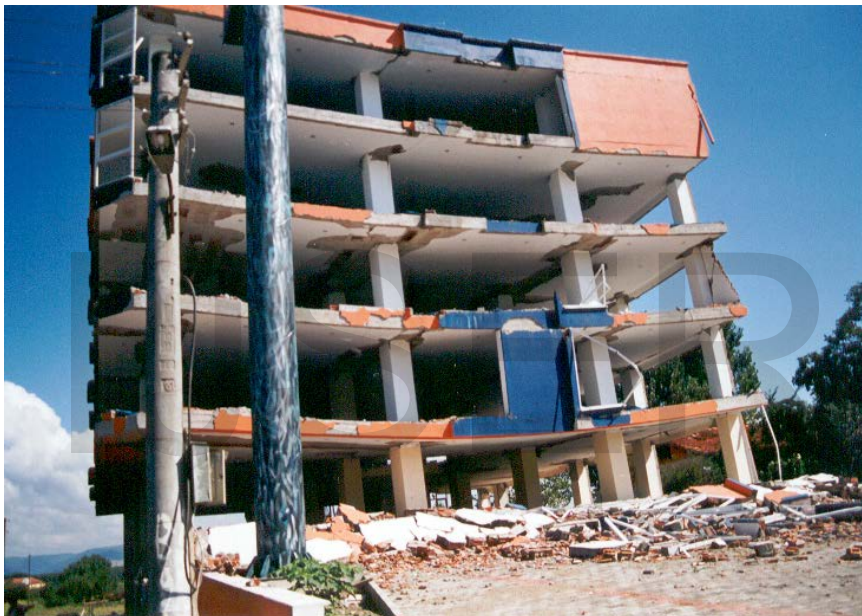
Fig. 12. Shear failure of flat-plate construction (punching failure)

The flat plate is a two-way reinforced concrete framing system utilizing a slab of uniform thickness, the simplest of structural shapes. A flat plate floor do not have beams supported the slabs. Serious shear failure of flat-plate (punching failure) was observed after the 1985 Mexico City and 1999 Marmara-Kocaeli Earthquake.

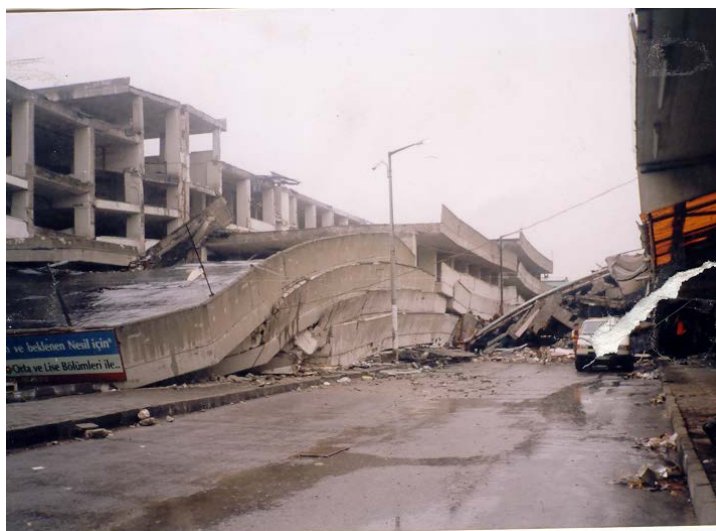
Fig. 13. The pan-cake collapse

Fig. 13 represents the pan - cake collapse of a RC building in Marmara region, after the 1999 Marmara-Kocaeli earthquake.

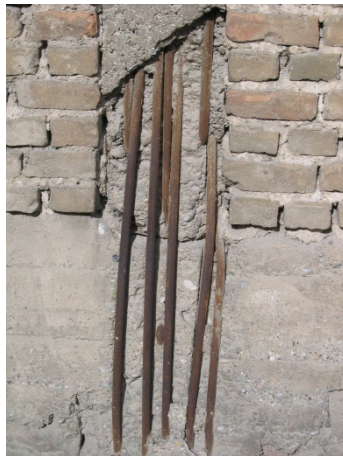
Fig. 14. Longitudinal reinforcement of a column is not closely spaced (450-600 mm)

In figures 14 and 15 bond splitting failure types are given.

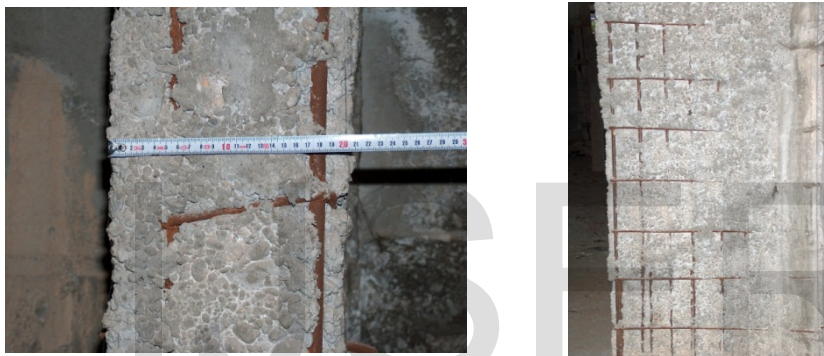
Fig. 15. The concrete cover on the deformed bars is thin

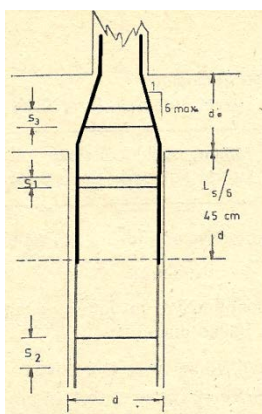
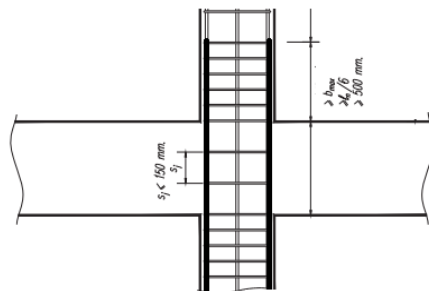
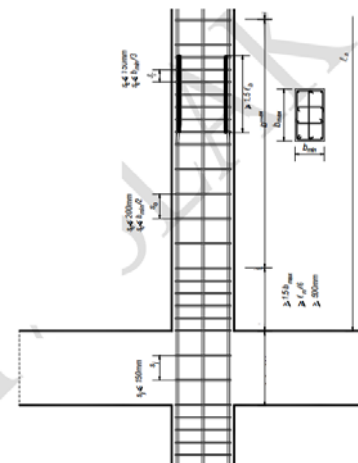
Fig. 16. Lap splices of columns in TEC

TEC-1975 [18]

TEC-2007 [12]

TEC-2017 (draft) [27]

(b) In the case where more than 50% of longitudinal reinforcement is spliced at the bottom end of column, lap splice length shall be at least 1.5 times  $\ell_b$ . The same condition shall apply to starter bars protruding from the foundation.

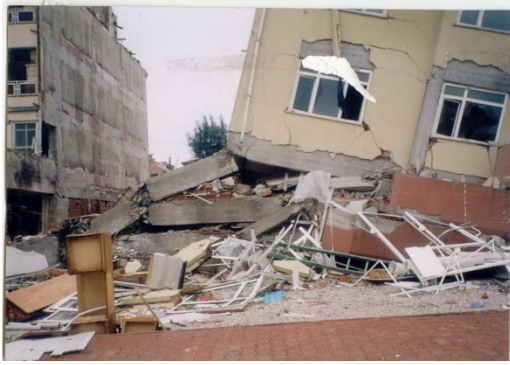
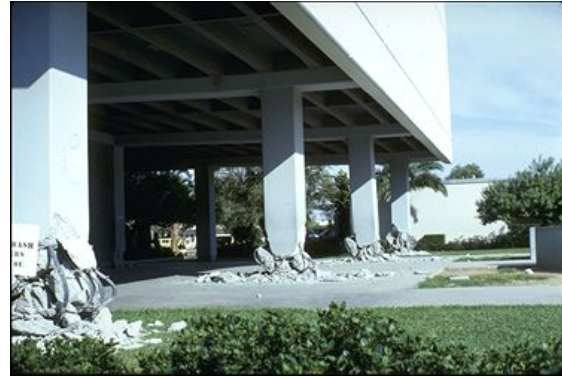
Fig. 17. Inadequate details at the base [19-23]

Fig.17-18 is a good example of splice failure of longitudinal reinforcement. Most of buildings collapsed because of inadequate lap splices in column- base connection region after 1999 Marmara Earthquake.

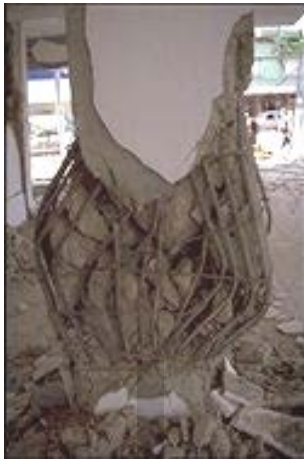
Fig. 18. Failure of short lap splices in moment-column frame

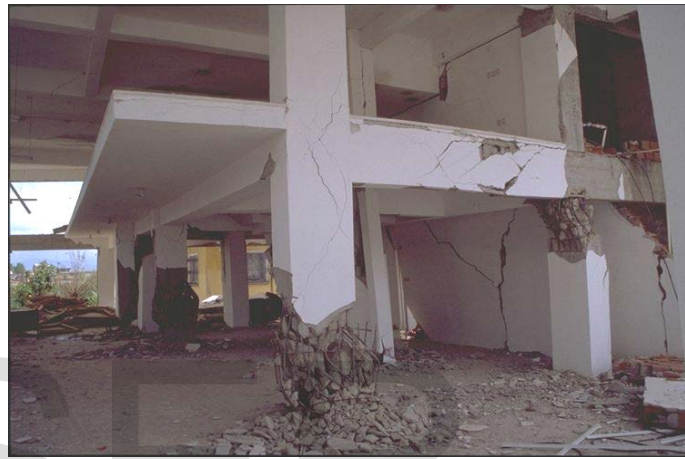
Fig. 19. Short columns failed

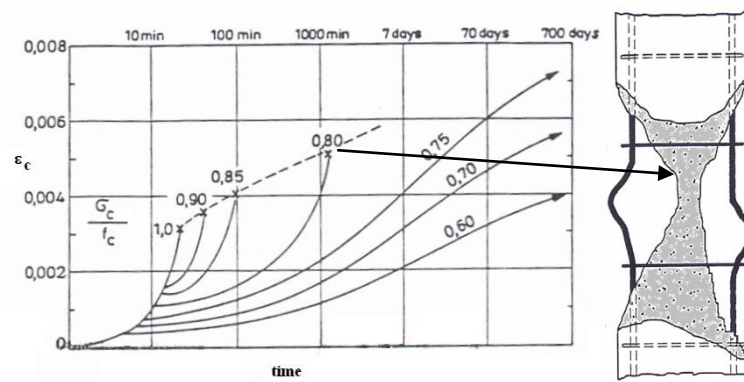
Fig. 20. Creep has an unfavorable effect on the strength of concrete [41]

dependent deformation of concrete that is subjected to permanent loads. Fig. 19 demonstrated that concrete specimen which are loaded up to 60%, 70% and 75% of their strength carry such loads forever without showing any failure. When the same specimen is loaded so that the stress in concrete is 80% or more of its strength, the specimen fails after a certain time [41]. Fig. 20 shows a creep failure. Creep causes significant deformation and makes some cracks occur. A harmful type of this failure is shown in Fig. 21. In Table 4 [42], experimental study results were given. It is clear that compressive strength of concrete is really very low according to the TEC-2007 and TBC-2000 design criteria.

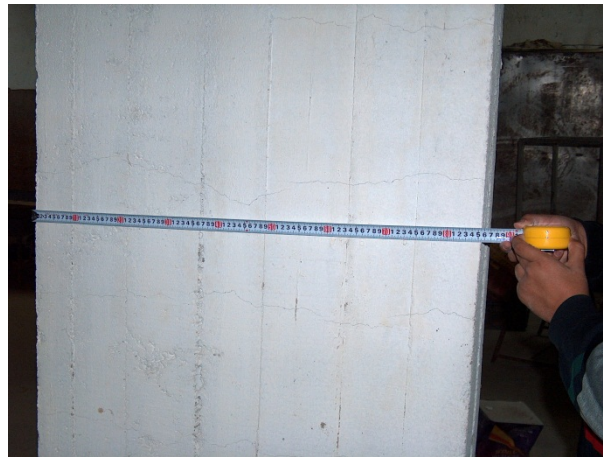
Fig. 21. Cracks caused by creep

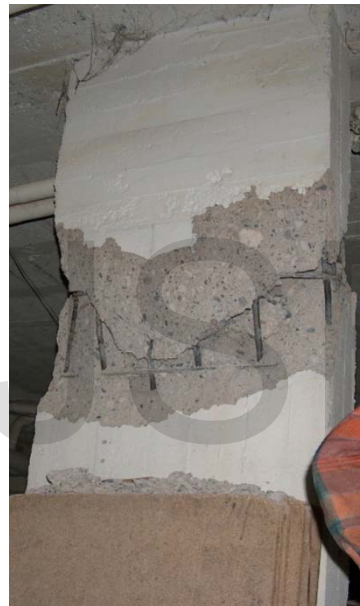
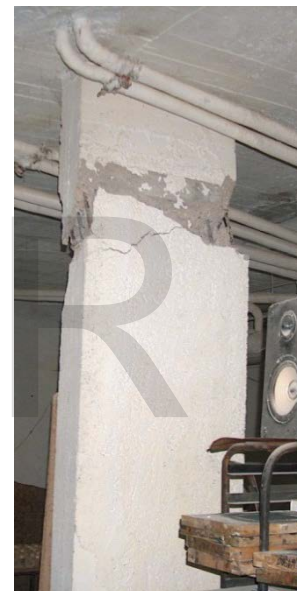
Fig. 22. Creep failure, heavily damaged column in an apartment [42]

Kaltakçı et al. [5-7] studied about the collapsed RC building in their self-weight. The main structural failing cause is creep deformation of the concrete. Creep failure, heavily damaged column in an apartment is shown Fig. 22 [42].

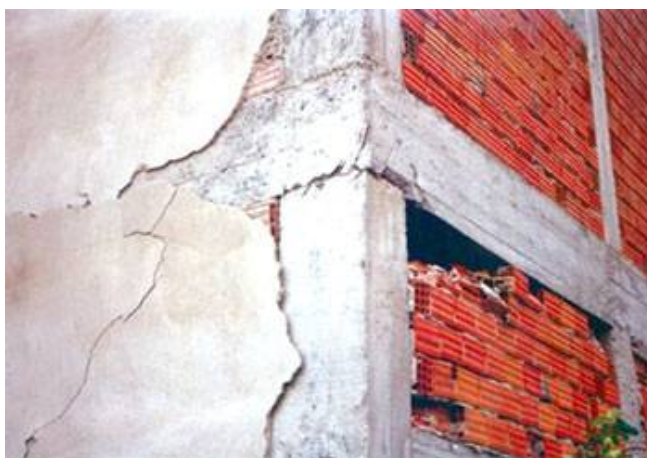
Fig. 23a. Undamaged column-beam joint

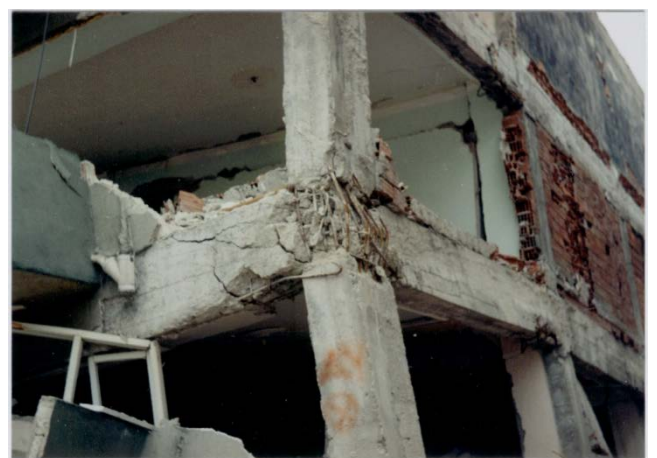
Fig. 23b. Figure Damaged column-beam joint

- insufficient lateral ties at the beam-column joints. A view of one of the damaged joints is shown in Fig. 23b. In the figure, beam-column connections consisted of weak reinforced concrete columns and strong beams. On the contrary, similar building that is shown in Fig.23a did not meet heavily damage after earthquake shock.
- Confinement reinforcement did not exist and beam reinforcing bars anchorage in the joint is inadequate. This type of damage was also reported for the September 21, 1999 Chi Chi earthquake [43].

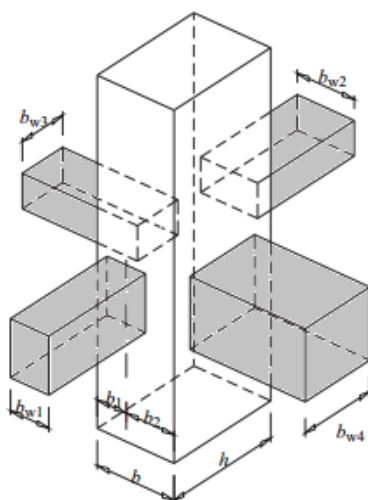
Fig. 24. Beam-column joints of frame systems
