Fate of landfills on Kureepuza

Amrutha Subhash and Sruthi M

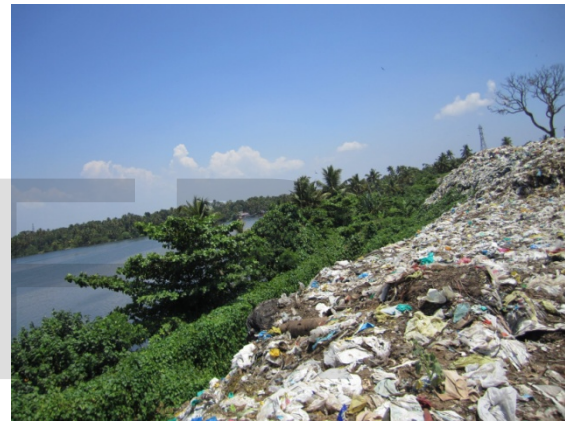
The soil is deep laterite clay saprolitic subsoil at a depth of 2-3 m. The water is about 105m below the subsoil. There are number of wells on the sides of the site and these are being used by the neighbouring residential population. The existing 109ha site has been used for disposal of unsegregated solid wastes. Much of the site is covered with garbage to a height of 3-4 m and currently uncovered. During monsoon season the leachate directly percolates through the soil to the nearby lake and ground water.

Fig.1. Kureepuza dumping site near Ashtamudi Lake

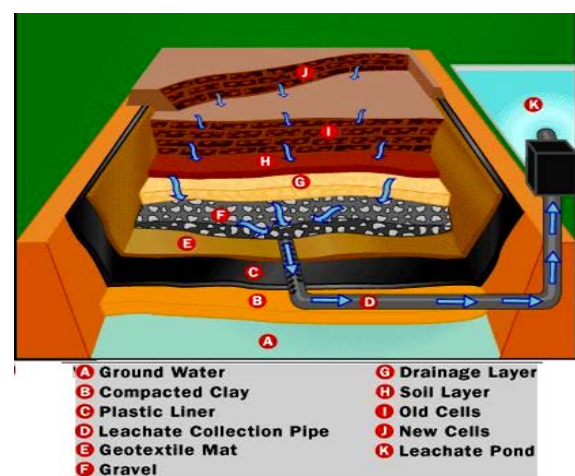
There are three critical elements in a secure landfill: a bottom liner, a leachate collection system, and a cover. Bottom layer may be one or more layers of clay or a synthetic flexible membrane (or a combination of these). The liner effectively creates a bathtub in the ground. If the bottom liner fails, wastes will migrate directly into the environment. There are three types of liners: clay, plastic, and composite. Normally clay is used as bottom layer. But natural clay is often fractured and cracked. A mechanism called diffusion will move organic chemicals like benzene through a three-foot thick

Fig.2. Sanitary Landfill

clay landfill liner in approximately five years. Best landfill liners today are made of a tough plastic film called high-density polyethylene (HDPE)
