Impacts of Roadway Condition, Traffic and Manmade Features on Road Safety

Abstract — Accident leads to disablement, death, damage to human health and property, social suffering and general degradation of environment. The road accident situation in India is alarming. Records show that there is one death at every 2.75 minutes because of road accidents. Road accidents inflict heavy economic loss to the country. Road Safety is necessary to reduce accident involving both human and vehicles there by making the road more safe and user friendly to traffic. NH-5 is one of the major connectivity from Chennai to Calcutta which caters to the need of transportation of light goods to heavy goods and passengers. Study area was undertaken on road NH-5 from Chilakaluripeta to Ongole with stretch of 183 Km in Andhra Pradesh state. The coal based power plants and steel industries have been set up in this place since 2006. The study Stretch is a major connectivity to number of heavy industries like Nalco, Bhushan steel, Jindal steel, GMR, ESSAR steel, Adani power, Monnet and many more small scale industries based on Talcher coal mines. The location in a roadway where the traffic accident often occurs

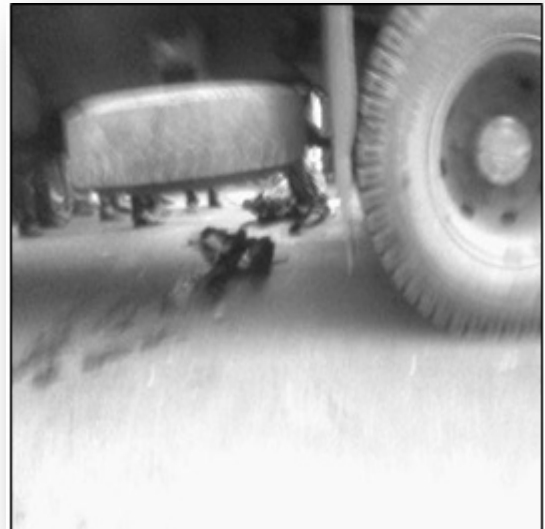
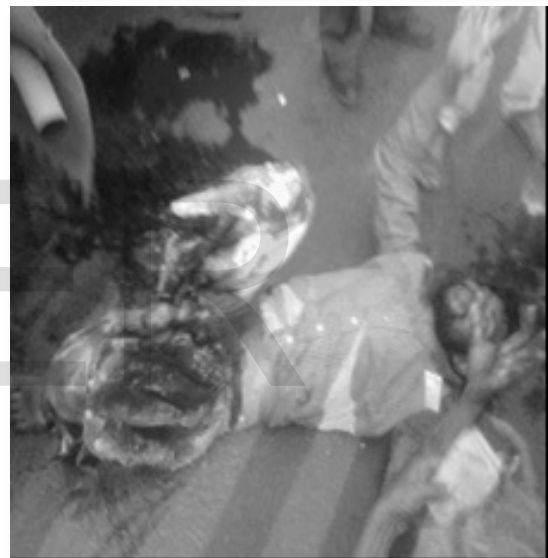
Fig. 2 & 3. Accident image of bike and a lorry

Description : On 30th march 2015 one Bajaj motor cycle with two person collided with a aluminum loaded truck in Rajupalem around 4.30 PM. The motor cycle was coming from chilakaluripeta to martur and truck was moving on highway. The motor cycle rushed to the right side of truck front. The truck applied brake and turned towards left side. The bike fell down under the rear right wheels. The victims were severely injured. The rider lost his right leg completely and left leg scratched while other was under truck with severe knee and head injuries. The rider had used helmet and saved from head injury. The ambulance came after 30 minutes and took victims to the hospital. The victims were two brothers from Martur town and rider lost his life after two hour of incident.

Cause of accident was due to presence of old banyan tree on the corner of T-junction and ditches of shoulder was filled with water. The motor cycle could not notice the truck due to that big tree and collided with truck on the highway. The tyre skid mark length was 11mt. The accident images were shown below:

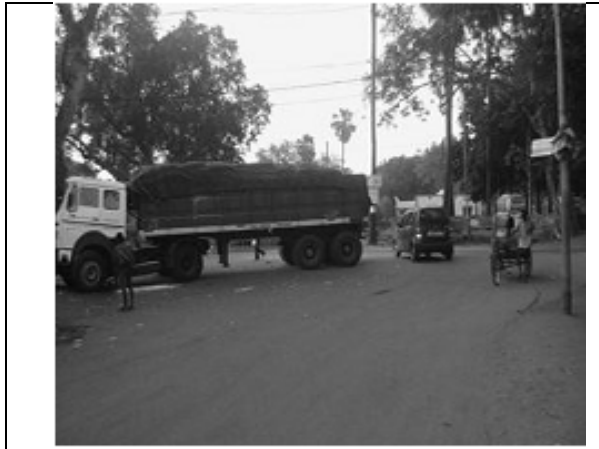
Fig. 4. Accident photo of a lorry

Description : The trailer was on the highway with normal speed. At a T-junction one auto with nine passengers was changing direction (left turn) from bus stop road to highway. Both vehicles became front to front. The trailer driver applied sudden brake and struck the vehicle with an old tree present at corner of junction. The auto was escaped from collision. Driver and helper were injured. The accident photo is shown here,

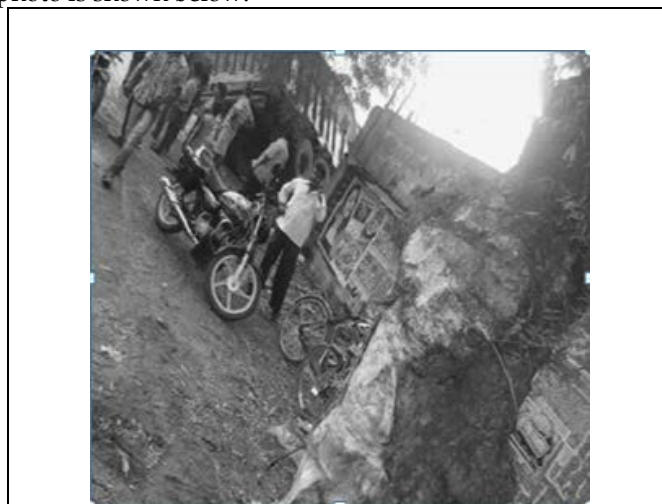
Fig. 5. Accident Photo of a Tree which was damaged in collision

Description : The truck was moving on NH-5. Near traffic post the truck driver could not notice traffic median due to absence of sign post and signal. The truck ran over median and hit with a tree and finally struck with compound wall. The driver became severe injured and helper became minor injured. The vehicle, tree and the compound wall were completely smashed. The accident photo is shown below.

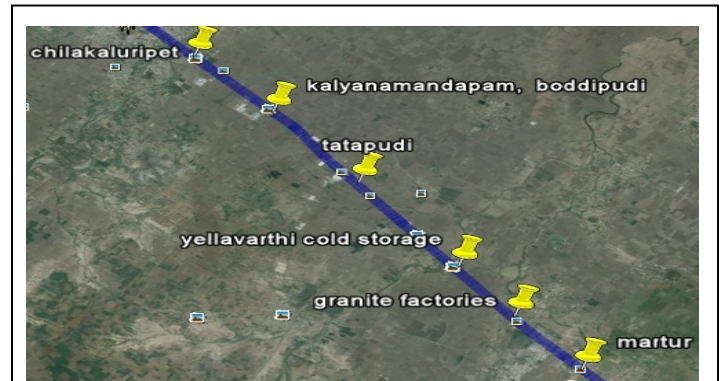
Fig. 6. Black Spot Points Stretch-1

Accident Point	Numbers	Problems	Safety Enhancement
Divyavoti Talkies	13	X-Unsignalised, 10w Garages, Sight distance obstruction by Shops	Junction Improvement, Sight distance visibility
Bazar Chowk	6	O-Unsignalised, Transformer, 2w Show Rooms	Junction improvement, Clearance Of obstruction on the Shoulder,
Budhi Thakurani	8	O-Unsignalised, Taxi stand, Stalls on the Shoulder	Clearance of obstruction on Shoulder, Sight distance visibility
SBI martur	6	T, Taxi stand, Vegetable Market	Clearance of obstruction on Shoulder, Sight distance visibility
Tatapudi	15	X-Signalized, Cinema Hall, 2w garages, Trees and Poles on Shoulder	Clearance of obstruction on Shoulder, Sight distance visibility
Kanchan Talkies	10	T, Cinema Hall, Trees on Blind Corner, Trees and Poles on Shoulder, Main Bus Stop	Clearance of obstruction on Shoulder, Sight Distance Visibility
Yalla varthi cold storage	16	X-Signalized, Paved Shoulder withno Marking, Transformer on blind corner, On Street Parking of Vehicles	Clearance of obstruction on Shoulder, Sight Distance visibility

Police Training Center	20	Paved Shoulder withno Marking, On Street Parking	Installation of Speed Breakers, Marking
Martur	11	T, Petrol Pump, Transformer on blind corner, Sight Distance obstruction	Junction Improvement, Clearance of Obstruction on Shoulder

4. Stretch I have the second highest no of accidents accounts for 32.5% of total accident. The Accident rate can be reduced by providing signalized junction, junction improvement, and shoulder Clearance, installation of humps, shifting of poles, removal of trees near the edge of pavement etc.

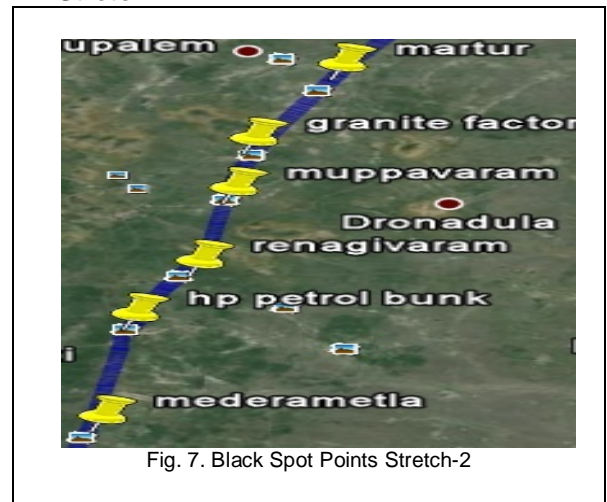
Fig. 7. Black Spot Points Stretch-2

Accident Point	Nos	Problems	Safety Enhancement
Market yard	14	Vehicle Parking on Shoulder, Trees and Poles on Shoulder.	Clearance of Road Side
Tulsi Dhaba	8	Meat and Fish Shop on The Shoulder, Old Trees on The Shoulder	Discouragement of Fish and Meat Shop on The Shoulder, Trees on Shoulder should be removed
Muppavaram	15	Median without Sign on the Road, Temple on the Shoulder, Trees on the Shoulder.	Medians to be Painted, obstacle on The Road Should Be Removed
Renangi varam	10	T, Wine Outlet, Unpainted Median, Trees on Shoulder	Median to be Painted, Junction Improvement
Hp petrol bunk	6	T, Unpainted Median,	Junction Improvement,
Mederametla	14	Village Area on Both Side, Godown, Plants on Shoulder	Speed Restriction, Shoulder Improvement

Accident Point	Nos	Problems	Safety Enhancement
Hp petrol bunk	08	T, On Road Bus Stop, Auto and Taxi Stand, Trees on Edge, Shop Verandah on Shoulder, Shoulder Ponding	Separate Bus Stop, Shoulder obstruction Clearance and Maintenance, Junction Improvement
Cold storage	11	Petrol Pump, Betei and Tea shop on shoulder, Shoulder Ponding by Drain Water, Heavy Machinery Garages	Road Side Clearance, maintenance of Shoulder
Rice mills	5	Cinema Hall, Shoulder Drop Off, Old Grift Tree Branches	Visibility by Cutting old Tree Branches, Shoulder Maintenance
Auto nagar	21	Motor Show Room, Dhabas, Shoulder Ponding By Drain	Off Street Parking Facility, Shoulder maintenance

5. No of accidents in stretch II accounts for 29.6% of total accidents. The accident rate can be minimized by clearing-off shoulders, reducing speed limit, junction improvement, providing Signals on the median, shifting structures on the shoulder.
