Landslide problem in Lalkhan Bazar Area of the Chittagong city, Bangladesh

Abstract- Landslides and mudflow after heavy monsoon rains are happening recurrently as the consequences of unwise hill cutting and deforestation in the Chittagong city, causing fatal accident including the loss of lives and property loss. In this paper, we present the main causes for landslide by determining the engineering and geological properties of the in situ soil samples. The analyzed slopes are consisting of two types of formation. Upper part comprises of hard and compact silt/clay layer with high cohesion (1.9-6.82 KPa) and Young modulus (519.4-2627.0 KPa). On the other hand, lower part consists of loose sand with relatively low cohesion (1.53-3.5 KPa) and Young modulus (49.16-55.0 KPa) The mathematical modeling using both liquid equilibrium and finite element method shows that the analyzed slopes are relatively stable (Factor of Safety and Shear Reduction Factor is more than 1) at dry condition. However, in the wet condition most of the slopes are vulnerable for landslide and need support to be stable for saving the people from accidents and injury.

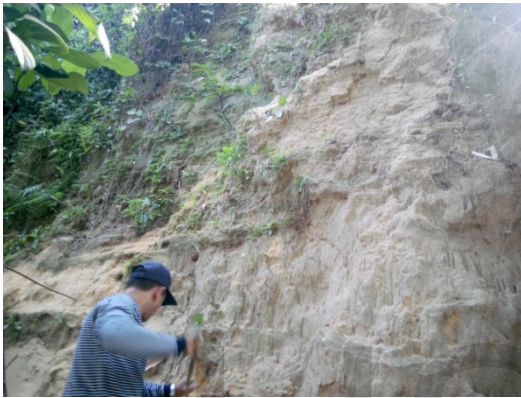
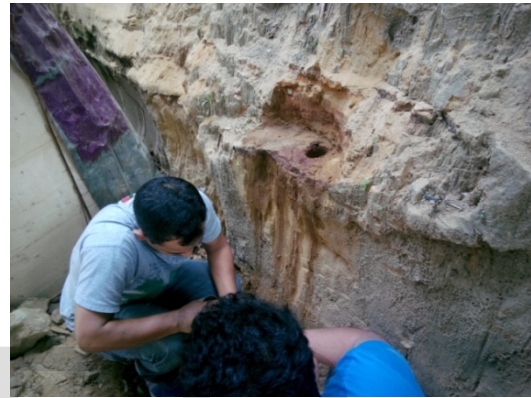
a.

Lalkhan Bazar area has some vulnerable slopes (Fig. 2a-b) that may cause disaster at any time. The slope angle of the slopes are ranging from 65 to 90° with some prominent joint or discontinuities in Matijharna (Lat. 22°20.827'N, Long. 91°48.863'E Fig. 2a-b) and Tankir Pahar (Lat. 22°20.91'N, Long. 91°48.857'E Fig. 2c-f). The upper part of the slopes are comprised of hard clay formation while the lower part consists of mainly loose sand particles (Fig. 2a-b). The upper part of the Tankir pahar area shows the indication (presence of kaolin (Fig. 2e) of

Fig. 2 Photographs of the study area, a-b) Matijharna, c-f) Tankir pahar, and g-h) Batali Hill

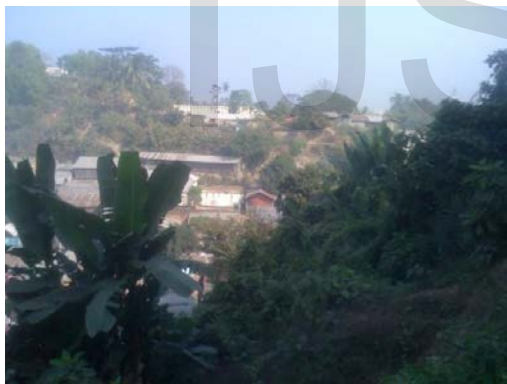
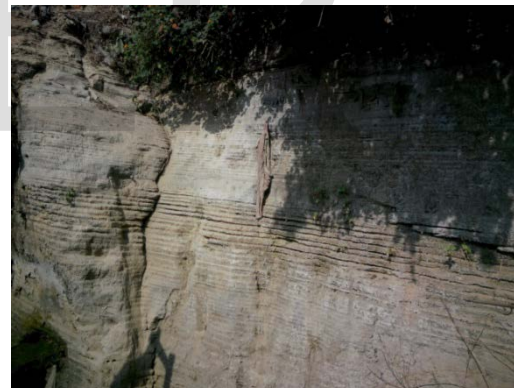
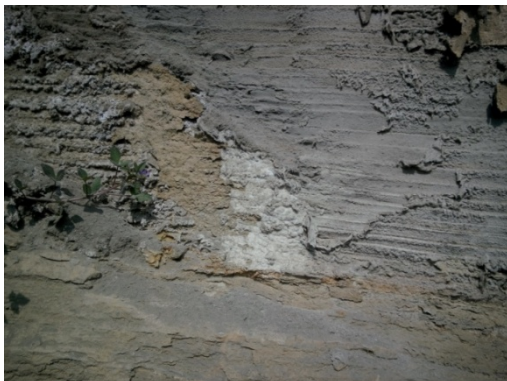
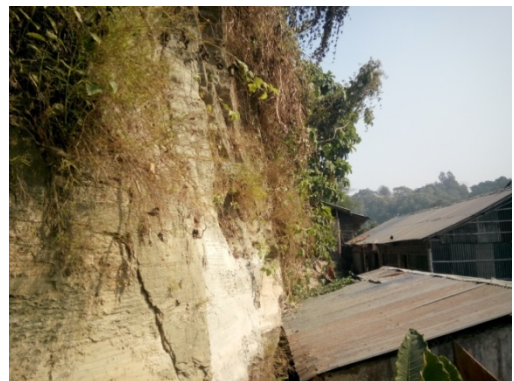
seepage during or after rainfall, which caused instability of the zone. The lower sand zone seems hard in the dry condition but it is very loose at wet condition. This phenomenon is observed during field and sample collection. The Batali Hill area (Lat. 22°20.742'N, Long. 91°48.778'E Fig. 2g-h) is very high with more than 80° slope angle. Some important construction, including telecommunication tower of the Chittagong City Corporation is situated on the top hill. There is a huge population will be living at the base of the slope in the mentioned area with risk.

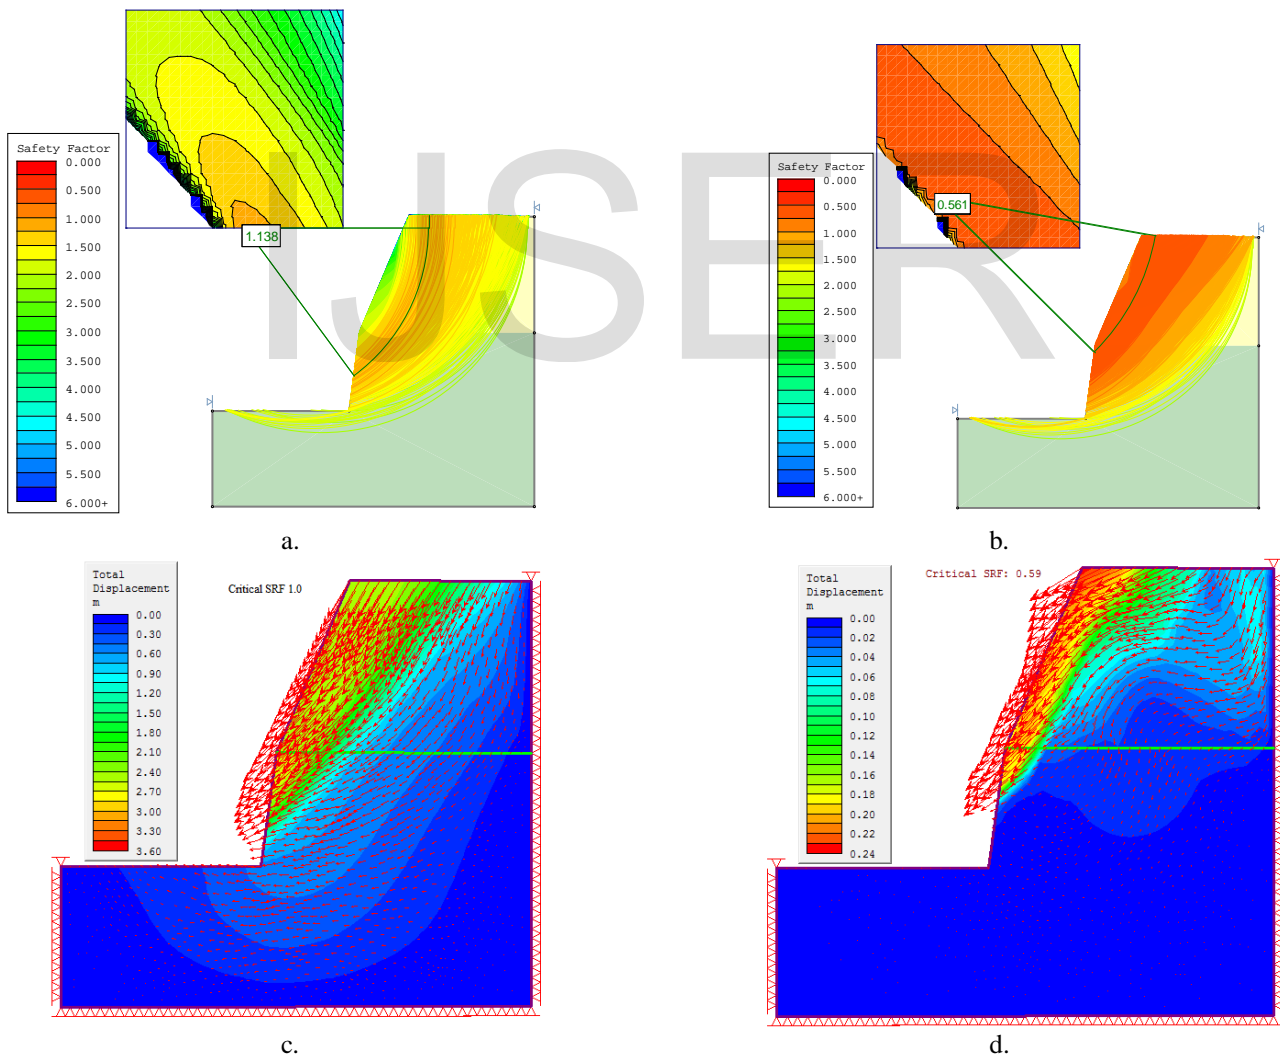
factor of safety (FS) and shear reduction factor (SRF) values <1 (Table 2). We represent the rigorous analyses of the limit equilibrium technique and finite element method for strength reduction factors of different slopes at better confidence (Table 2). The SRF values are in good agreement with FS values in most cases. Figures (5c-d, 6c-d, 7c-d) show that the deformation vector in the slopes is indicative for greater deformation of the upper part of the slope face.

Fig. 6 FS value using the Bishop's simplified method at a) dry condition and b) wet condition and SRF at c) dry condition and d) wet condition of the Tankir Pahar area of Lalkhan Bazar of the Chittagong city
