Limitation of Corrosion Action for Concrete and Steel Corrosion action in aggressive conditions with time

Usama Mostafa Mohamed MAHRAN
Civil Engg. Depr. Faculty of Engg. Assiut University, Assiut –EGYPT

ABSTRACT- In this paper, the corrosion for both concrete and steel studied, program of thirty five samples start at year 2002 were prepared with the same steel and the slabs dimension were 50cm width 14 cm thickness and 240 cm span length, bottom steel five bars with diameter 13 mm and top steel with 10 mm width. The percentage of water to cement was 0.56 and the mixing water was with the chloride concentration 3% percent of the cement weight. All slabs were exposure in the laboratory temperature and spread daily with water concentration 3% of chloride, the steel on slabs were connected to the electronic circuit to accelerate corrosion process. The slabs were divided to three groups Group (L) with the calculated rate of corrosion of 10% were tested at year 2004, both Group (M) with 30% and Group (R) with 50% repairing were started at year 2004 and the rate Corrosion situation of steel before the repairing were measured after the slabs cover removed before the repairing process. Th

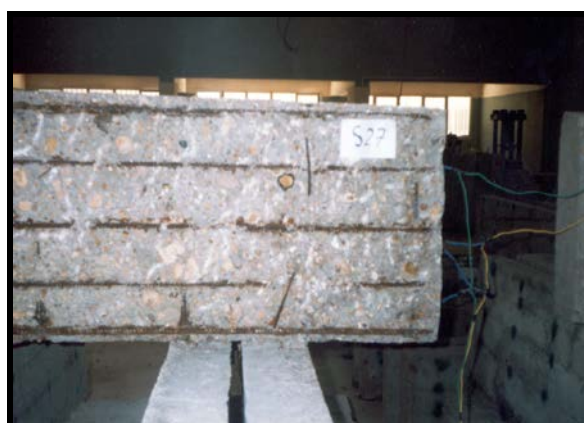
Fig. (1 a) Removing of contaminated concrete covered layer of slab27 (M).

After the application of dynamic corrosion process, all slabs had developed cracks along the line of bars and some hairline cracks perpendicular to them with some corrosion stained in evidence on the surface. The slabs then were opened carefully by using the hammer and nail to remove the concrete cover to a depth at the center of the reinforcement. The corrosion degree was estimated by area reduction percentage for the entire reinforcement net of each slab, Then the average value was calculated for each slab, Hence the slabs was divided into three groups low 10% corrosion were repaired year 2003, medium corrosion 30% were repaired year 2004 and high corrosion 50%. General visual results of corrosion and opening different types of slabs are shown in fig. 1.

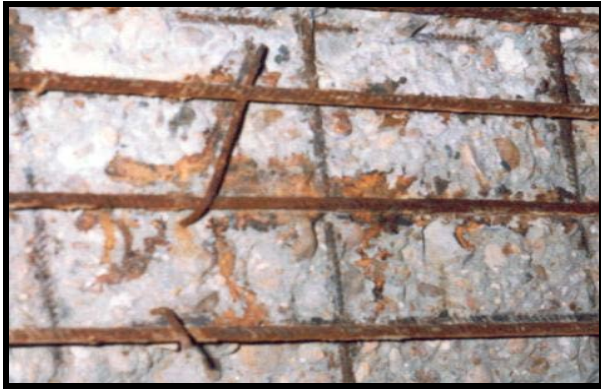
Fig. (1 b) Removing of contaminated concrete covered layer of slab27 (H).

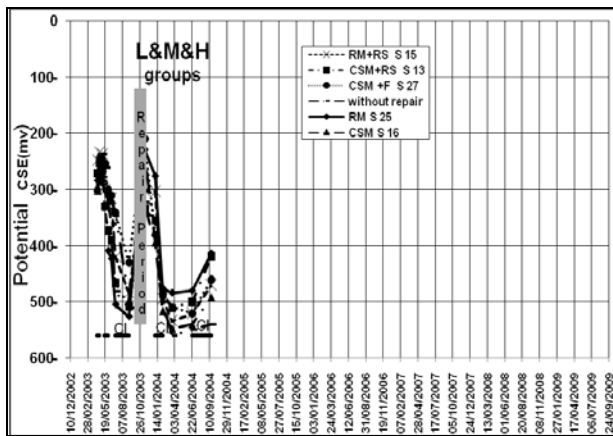
Fig. (2) Variation potential average values of steel with time for slabs group (L)

All Slabs, which were repaired and strengthening with Crushed Stone Basalt Mix 2.5cm, Ready Mix 2.5cm and Crushed Stone Basalt Mix +Fibers 2.5cm didn't show any scaling, nor rust stain; they had a good appearance after repair. The results show some differences in the two main performances of the anodic potentials of the repairing systems of group M; the slabs in each repairing and strengthening system had the same behavior with a small difference of not more 40 mv, and all of them had low anodic potentials than the slabs without repair. The following figures describe the variation of the potentials with the time for the average values of the all measurements for each repairing systems (CSM, RM, CSM+F) and slab without repairing as shown in fig. 2, fig.3 and fig.4.

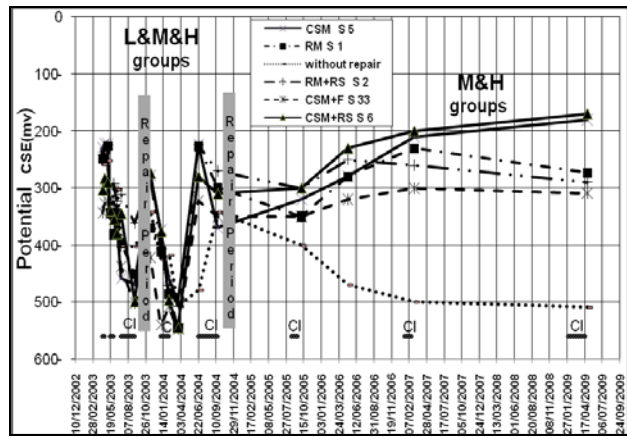
Fig. (3) Variation potential average values of steel with time for slabs group (M)

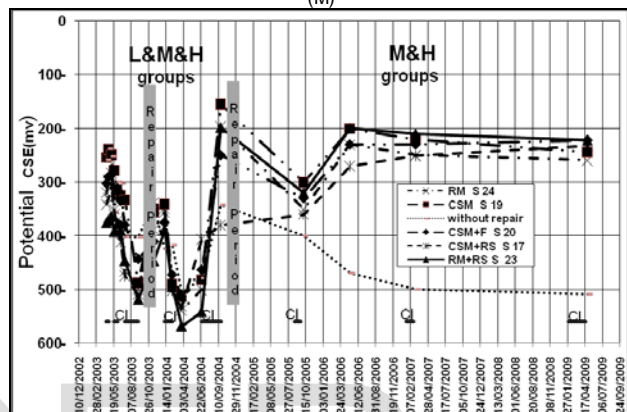
Fig. (4) Variation potential average values of steel with time for slabs group (H).

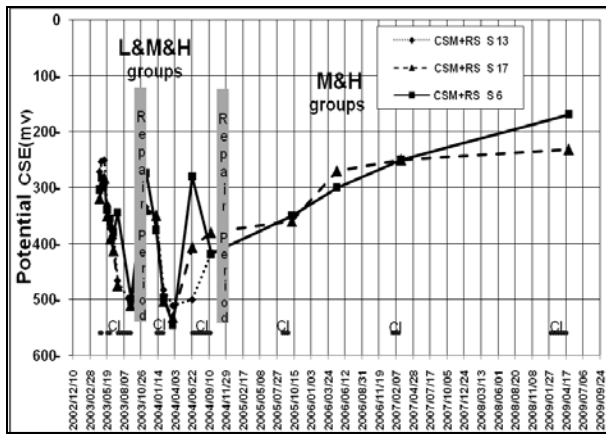
Fig. (6) Comparison potential values of steel with time for slabs repaired (CSM+RS).

The slabs S5, S16 and S19 were repaired and strengthened with Basalt Crushed Stone Mix layers, while both slabs S6, S13 and S17 were Strengthened with three bars of diameter 10 mm as mentioned before, these layers had full contact to the old concrete slabs and there weren't any cracks in the contact area between the CSM layer and the old concrete. Fig. 5 and fig. 6 show the comparison between these slabs.

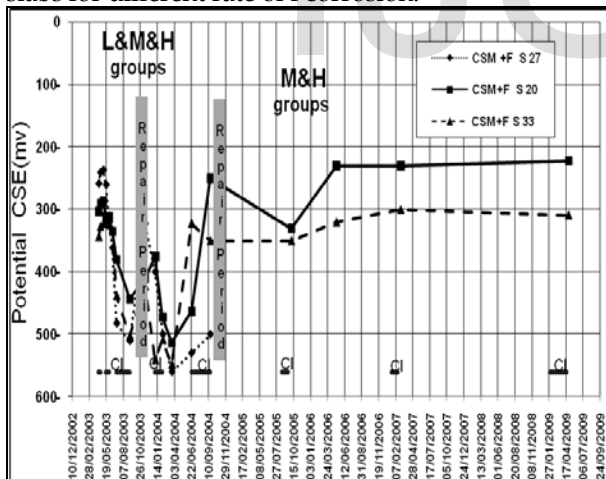
Fig. (7) Comparison potential values of steel with time for slabs repaired (CSM+F)

The slabs S20, S27 and S33 were repaired and strengthened with Basalt Crushed Stone Mix Harex Steel Fibers layers, these layers had full contact to the old concrete slabs and there weren't any cracks in the contact area between the CSM layer and the old concrete. Fig. 7 shows the comparison between these slabs with 2 or 3 bars of diameter 10 mm as mentioned before, these layers had full contact to the old concrete slabs and there weren't any cracks in the contact area between the RM layer and the old concrete. Fig. 5 and fig. 6 show the comparison between the load and point of max deflection these slabs for different rate of f corrosion.

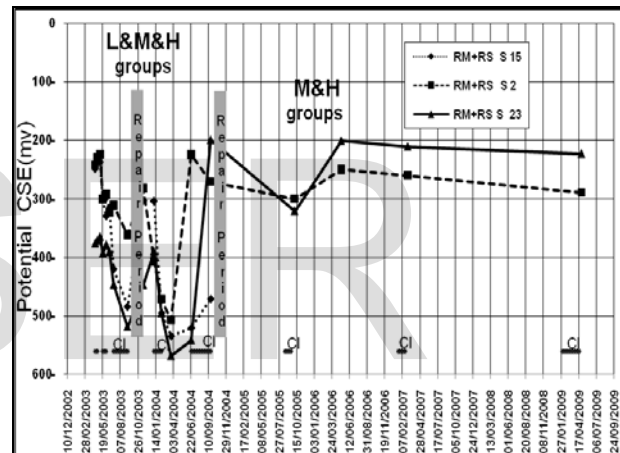
Fig. (9) Comparison potential values of steel with time for slabs repaired (RM+RS)

The slabs S1, S24 and S25 were repaired and strengthened with resdy mixing layers, while both slabs S2, S15 and S23 were repaired and strengthened with 3 bars of diameter 10 mm as mentioned before, these layers had full contact to the old concrete slabs

and there weren't any cracks in the contact area between the CSM layer and the old concrete. Fig. 8 and fig. 9 show the comparison between these slabs.
