New-build DWT 49999 t Oil/Chemical Tanker: Mapping and Local Monitoring of the Piping System

Dario Korljan*, Liane Roldo
University of Split, Faculty of Maritime Studies, Split, Croatia
*dkorljan@pfst.hr (corresponding author)

The vessel under study is an oil and chemical tanker built in 2019 with a deadweight tonnage of 49999 t DWT. The current draught is 10.9 m, the length overall (LOA) is 183.07 m and the width is 32 m.

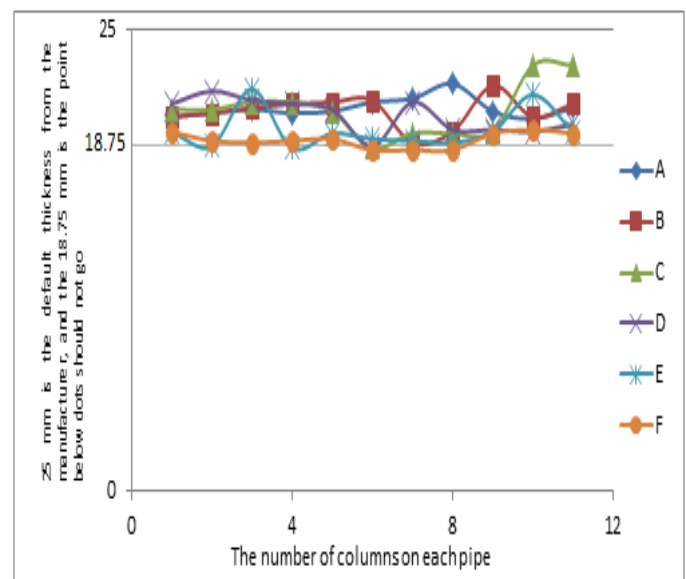
Fig. 3. Distribution of the wall thickness of the exhaust gas cleaning pipe.

The wall thickness of the EGCS overboard pipe (Fig. 3) in almost all measurements is above the critical thickness. X-axis represents the number on of columns on the pipe, while the Y-axis is the value below points in the chart should not go. Dots on each line (1-11) (according to Table 2) represent the number of points, while the A, B, C, D, E, and F parameters represent columns - (details in Fig. 4).

Measurements of the EGCS overboard pipe taken with the digital meter from the Fig. 2. are entered into the Table 2. The lowest value of any square from Fig.3. should not be less than 18.75 mm.

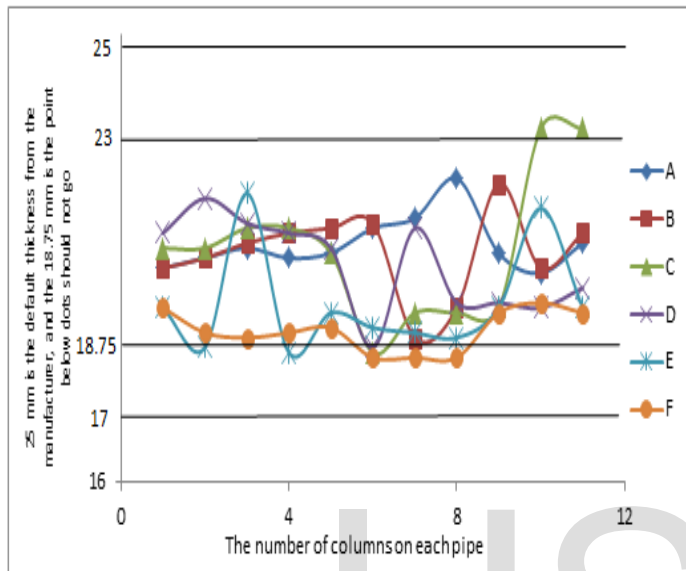
Fig. 4. A closer look to every point from Table 2. measurements of the EGCS pipe. If the wall thickness is below 18.75 mm, the vessel has to replace the pipe in dry dock.

In Fig. 4 and in Table 2, it can be seen in detail that spots D, E, and F are slightly less than 18.75 mm thick. To monitor any changes in wall thickness, measurements were taken over a period of one month.

In open circuit scrubbers, there is probably no solution to this type of problem other than to replace the pipe from time to time, since the last meter of pipe connected to the hull cannot be made of polymer. With a closed loop scrubber system, this problem does not exist because it is a closed system that does not use any piping overboard. The only difference is that the cooling water is not drained overboard after use, but is stored in an independent tank. This creates a closed loop system [7].

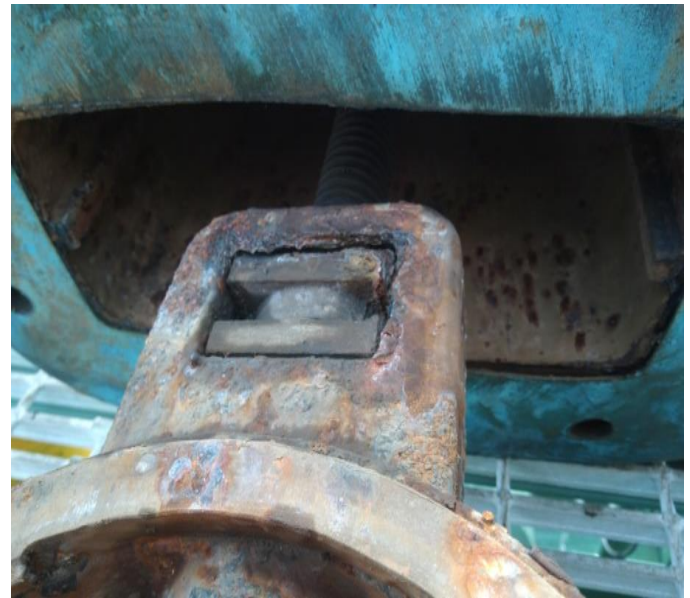
The environment that constantly surrounds the ship is unavoidable, whether it is sun, rain or strong waves at sea. The sea itself is also a major problem for the pipes, as there is a lot of salt that forms rust (Fig. 5). The rust (iron oxide) reduces the thickness of the pipes, which can often lead to breaks and cracks.

Fig. 5. General corrosion associated with a valve on a fire pump on the upper deck of the ship.

The crew on board can prevent this if the rust is detected in time and well maintained. This means removing the paint from the problematic areas, proper brushing and scraping treatment, applying a proper protective coating, and finally applying a new coat of paint that is highly resistant to all environmental conditions [13].

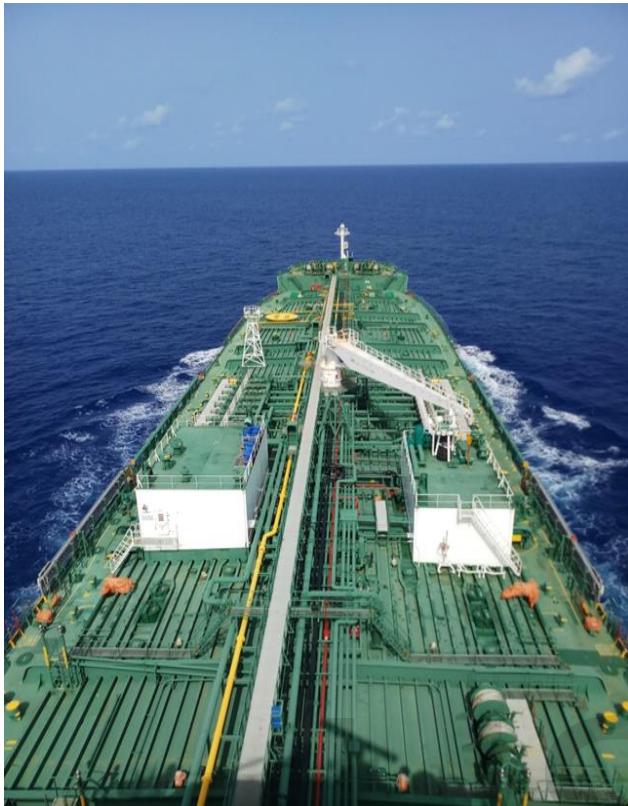
The problem can also arise if the maintenance work is not done properly, for example, if a crew member is not dedicated to the task and does not perform the rust removal properly, painting over that part is not a good solution. The crew will likely have to do the same job again because it was not done correctly the last time. Each step must be done correctly to prevent rust. The next factor is the waves. It is well known that the ship sags and swells due to the waves. Therefore, the pipes on the deck are not 100% straight from the stern to the bow (Fig. 6).

Fig. 6. View from the Funnel top on the arrangement of pipelines.

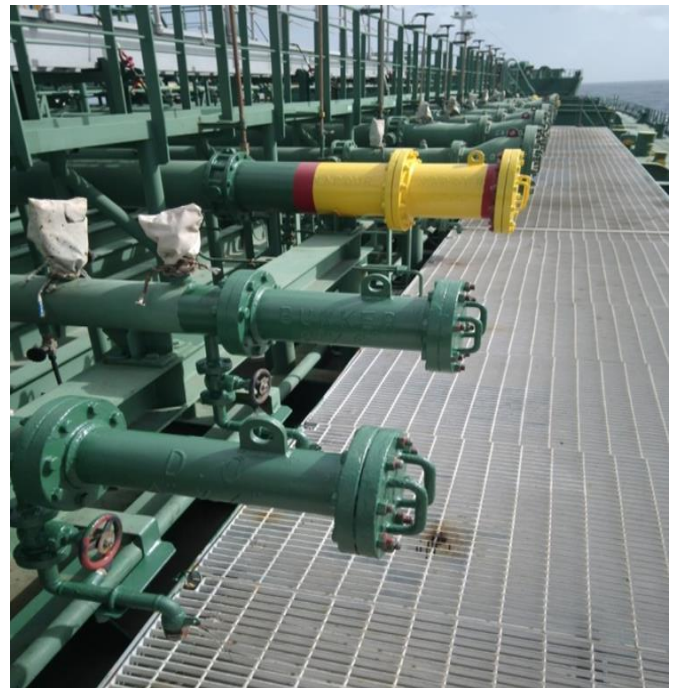
The term sagging means that the ship is between two waves and the midship area is loaded more than the stern and bow. When the ship sags, the pressure on the deck acts toward the middle, while the stress on the hull portion is opposite. The cargo itself pulls the ship down with its weight. On the other hand, hogging represents the exact opposite effect of sagging. In this case, the ship sails over the wave, so that the stern and bow are subjected to greater stress than the midship area. The pressure acts toward the center in the double bottom area, while the stress on deck is opposite. The weight pulls the ship down in the stern and bow area. If the tubes were straight, cracks and breaks would occur in any rough weather, so some parts of the tubes are as shown in the following pictures (Fig. 7) [15].

Fig. 7. Properly maintained manifolds on deck through which the cargo loading is done.

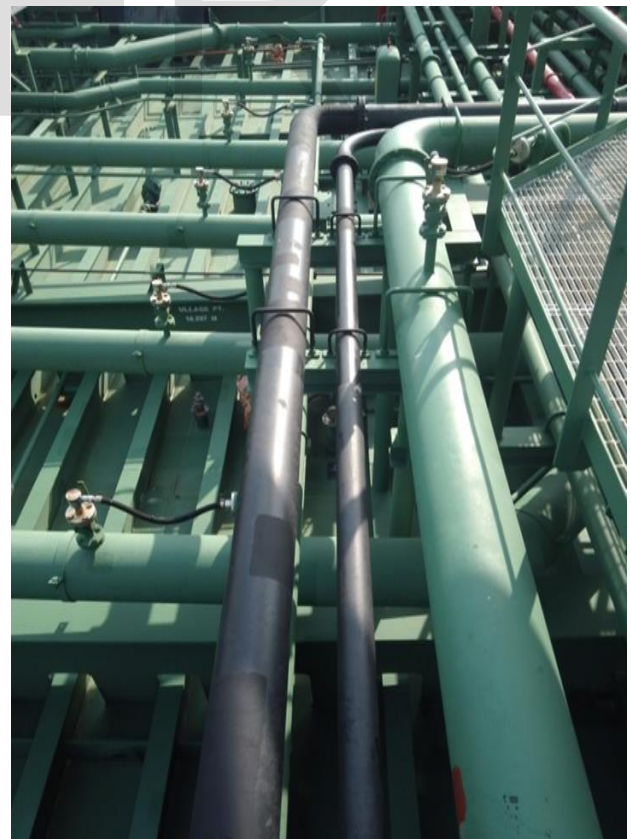
Product tankers very often carry crude oil, which contains some volatile organic compounds (VOC). When the cargo is loaded at a terminal, the pipeline from the terminal has a long vertical drop line that causes the cargo to accelerate due to gravity (Fig. 8). This can cause a sudden drop in pressure that promotes cavitation. The crude oil is a complex mixture of different hydrocarbons, and the volatile organic compounds in the crude oil refer to some light end components ranging from hydrocarbon chain C1 to C10. These components may evaporate during loading or transfer operations due to pressure fluctuations. The environmental impact of VOC emissions is their contribution to global warming, especially methane [16]. Various international regulations are regulated and reinforced by laws [17].

Fig. 8. A way of pipes on deck in order to prevent cracking and stretching due to sagging and hogging.

The waves are a big problem for the ship because the ship sags for a short time. Therefore, the pipes on the deck don't run 100% straight from the stern to the bow. This is a technical solution designed to prevent sagging, hogging as well as cracks and breaks due to vibrations [15].
