Shear Behavior of Corrosion Induced Reinforced Concrete Beams Retrofitted with Ferrocement Jackets

JeenaSulaikha, S. R. Akhil Raj

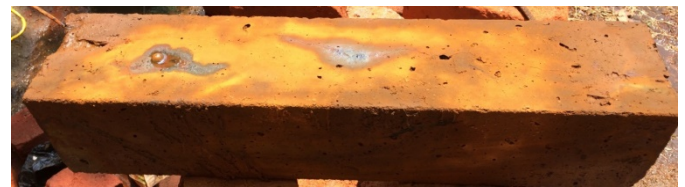
Figure 2 Corroded Prism Specimen

Before preparation of the prisms, the weight of the reinforcement steel was noted. The prisms were prepared and left for curing. These prisms were then subjected to various degrees of corrosion, i.e., 5%, 10%, 15% of mass loss of steel reinforcement. After the required corrosion was achieved, the prisms were demolished to extract the corroded reinforcement.

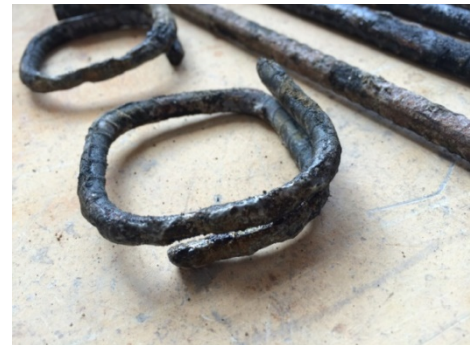
Figure 3 Figure showing Corroded Reinforcement

They were then cleaned as per ASTM G1[8]. The coefficient of resistivity, λ , was obtained from the ratio between the predicted theoretical mass loss to the actual mass loss of the reinforcement steel[9]. The average value of λ is obtained as 1.45.

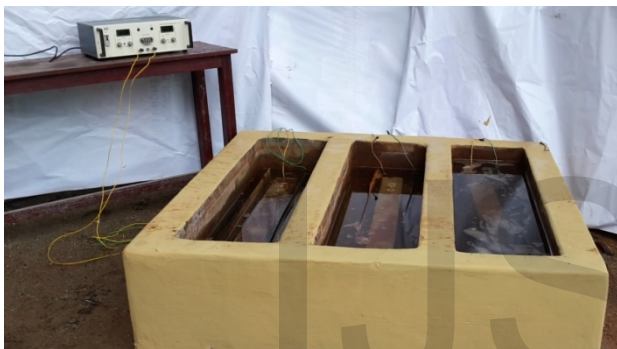
After a curing period of 28 days, they were subjected to various degrees of corrosion (5%, 10% and 15% of mass loss of reinforcement). The beams were immersed in 4% NaCl solution along with a stainless steel casing which acts as the cathode and the reinforcement steel inside the beams act as the anode. The beams were connected to a DC source with constant current. The time required for corrosion was obtained from the modified Faraday's Law, wherein the coefficient of resistivity was multiplied to (1).

Figure 5 Corrosion of RC Beams

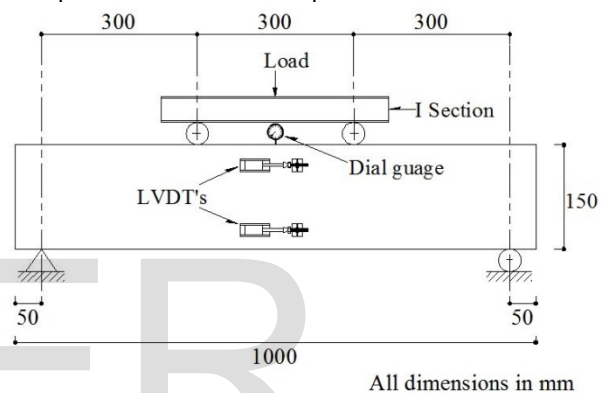
The beams were prepared shear deficient, and hence the shear behaviour of these beams was studied. The beams that were retrofitted at the shear spans with ferrocement jackets were then left for curing for 14 days. After the completion of curing period, the beams were then tested in a 1000kN universal testing machine. The shear behaviour of the corroded reinforced beams and retrofitted corroded reinforced beams were compared to that of the respective control beams.

Figure 7 Schematic Diagram for Beam test set

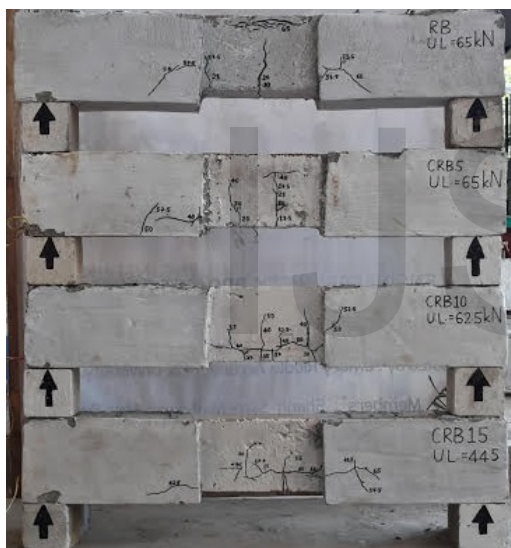
The beams were retrofitted at shear spans by means of ferrocement U- wraps. From figure 9, it can be seen that the beams were safe in shear after retrofitting the shear spans.

Figure 9 Crack Pattern of Corrosion Induced Retrofitted RC beams

- The crack pattern in corroded retrofitted beams shows that the beams have been made safe in shear when retrofitted using ferrocement at shear spans.
- When compared with unretrofitted control beam, the load carrying capacity of:

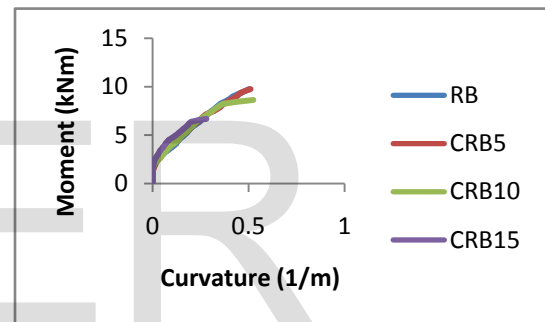
Figures 12 and 13 shows the moment curvature graphs for the corrosion induced RC beams. The curve is linear up to first crack moment. Further when the moment increases, the curve shifts from linearity. When the moment reaches yield moment, the curves become flat. When steel yields, a large increase in curvature occurs with a small change in moment[11].

Figure 13 Moment Curvature of Corrosion Induced Retrofitted RC beams
