## Simulation Based Energy Use Assessment of old housing stock ibadan, oyo state, Nigeria

Keywords: building envelope, traditional housing, energy use, simulation

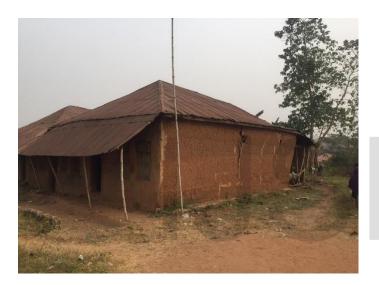
Fig 1- photograph showing building under study with the damaged kitchen wall at the rear and the small high level windows Source: Author's field work

A closer examination reveals that there are definite lines on the earthen walls indicating that the walls were raised using layers of earth. These lines upon measurement, indicate that each layer is 460mm high and the thickness 250mm. From the interview conducted, the earthen walls underwent a modified pre-construction process, a combination of two traditional techniques of earth construction. The earth was dug up from trenches nearby and mixed to a state of plasticity by pulverizing it while in the trenches with the feet (Yasemin Ebril, 2018). Sand, consisting of aggregates between 5mm and 13mm diameter was added to stabilize.

Ordinarily, this mix should have been poured into wooden molds or rolled into balls and placed in layers to raise the walls (based on the adobe or cob techniques) instead, it was placed in between form work previously erected (Baglioni E et al, 2016) The height and width of the formwork (previously stated) gave the wall its distinctive lines and thickness. The windows are made of timber and have four panels each with an operable fan light (also in timber). The main entrance door is also of the same material and configuration. The roofing material is corrugated zinc and has evidently undergone corrosion over the years. The rafters and struts are also of timber however they are roughly circular in cross section rather than rectangular.

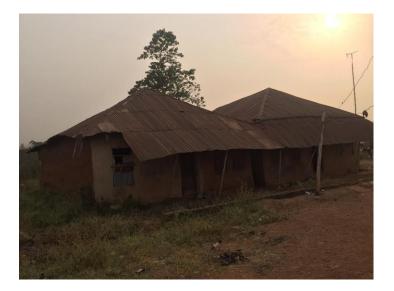
Fig 2- photograph showing building under study on the right with the "uninhabited twin" on the left.

The building under study is one of two buildings erected side by side with a corridor space of 1.25m in between them and is the only habitable one of the two. Each building is separately roofed and done in the same design style.
