# Study of Effectiveness of Rainwater Harvesting Structures on Bhavani Sub-basin, TamilNadu,India

**Abstract**—Water scarcity has become one of the main problems in India. It is estimated that by 2020, India will become a water-stressed nation. Surface water sources get reduced and we partially depend upon ground water for various needs. This sub-surface water needs artificial recharge. One such simple method is the construction of check dam.

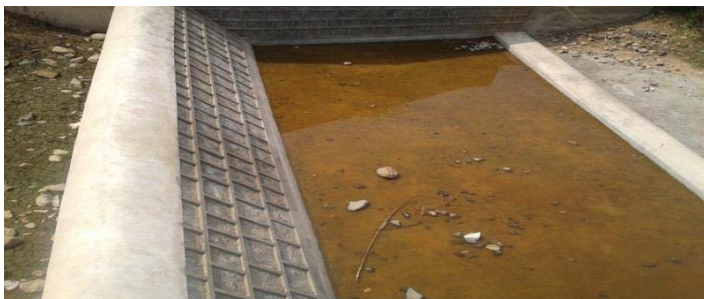
- Length of the check dam : 6m
- Height of the check dam : 1.2m
- Maximum length of the water : 200m
- Width of the stream : 10m
- Effective height of the check dam : 0.75m
- Volume of water stored :  $200 \times 10 \times 0.75 = 1500m^3$

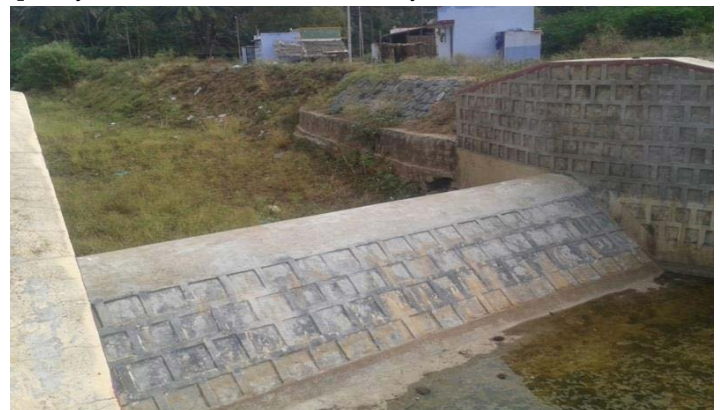
Images of check dam, GWL and average rainfall data, water quality is shown below for this study area.

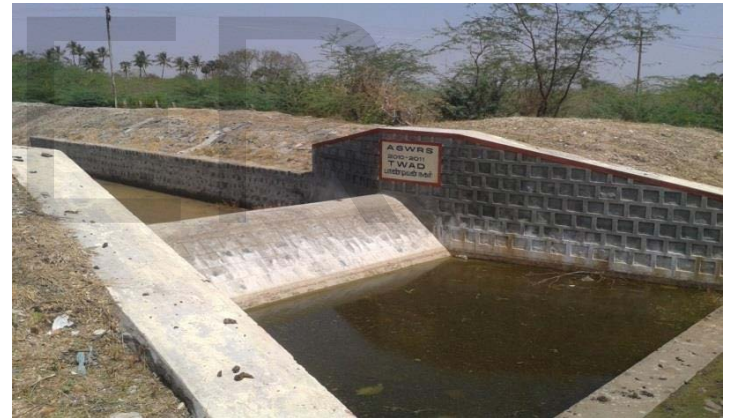
Images of check dam, GWL and average rainfall data, water quality is shown below for this study area.

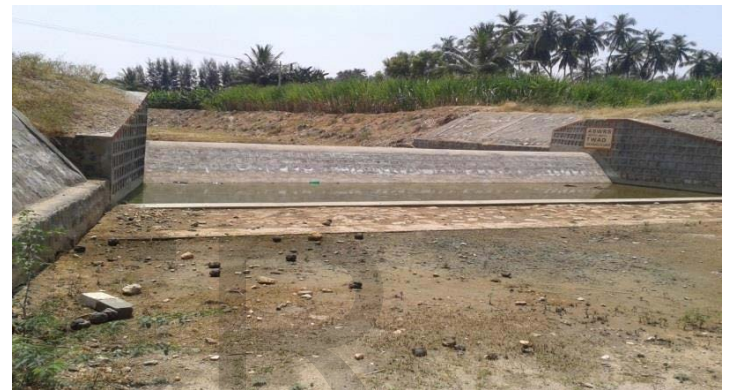
Images of check dam, GWL and average rainfall data, water quality is shown below for this study area.

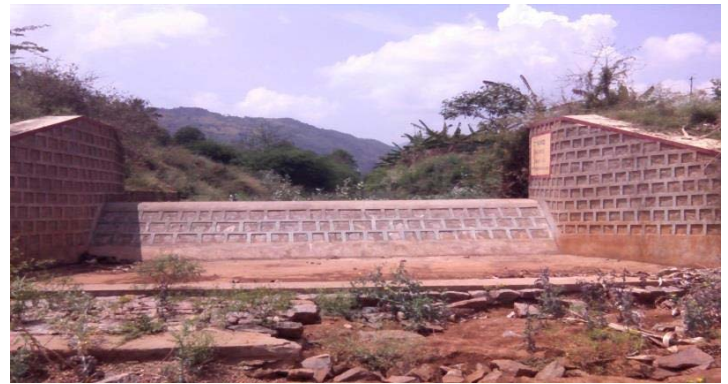
quality is shown below for this study area.

Images of check dam, GWL and average rainfall data, water
