Tero-Drainage Affectance in Life Cycle Costs of Road Pavements at an Intersection in Nigeria: A Case Study of Multi-Route Intersection of Iwo Road, Ibadan, Oyo State

O. Joy Oladejo

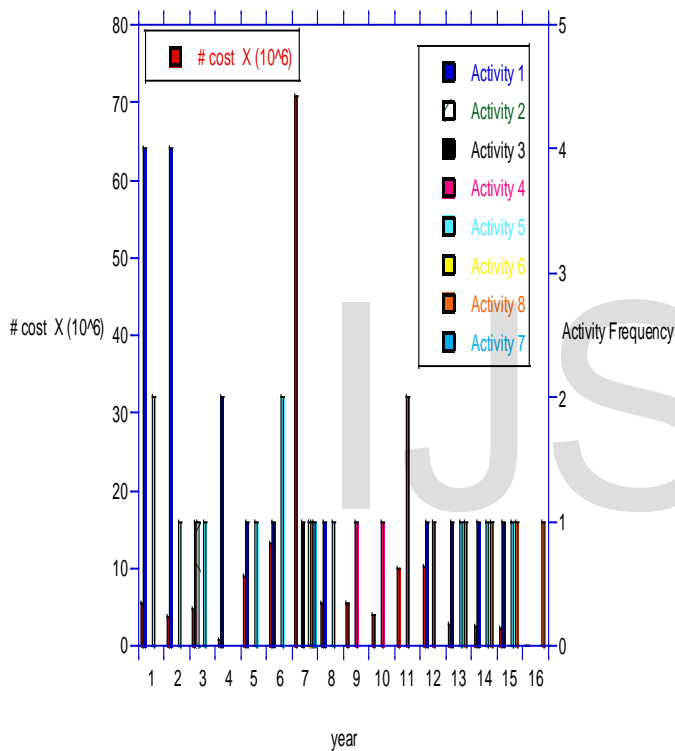
Fig. 3. 1: Cost and Frequency of individual activities over the 16 year period

1. Activity 1 – De-silting of drains only
2. Activity 2 – De-silting of Culverts, catchment pits only
3. Activity 3 – De-silting of Drains/Culverts, and removal of obstruction only
4. Activity 4 – Scarification, asphalt and de-silting of drains only
5. Activity 5 – Scarification of failed area, removal of unsuitable material, provision of lateritic/stone base, priming and asphalt
6. Activity 6 – Construction of 2.5m x 2.5m open channel drain at Ife out bound leg

De-silting Only	=	
N 14,027,231.57 (8.98%)		
Occasioned Construction Only	=	N
67,276,428.08 (43.1%)		
Vegetation control/Cleaning	=	N
2,623,005.01 (1.68%)		
Scarification	=	
N 66,537,817.32 (42.62%)		
Environmental Incursion	=	
N 5,661,098.71 (3.63%)		
Total Maintenance cost	=	N
156,125,580.71

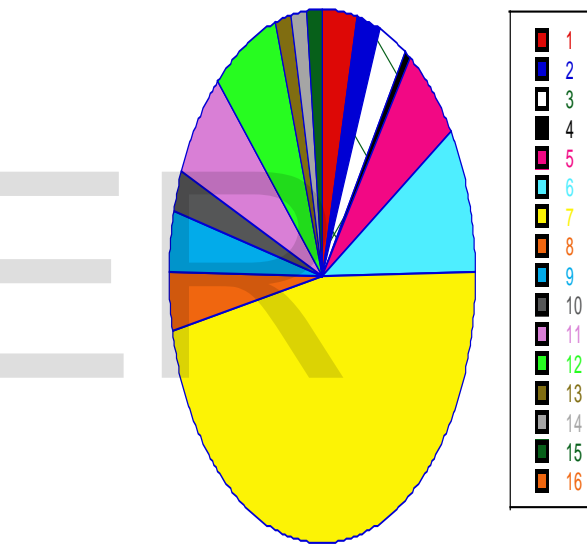
Fig. 3.2: Yearly Cost of Maintenance from year 1 – year 16

Total Yearly cost (excluding environmental Incursion cost) = N150,464.482

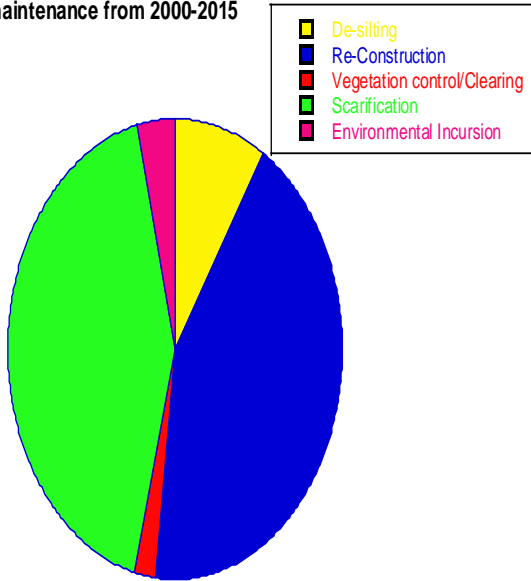
Fig. 3.3: Costs of Maintenance from 2000 – 2015

Total Maintenance Cost = N156,125,580.71

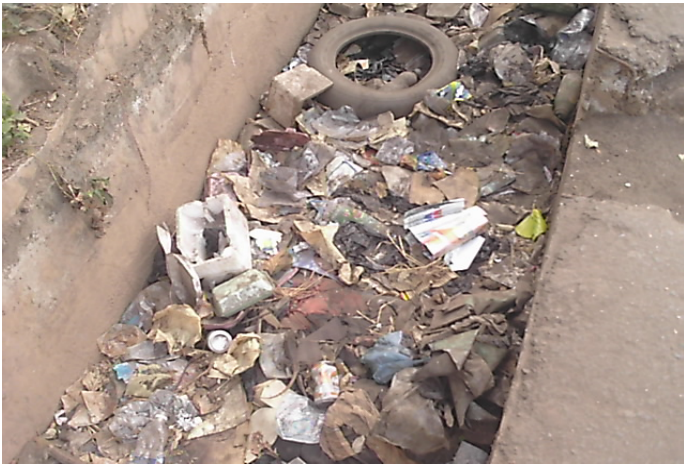
Plate 3: Water Incursion at the Rotary drainage

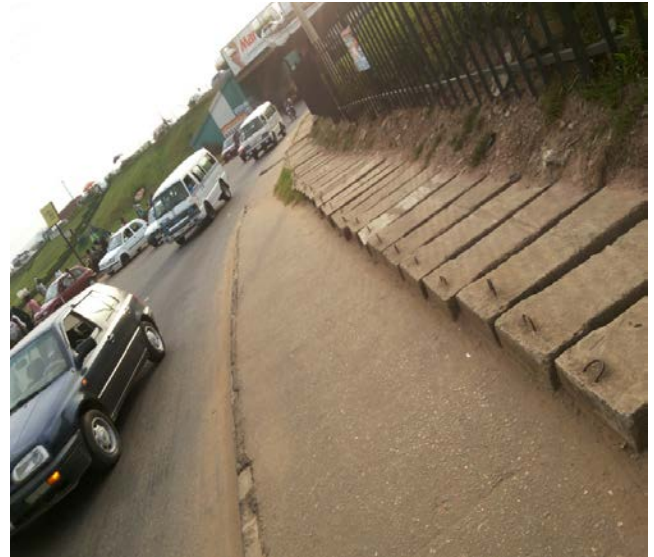
Plate 5: Restored condition of the rotary drainage

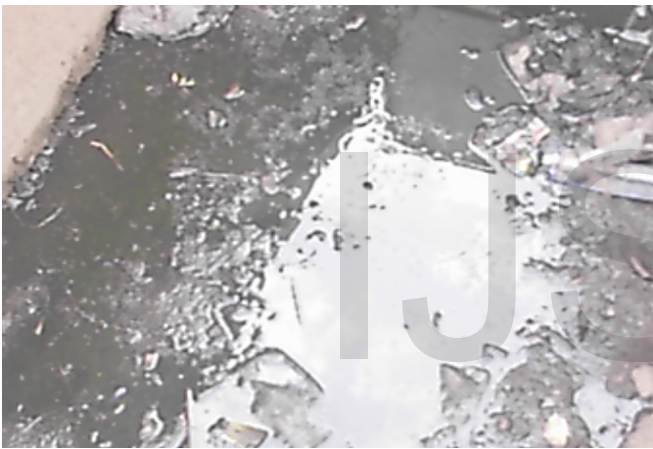
Plate 4: Deteriorated pavement surface at the intersection

The field survey revealed frequent pavement deterioration and its attendant repairs (Table 3.7)

at this intersection which forces motorists to reduce speed at the failed spots resulting in heavy traffic congestion.

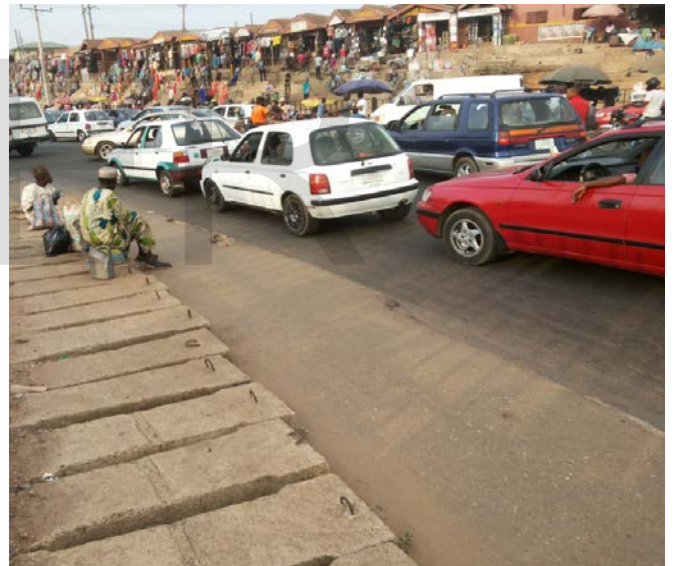
Plate 6: Restored condition of the rotary drainage
