# Assessing on the Geotechnical Problems Which Causes for the Road Failure from Gilgel Beles to Bahir Dar Road Segment

Habtamu Washe Mite<sup>1</sup>, Maschal Tilahun Zenebe<sup>2</sup>,

<sup>1</sup> Department of Civil Engineering, College of Engineering, Assosa University, Assosa, Ethiopia

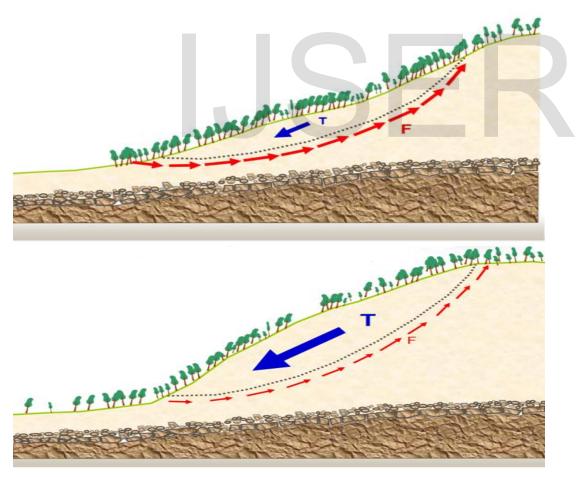
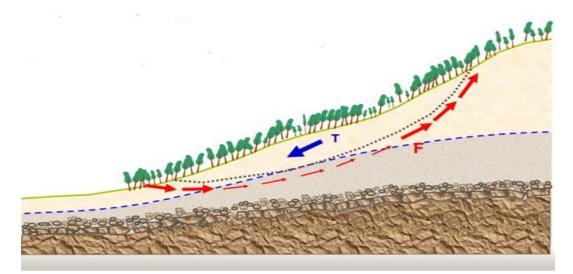
Figure 16: Diagrammatic representation of slope failure mechanisms in the study site

"T" less than "F" i.e. slope will not fail (T =driving actions and F = resisting actions)"T" greater than "F" i.e. slope will fail (T =driving actions and F = resisting actions)Water reduce "F" i.e. slope may slide (T =driving actions and F = resisting actions)Engineering analysis of slopes
