Study of IQS & Improvement in Harvester Combine IQS Score by TQM Approach: A Case Study of Harvester Combine SWARAJ – 8100 Model

Harish C. Tiwari, Sarabjot S. Mann

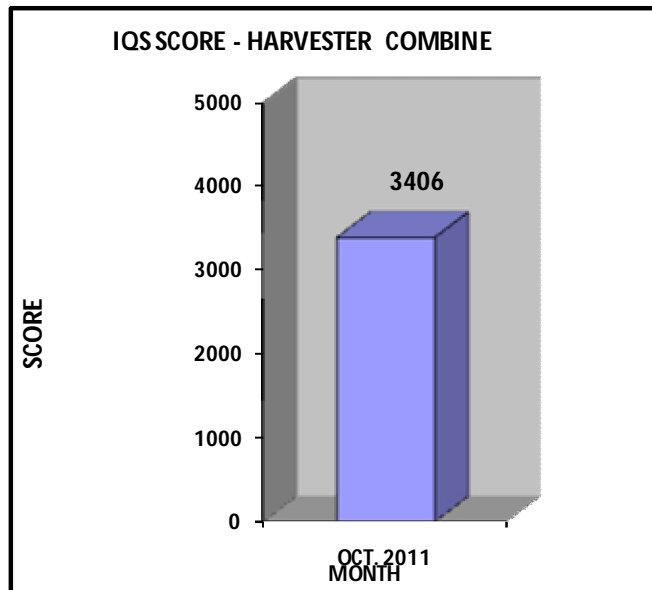
Fig. 4 IQS Score – Overall

At the start of this research, when data was collected, overall IQS score of Harvester combine observed was 3406. It is shown by Fig. 4. This score was sum of the score of three aggregates i.e. HPU, Supplies & Design having 1684, 1057 & 665 score respectively. It is shown by Pie chart in Fig. 5

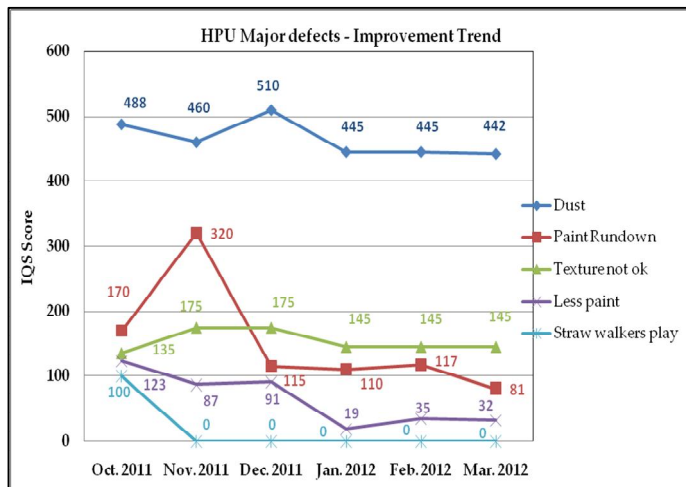
Fig. 16 HPU Defects – Improvement trend

Inference: Paint rundown, less paint & Straw walker's play defects have downward trend proving improvement, while Dust & Texture not ok didn't improved significantly due to traditional paint facility and scarcity of trained painter.

II. Paint rundown defect reduced from 170 to 81 score having 52% improvement. It was due to the training provided to the new/semi skilled painter, paint viscosity control and introduction of elevator for painting at elevated position of HC.

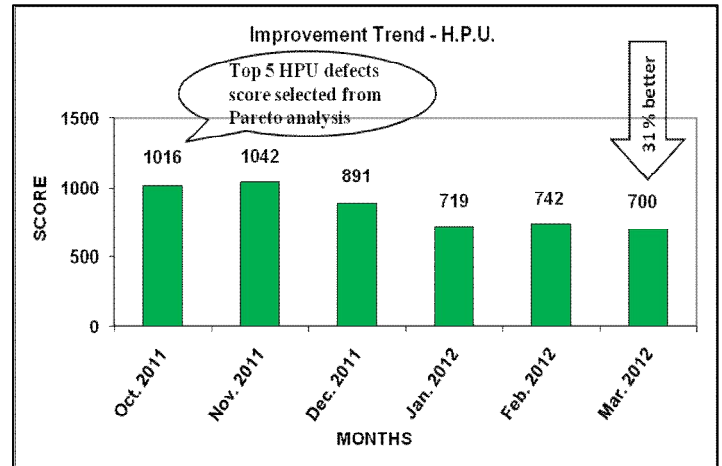
Fig. 19 HPU IQS Score – Improvement trend

Inference: IQS score of 5 HPU major defects was reduced from 1016 to 700, securing 31% improvement.

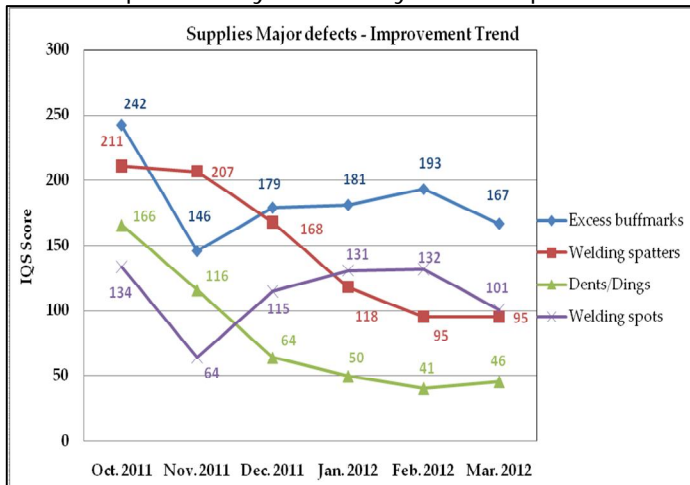
Fig. 17 Supplies Defects – Improvement trend

Inference: Excess buff marks, welding spatters & dents/dings defects have downward trend proving improvement, while welding spots didn't improved significantly due to improper welding practices & lack of trained labor at supplier end.

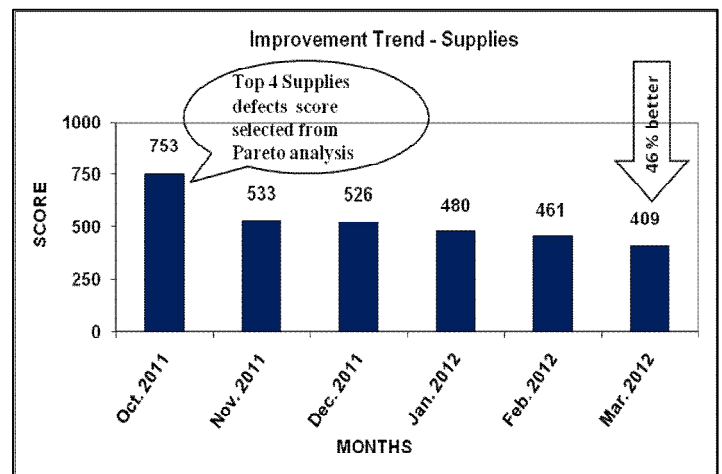
Fig. 20 Supplies IQS Score – Improvement trend

Inference: IQS score of 4 Supplies major defects was reduced from 753 to 409, securing 46% improvement.

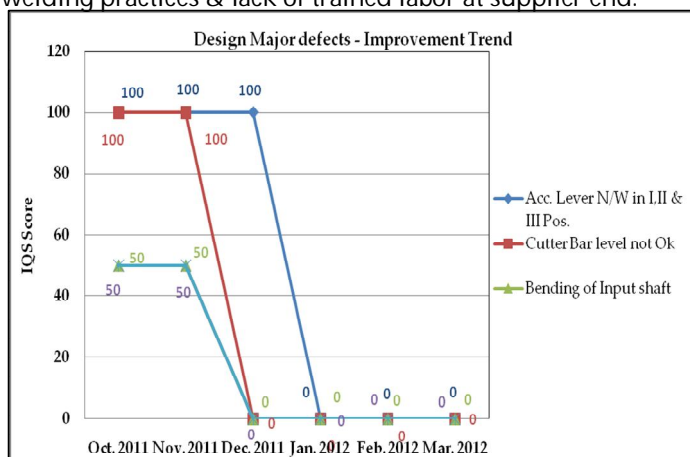
Fig. 18 Design Defects – Improvement trend

Inference: All design defects were eliminated showing drastic improvement. It was due to the acceptability of need for product development by company.

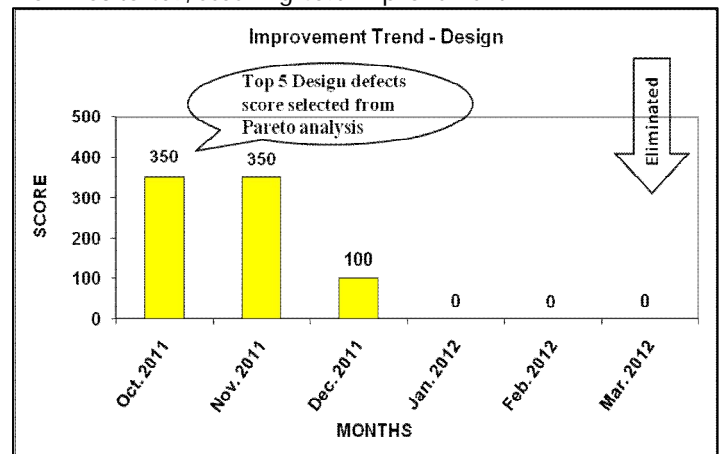
Fig. 21 Design IQS Score – Improvement trend

Inference: IQS score of 5 Design major defects was reduced

from 350 to 0, eliminating all 5 defects.

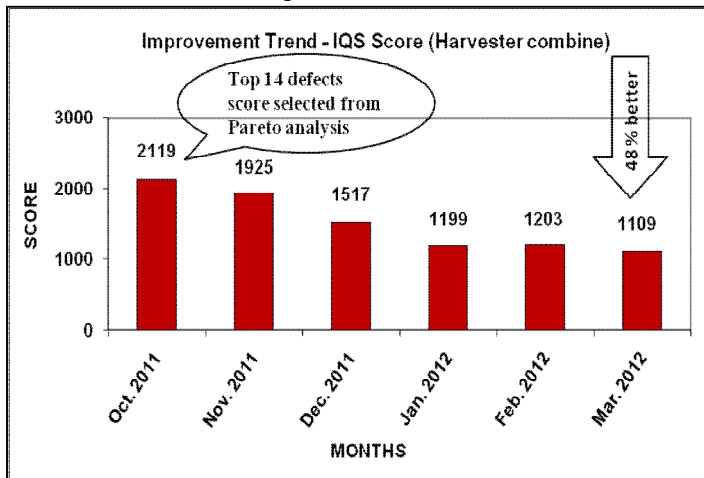
Fig. 22 Overall IQS Score – Improvement trend

Inference: Overall IQS score of 14 major defects was reduced from 2119 to 1109, securing 48% improvement.
