Modified Binders (developed In-house) for Boiler Pressure Parts Hot Reheater & Cold Reheater Coils to prevent failure and misalignment during operation

Index Terms— Boiler, Reheater, Tube failure, Binders, CRH, HRH

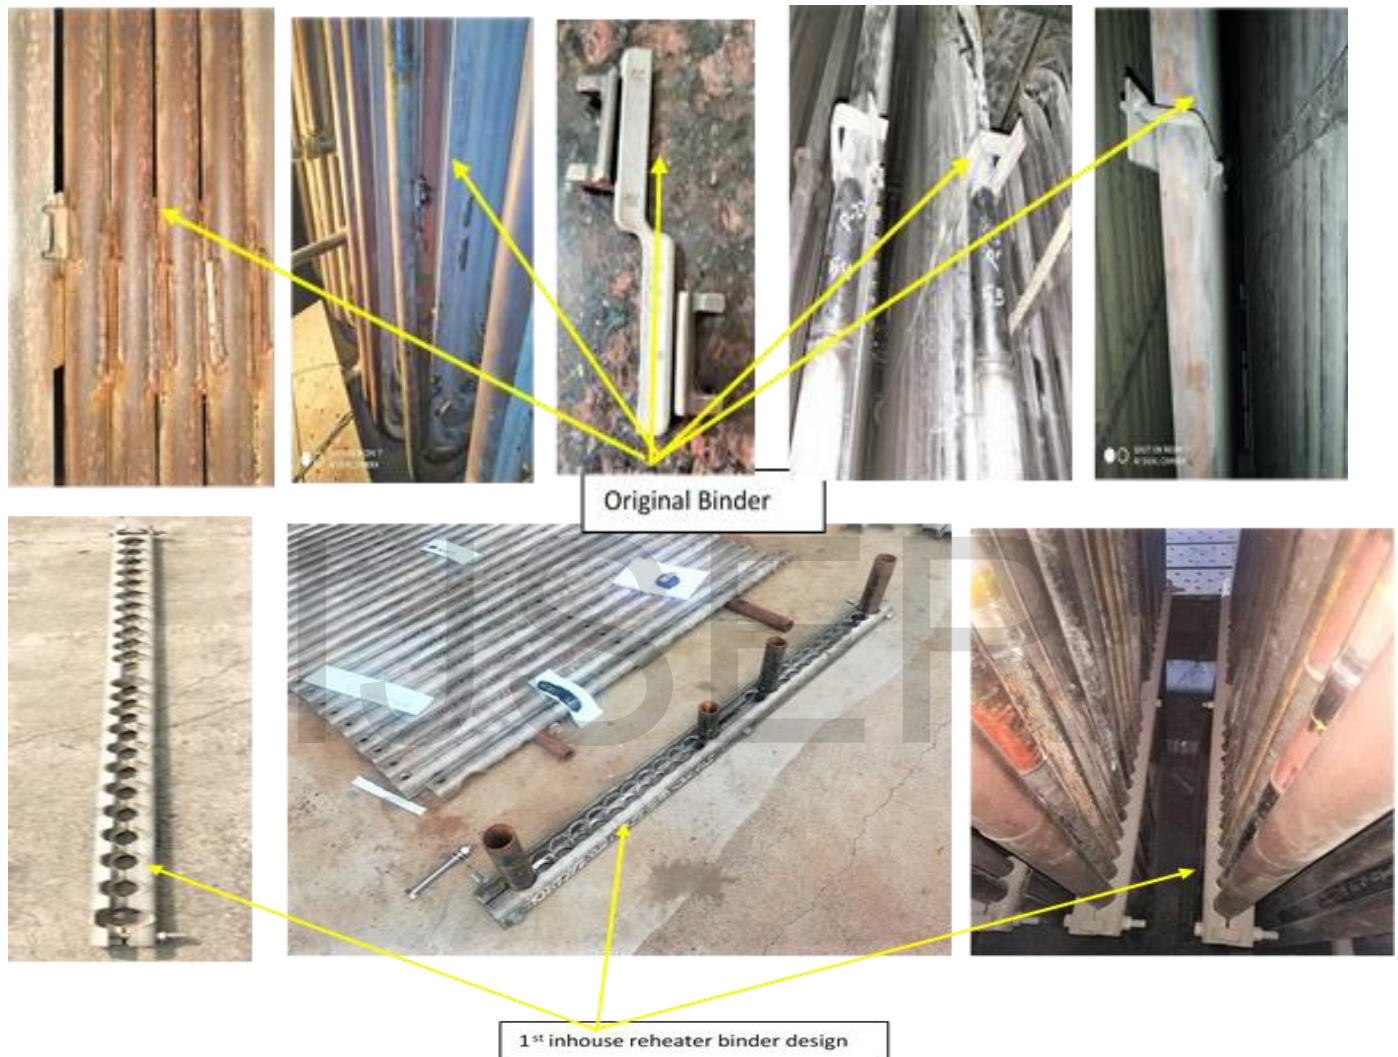
- New developed binders have provision of unrestricted vertical movement of tube in either direction and hence tubes in align condition during all operational situation.
- New developed binders are designed in such a way that it is not welded at any point of the tubes for their installation resulting no stress developed on tubes during all operational condition.
