PREMATURE FAILURE OF DISTRIBUTION TRANSFORMERS –A CASE STUDY

III. CASE STUDY

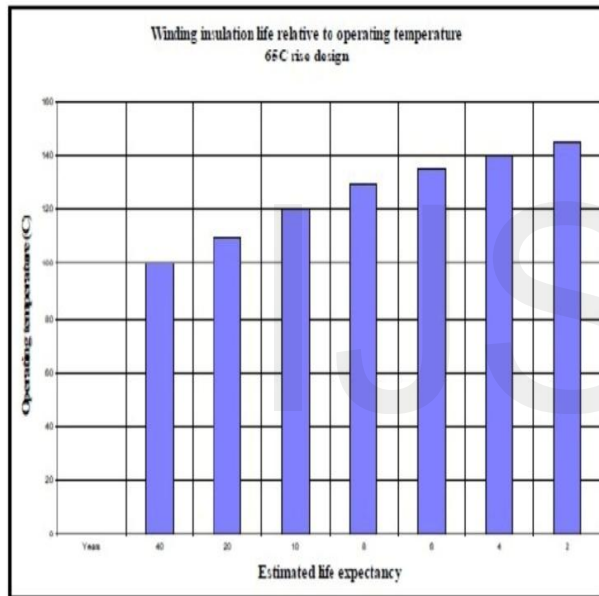
Figure 3. Transformer life expectancy vs. operating temperature

This could be a classic example of overheating of both low and high voltage winding. The overheating may be due to prolonged overloading. Prolonged overloading may be caused by use of inadequate size fuses. It has been observed that line operators use more than the recommended capacity fuse wires either due to lack of knowledge or just to avoid frequently replacing the fuse especially in remote rural areas. Since this transformer was installed in rural area this must have been the reason for failure. In case of prolonged overloading, the additional loss generates more heat, which affects the burning of winding insulation, causing ultimate failure of the transformer. Cold load pickup (CLP) current may also be one of the causes of its failure. CLP is a

phenomenon that takes place when a distribution circuit is reenergized following an extended outage of that circuit. Usually when a distribution circuit is restored after an extended outage, the demand is more than pre-outage demand. In M.P., load shedding of 1 to 6 hours is common in rural areas. In rural areas if connection of 5 pumps is authorized, after load shedding when supply is restored, 10 pumps are operated by the farmer to finish the required irrigation i.e. the load is doubled by each farmer. Hence CLP current is many times greater than pre-outage current which causes heavy overloading of the distribution transformers. It may be assumed that due to overloading, the temperature of the oil would have reached more than 140°C and its life became less than two years [5], i.e. transformer failed within warranty period of three years. Fig. 3 has been reproduced from[5].

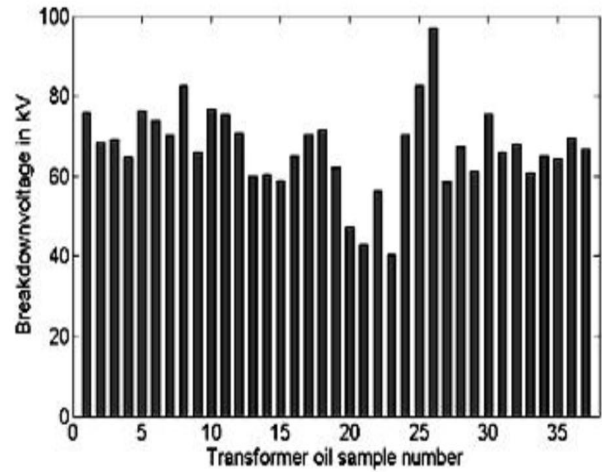
Figure 12 Transformer oil breakdown voltages in kV for each transformer oil sample [7].

Muller et al 2011 shows analysis of 37 oil samples of distribution transformers with different load histories and ages. These transformers were 10 to 55 years old and were working satisfactorily. It was found that BDV of 31 samples was above 60kV and 18 samples had BDV above 70kV as shown in Fig. 12. They were generally in a good condition regardless of their age. Mohammad R 2008 gives measurement of some parameters for nine oil samples of operating power transformers manufactured by the same company. Fig. 13 shows that all nine oil samples of operating power transformers had BDV in the range of 50 to 70kV. The aging of insulating paper and oil is studied by Shim 2010 by performing accelerated thermal aging test. Sealed aging test vessels containing copper, laminated core, Kraft paper and insulating oil were aged at 140°C for 500, 1000 and 1500 hours respectively. It has been reported that at operating temperature of 140°C, BDV was reduced from 55kV to 40kV i.e. BDV was reduced by about 30% of initial value, for aging time of 1500 hours (62.5 days only), which can be seen in Fig. 14. The test vessel does not represent the actual transformer and Fig. 14 only indicates the trend of variation. This trend is in agreement with present study of failed transformers in which BDV of all the 27 oil samples lies in the range of 12 to 46 kV, as shown in Fig. 15. This indicates that the temperature of the oil must have reached to above 140°C. Hence it may be a deciding factor for degradation of the oil due to thermal aging.

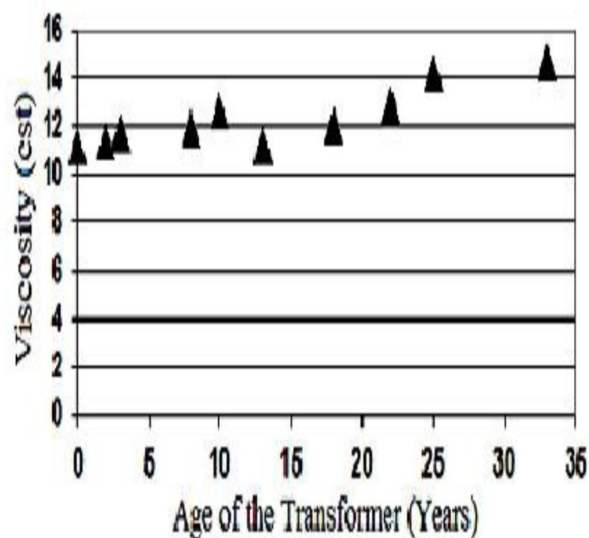
Figure 16 Viscosity of the oil specimens from transformers having different ages [8]

Mohammad R 2008 has reported that viscosity of all 9 samples was between 10 to 14 cSt i.e. well within the range as per IEC specifications, as shown in Fig.16 These transformers were of the age 2 to 35 years approximately and were working properly. The viscosity of transformer oil is varying from 28.09 to 65.0 cSt in the present study of 27 samples as shown in Fig.17. This high value of viscosity will result in inefficient cooling of transformer and the temperature of oil may exceed permissible limit. Hence it is a deciding factor for thermal aging of the oil.

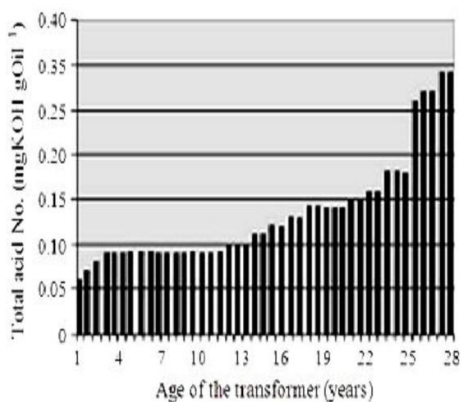
Figure 18 Acidity of the oil specimens taken from 43 power transformers of various ages [8]

TAN is defined as the acidity of the oil which is milligrams of 0.1 normal KOH needed for neutralizing the acidity of 1 g oil. Reference [8] gives measurement of acidity of oil specimens taken from 43 working transformers of different ages (up to 29 years old). It has been reported that 20 working transformers having age up to 13 years had TAN less than 0.1 mg KOH/g oil and 18 transformers having age 14 to 25 years had TAN from 0.1 to 0.18 mg KOH/g oil i.e. 38 out of 43 transformers, having age of 1 to 25 years, had total acid number in the range of 0.06 to 0.18 mg KOH/g oil which is evident from Fig. 18. This means that up to the age of 25 years TAN remained below 0.18 mg KOH/g because transformers were not overloaded and hence not overheated.

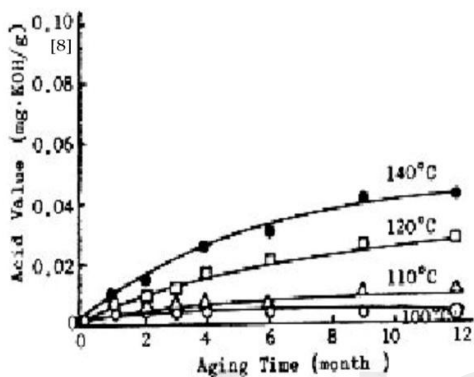
Figure 19 Increase in acid value of insulating oil due to thermal aging (Insulating paper) [9]

Yoshida et al 1987 gives results of investigation of changes in characteristics of cellulose insulating materials i.e. insulating paper and pressboard, through accelerated tests using models of oil- impregnated insulating systems but these model coils do not represent the actual transformer. Fig. 19 shows the increase in acid value of insulating oil due to thermal aging in the presence of insulating paper only. It has been reported that aging of model coil for 12 months at a temperature of 140°C caused the TAN to increase from 0.002 to 0.042mg KOH/g approximately.

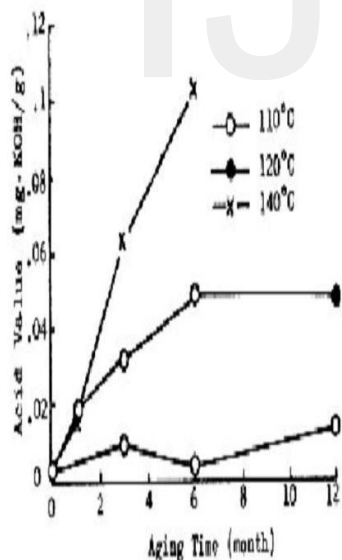
Figure 20 Increase in acid value of insulating oil due to thermal aging (Pressboard) [9].

Fig. 20 shows the increase in acid value of insulating oil due to thermal aging of model coil in the presence of pressboard only. It can be seen that a temperature of 140°C and 6 months aging caused the TAN to increase from 0.002 to 0.105 mg KOH/g approximately.

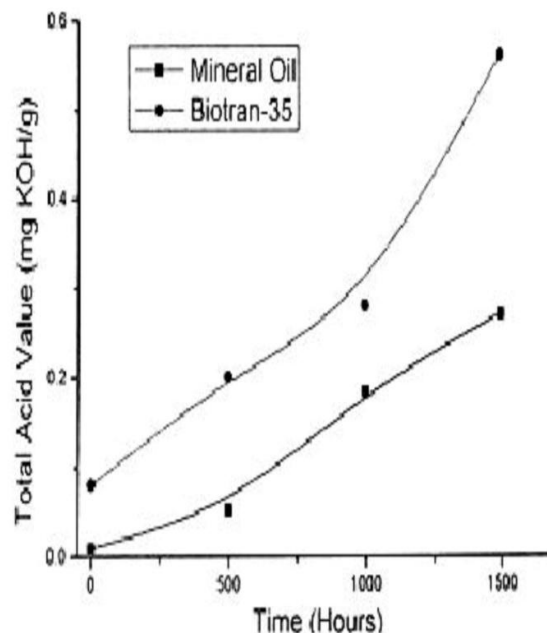
Figure 21 Total Acid Number [10]

Shim 2010 simulated the distribution transformer by sealed vessels containing all materials in the same ratio as in transformer and reported that TAN for mineral oil increases from 0.01 to 0.26mg KOH/g oil at a temperature of 140°C for aging time of 1500 hours as shown in Fig. 21. This validates the results of the present study. In present investigations, it has been found that TAN of all oil samples varies from 0.224 to 1.12 mg KOH/g as shown in Fig. 22. TAN of the 21 oil samples lies between 0.224 and 0.336. This increase in TAN is due to combined thermal aging of insulating paper, pressboard and oil in actual distribution transformers.
