Quality Improvement in Finished Cold Rolled Sheet by reducing the defect

Ranjan Prakash*, Baidya Nath Roy**

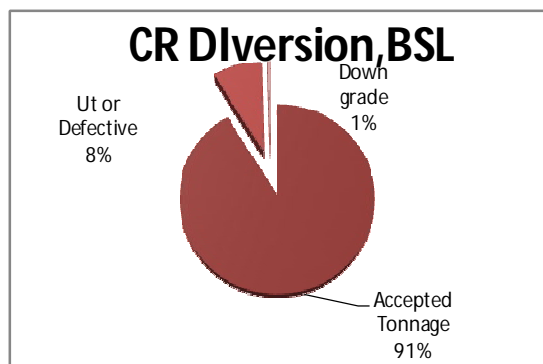
Chart: 1 CR Diversion from Inspected tonnage.

83455 tonnage of cold rolled product made in my work place, BSL, was observed in order to find out the defects into it. Data analysis for defect observation and the diversion of the CR product:-
