A Conceptual Underwater Diving System for Pipeline Repairs in Nigerian Muddy Water Niger-Delta Oil and Gas Locations

Jasper Agbakwuru

Abstract— Inspection and repair of leaking underwater pipeline in muddy water is generally difficult to perform in line with relevant engineering and construction standards. This is basically due to the requirement to closely and visually inspect the problem and then developing best strategy to fix it. It is therefore obvious that when the problem or the leak area or location is inadequately examined due to muddiness of the water mass, strategizing for repair becomes a trial and error operation. The consequence is re-pair-leak-repair cycle observed in most cases. Unfortunately, the poor visibility of underwater conditions is not a global problem. It is local to Swamps and Estuaries of Delta, and in the case of the Niger Delta of Nigeria to a depth of about 20m. The essence of this paper is to point out this local problem that requires a special engineering stand. A system of plume-detector-led manned motorized hyperbaric bell is suggested as a system that satisfies that leaking pipeline installed in a muddy water can be identified, close-visually i

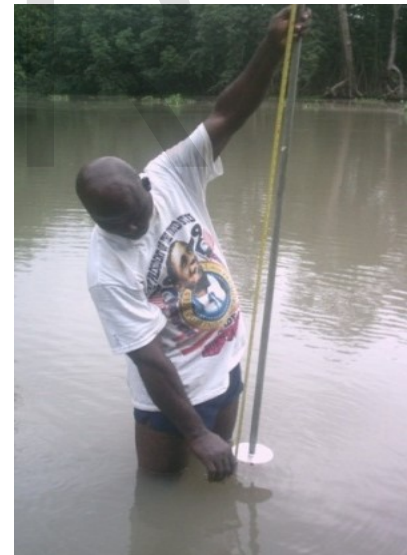
Figure 1: Picture showing a flowing river in Ekpan Effurun, Delta State of Nigerian Niger Delta area

Poor underwater visibility is a condition where the ability to see through in the water is impaired. In this paper, such condition is termed a muddy or unclear water condition. Field practice has shown that no matter how good one is at working with Remotely Operated Vehicles (ROVs), the ROVs are not good for inspection in limited visibility conditions. It is noted that in those cases, even a working diver has to carry out the inspection by 'touch'. These challenges do not imply that it is not possible to inspect and repair pipelines installed in muddy water. The main concern is that the visual inspection is inadequately done and once the affected pipeline cannot be retrieved to surface, the proper repair becomes unguaranteed. Unfortunately, this is the case with Nigerian most Niger Delta Shallow water and Estuaries with depth up to 20 meters. The reasons for the underwater poor visibility are well discussed in Agbakwuru J., 2012, Arumala J.O., 1987 and Agbakwuru et al., 2012. A typical sample of muddy water of Nigerian Niger Delta is shown in Figure 1.
