Corrosion and Adhesion Behavior of Recycled High Density Polyethylene (HDPE) Coated Mild Steel

A. H. M. E. Rahman, Ma'Moun A. Ayyad, Issam Abu-Mahfouz, and Joshua Bachert

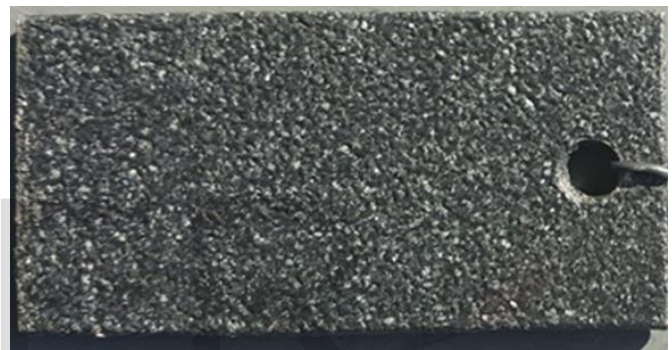
Figure 2: HDPE powder coated mild steel.

Figure 2 shows a HDPE powder coated mild steel sample. Based on the visual inspection, it was found that some areas of steel substrate were insufficiently coated for few samples out of 30 coated samples. Additionally, the coating was not uniform or sufficient around the sharp corners or edges in the samples. The thin coatings that were found on few samples were a result of powder falling off before curing. This phenomenon occurred when turning the sample to coat the other side and can occur even with normal powder coats. These results suggest that the HDPE may not be able to hold a static charge if the powder particles were too large. If the powder particles were finer, the static charges used could have been enough to hold them onto the steel substrate surface. The static charges may also have been easily conducted away from the HDPE powder after coating because the mild steel is a good conductor of electricity.

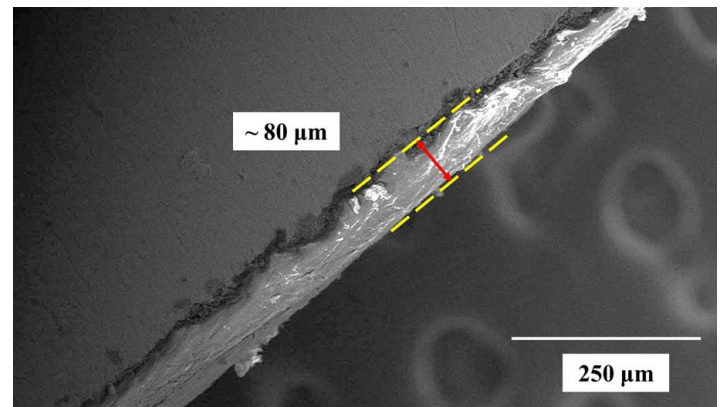
Figure 3: SEM image of substrate/coating interface showing the thickness of the coating.

Figure 3 shows SEM image of substrate/coating interface showing the thickness of the coating. The average thickness of the coating obtained was $\sim 80 \mu\text{m}$. On nearly all samples, there was a dark line that followed the substrate/coating interface. This line indicates that there was some separation between the polymer and the steel. This was likely a result of the polishing process. As the sample was moved back and forth on the abrasive surface, it could have pulled the coating away from the

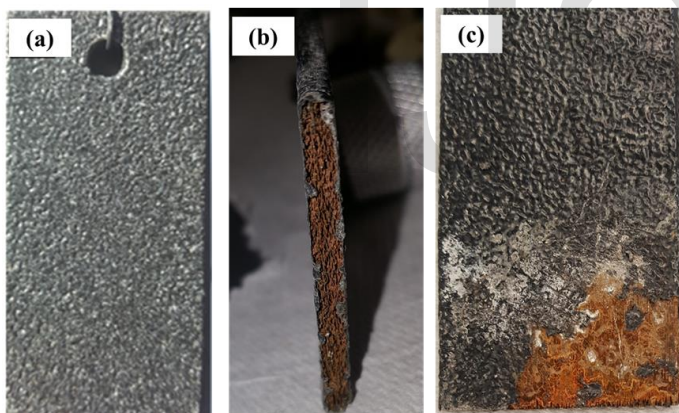
Figure 4: Photographic images of samples (a) before immersion, (b) after corrosion in acid solution - edge view, and (c) flat surface near the bottom end.

The visual observation found that the bubbles were formed as soon as the samples were immersed in the acid solution. The bubbles were concentrated around the corners and edges of the samples. This suggested that the coating may have had poor coverage at the sharp fillets. However, the bubbles appeared to be stagnant with no signs of vigorous reactions. The acid solution also discolored because of the formation of corrosion products. However, the corrosion reactions were not same as for all samples. Some specimens were coated very well and showed less corrosion compared to other samples. Figure 4 shows photographic images of samples; (a) before immersion, (b) after corrosion in acid solution - edge view, and (c) flat surface near the bottom end. It was evident that the steel had been corroded. This again confirmed that the coating was not sufficient at the sharp fillets of the steel and allowed the acid to penetrate behind the coating. This damage affected approximately up to 2 mm from the bottom of the sample.
