Geomorphologic Characterization of Dingalan Town Proper and Barangays in its Proximity: Implications for Infrastructure Development and Sustainable Land Usage

A Thesis submitted to the School of Civil, Environmental, and Geological Engineering
in partial fulfillment of the requirements for the Degree

Bachelor of Science in Geological Science and Engineering

Mapúa Institute of Technology

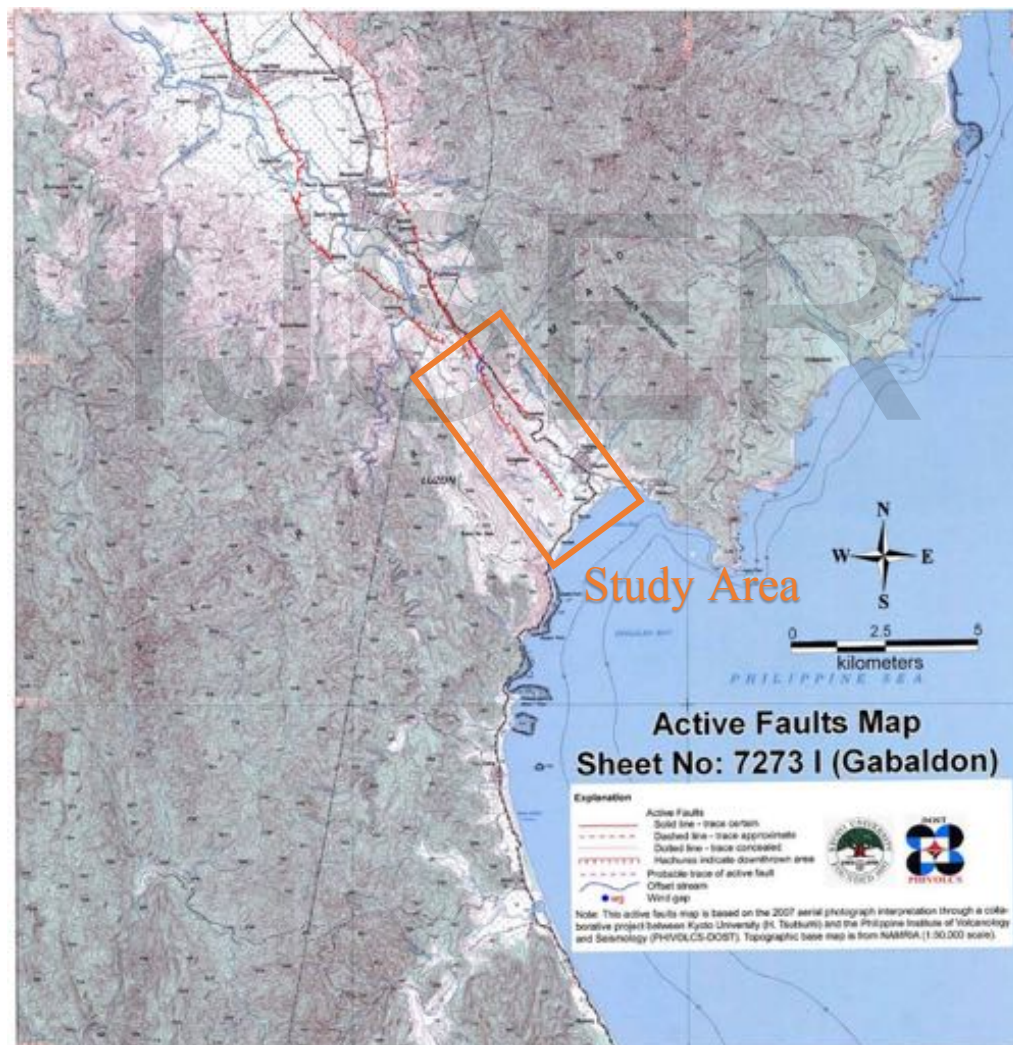
Figure 2.1 Active Faults Map of the Gabaldon Quadrangle. (source: PHIVOLCS)

Range, and only about 14% of its land area is flat (Lancion, 1995). The Gabaldon segment of the Philippine fault governs the structural aspect of the area (see Figure 2.1).

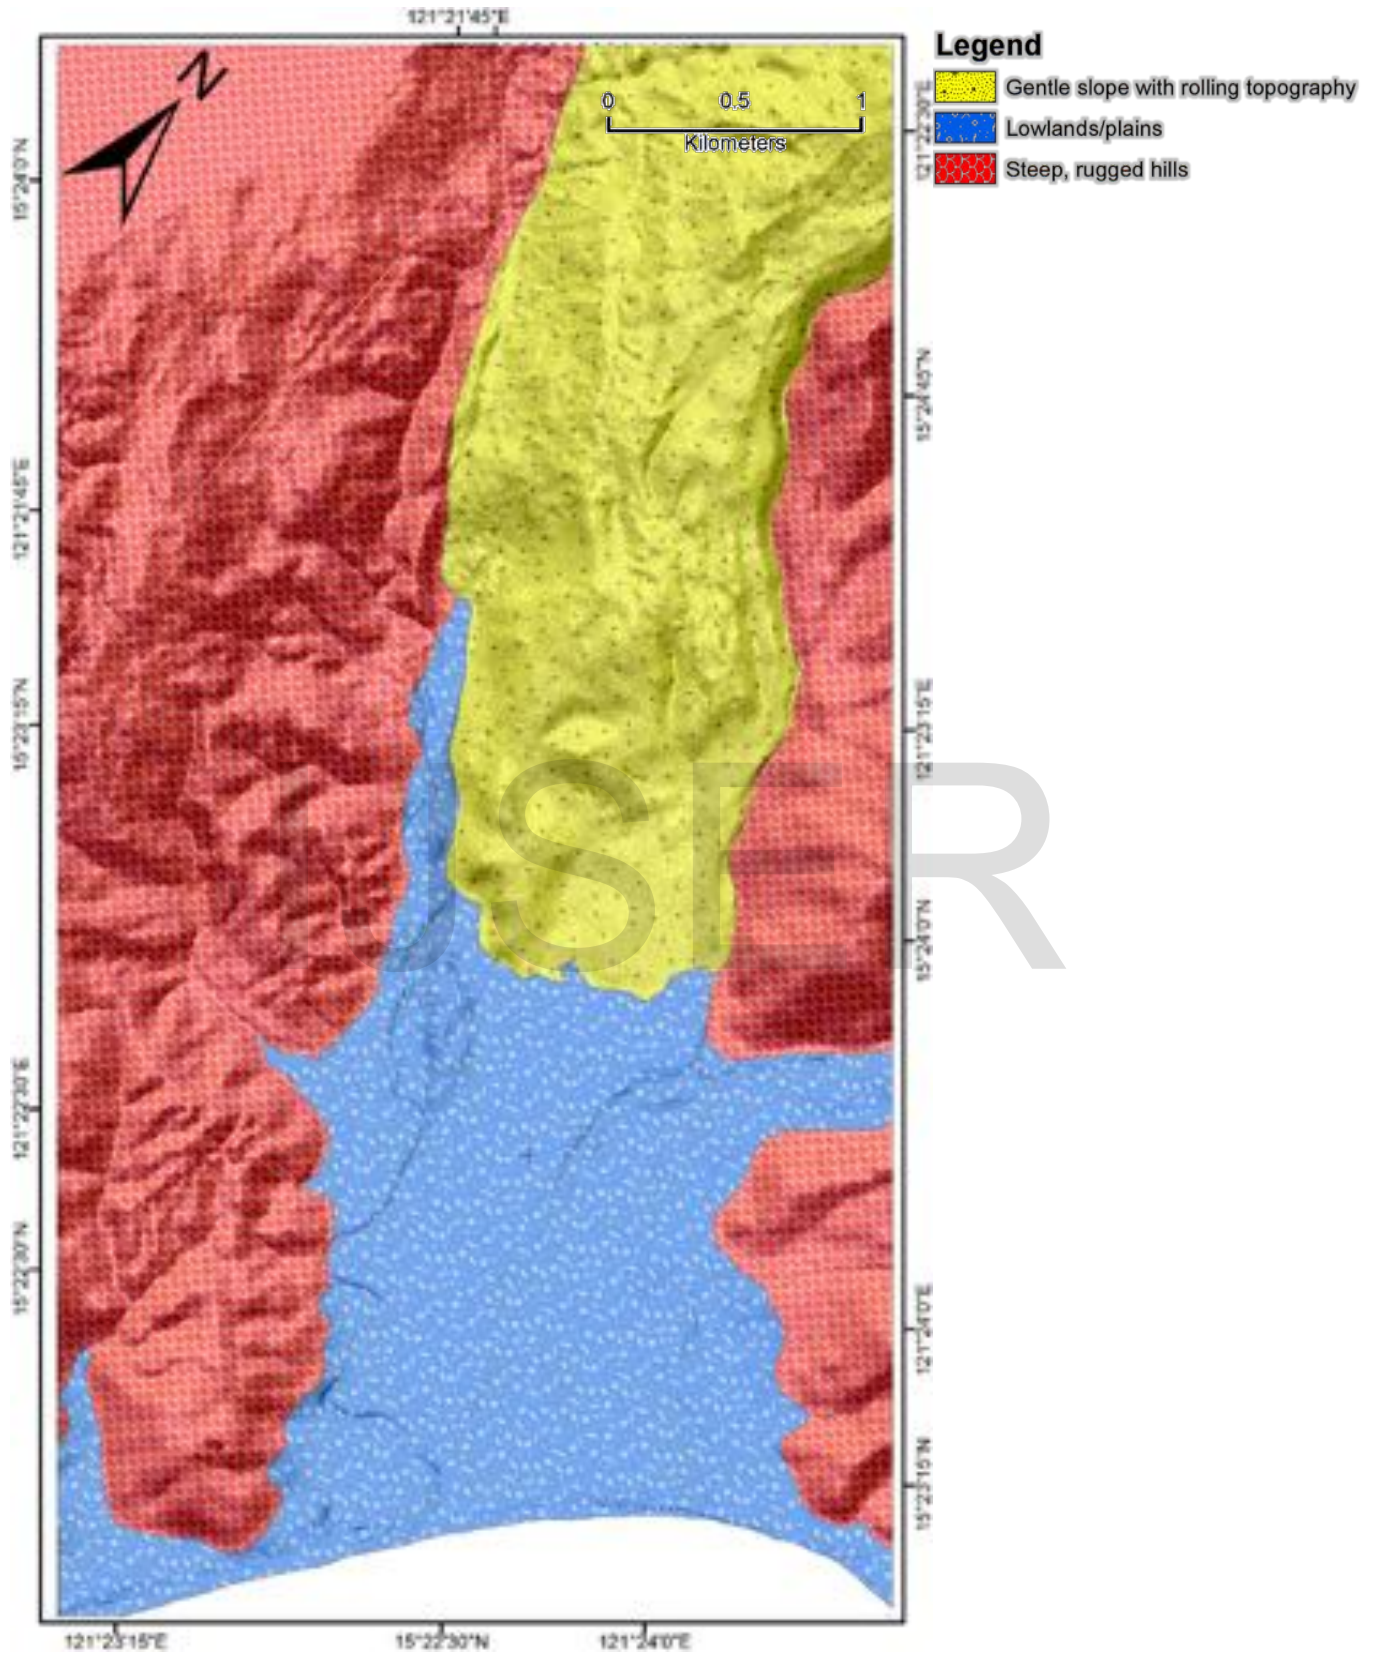
Figure 3.6 Map showing the three major physiographic regions in the coverage area.

Morphometric analyses (figure 3.7) permitted the categorization of the field of study into physiographic regions (figure 3.6). The area was classified into three domains, namely, lowlands/plains, gentle slopes with rolling topography, and steep, rugged hills. The low-lying plains are characterized by recumbent inclinations with elevations between 0 to 45 meters above mean sea level (AMSL). The region corresponds to the fluvial landform regime, showing parallel and sub-

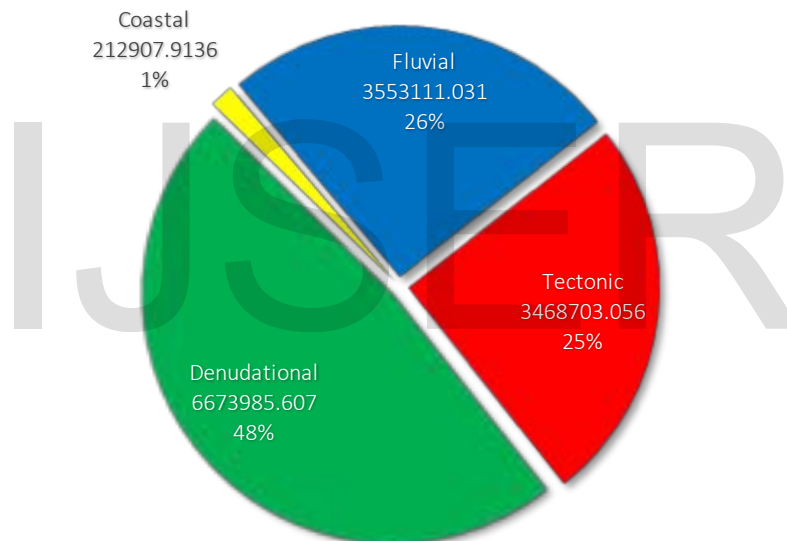
Figure 3.8 Statistical distribution of the geomorphic environments/classes in the study area.

Four geomorphic environments comprise the area of study. Categorically, these are coastal, fluvial, denudational, and tectonic landforms. From the calculated statistics (figure 3.8), denudational landforms are the most widespread, covering 48% or 6.68 sq. km. of the study area. Next are the fluvial landforms encompassing 26%, tectonic landforms at 25%, and the least are the coastal units at 1%. Table 3.2 enumerates the landform units under each group.

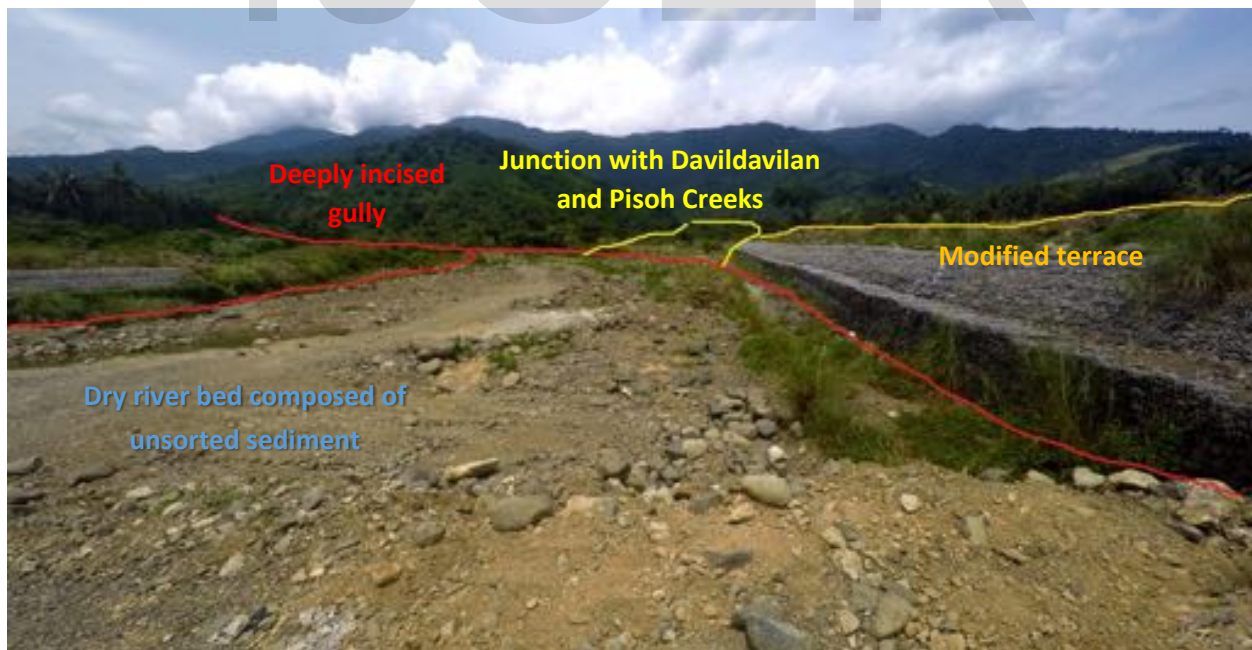
Figure 3.10 View upstream of the Langawan River with facing direction N35°E taken at 15.39° N, 121.39° E showing the dry river bed, location of the gully, and modified river terrace on the river banks.

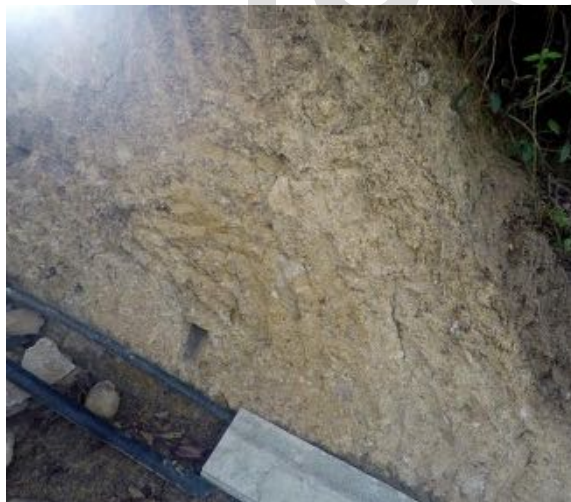
Figure 3.11 Road excavation portraying the lack of bedding and ill-sorted composition of the deposit near its crest. Taken at 15.41°N 121.37°E with a facing direction of N35°E.

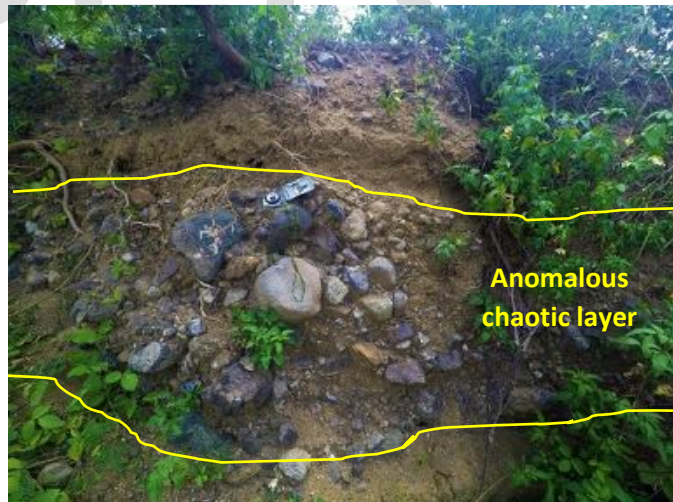
Figure 3.12 Cutbank showing a thick matrix-supported breccia layer unconformably overlaying on the defunct riverbank prior to the catastrophic mass movement. Taken at 15.39°N 121.38°E by the floodplain of Dingalan River.

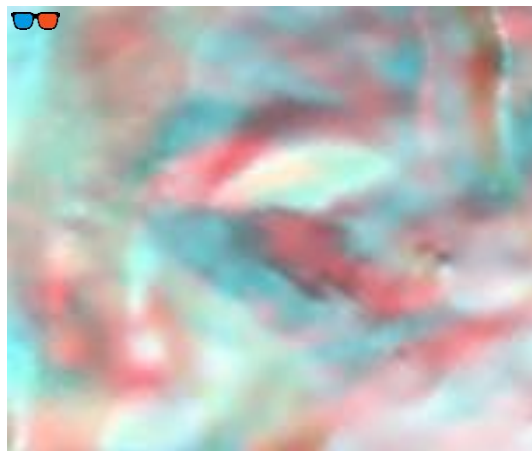
Figure 3.14 Oblique perspective anaglyph image of the relatively deeper rotational landslide with obscured extents due to erosion.

Contrary to these recent shallow landslides, a deeper rotational landslide is perceived in the DEM with a southeast slip direction, lodged above the debris avalanche deposit. A large, conspicuous scarp is observed, but the extents do not justify the exiled material, so a possible erosion of the landslide body has occurred. The anaglyph image of this feature is displayed in figure 3.14.

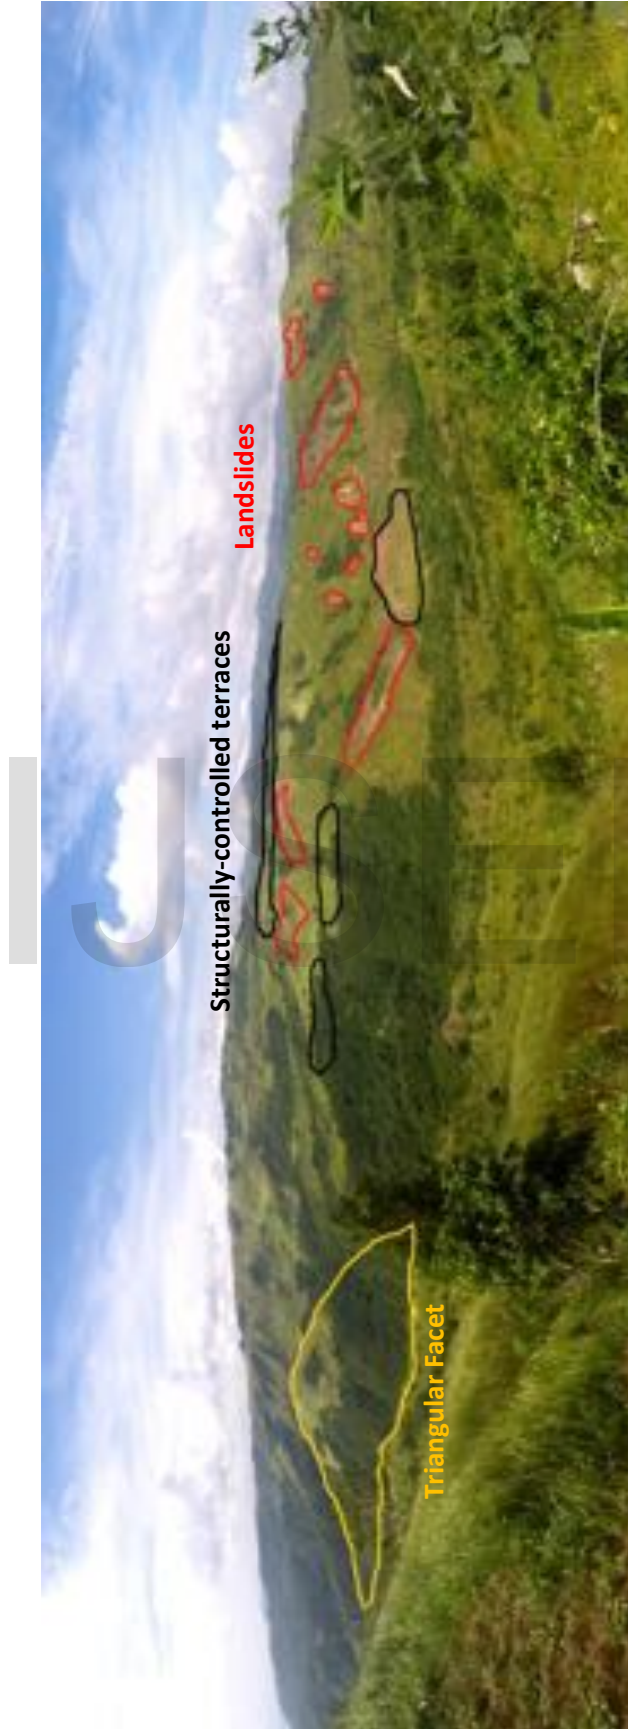
Figure 3.15 Panoramic view of the east facing slopes northwest of the study area showing the structurally controlled slopes, denudational slopes, landslides, pressure ridges, and triangular facet.

Multiple incipient shallow rotational landslides were observed to prevail in the structurally controlled slopes north of the covered sector. These features are newly formed, so they are absent in the aerial photographs and DEMs. Climate is the foremost instigator in the development of the sliding soil mass. Pronounced scarps, clear to subtle body extents, and widths not exceeding 60 meters are the general descriptive characteristics of the said features. Figure 3.15 shows the land failures atop the east facing structurally-controlled slopes.

The highly eroded denudational slopes with structural control are located on the opposite side of the floodplain in front of the aforesaid class. The PF map of Tsutsumi and Perez (2013), shows that the fault does not stretch to this sector, in consequence, structural control on these slopes pale in comparison to the adjoined slopes where tectonic influence is sharply established. Seismic indicators include pressure ridges and a well-defined triangular facet. However, erosion overwhelms seismic impact as copious stream networks dominate the slopes. Furthermore, peculiar tones of the aerial photos showing the lack of trees and eroded ridges assert the imperative denudational control. The leftmost part of figure 3.15, and figure 3.18 illustrates this slope form.

Prevalent structural control of the Gabaldon Fault is exemplified by numerous pressure ridges on the elevated areas northwest of the field of study. Though most are eroded, the striking linearity of these features remained perceptible. These ridges collectively influenced the sag ponds and replacement seismic attributes to the larger terraces in the slopes, as well as the drainage pattern of the sloping region. The ridges trend NW-SE parallel to the fault trace was seen during the aerial photo interpretation. These features are present in figure 3.15 above, while another example was presented in figure 3.26 above.

morphology albeit maintaining substantial information on its predecessor. Similarly, the entire slope exhibited structural features and landforms. The relief shift from undulating to rugged, occurring by the sag pond, further exemplifies the significant tectonic alteration in this slope. Based on its rolling and undulating topography, it can be presumed that the soil cover have higher porosity and less consolidation in comparison to the adjacent slopes with minor structural influence. The number of land failures alone, promote the inferior pedology in the area. This can be viewed in the rightmost area of figure 3.15 above, while figure 3.28 below presents the three dimensional appearance of this morphologic feature.

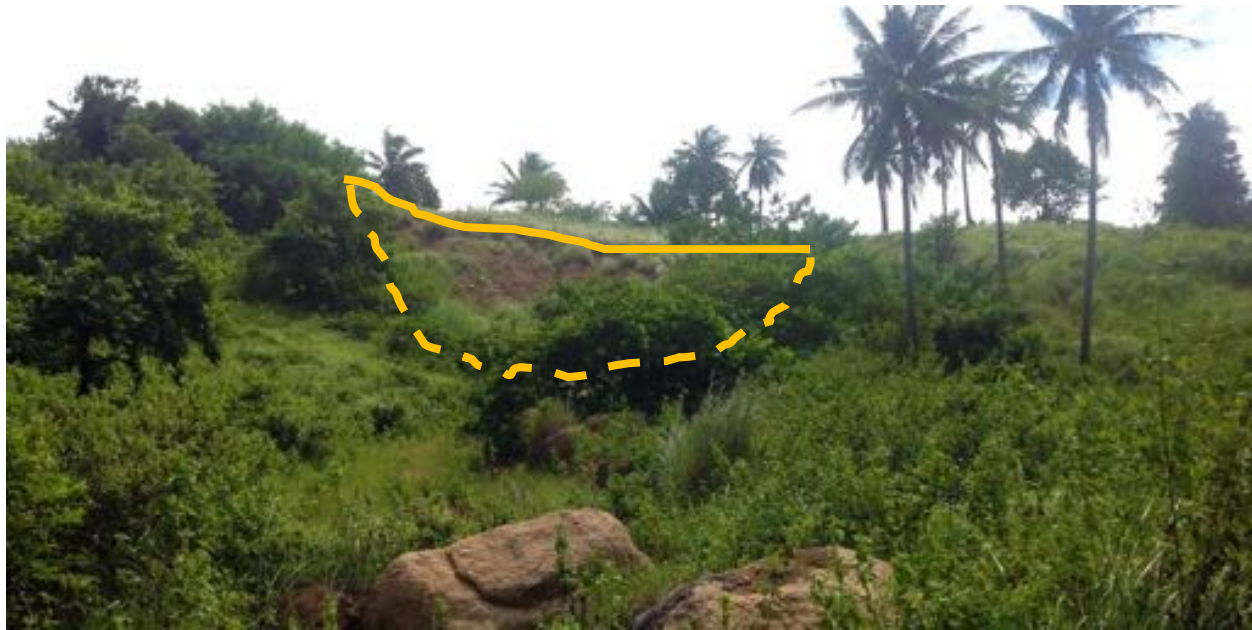
Figure 3.16 View looking north, taken at 15.41°N 121.37°E, showing the perceptible scarp and crest of a landslide but has a concealed body due to thick vegetation.

Figure 3.16 displays another landslide scarp and crest upon the debris avalanche deposits with a secluded body as a result of the dense grasses and shrubs. Lateritic soils comprise the feature with a slip direction of west. Inference regarding the seismic nature of the unit can be argued because of the likelihood of an existing fault scarp, but undetected during the delineation due to the overprinting nascent smaller debris slide over the debris avalanche deposit.

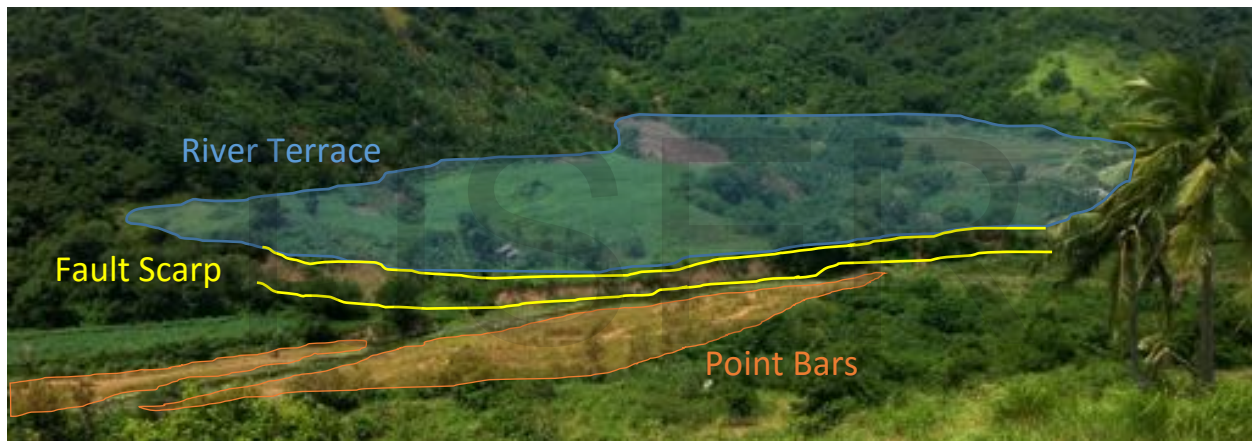
Figure 3.19 View looking southeast taken at 15.41°N 121.38°E showing the valley bottom illustrating the elongated east-dipping fault scarp on the river terrace as well as the point bar deposits of the Dingalan River.

Several fault scarps are readily detectable on the aerial photographs and DEMs. Existing dense flora, however, obliterated and hindered the field observation of some of these features. Contrarily, east facing scarps positioned by the valley floor were seen in the field, but not in the remotely sensed data. This scarp was observed cutting the earlier formed river terrace of the Dingalan River. An example of which is displayed in figure 3.19.

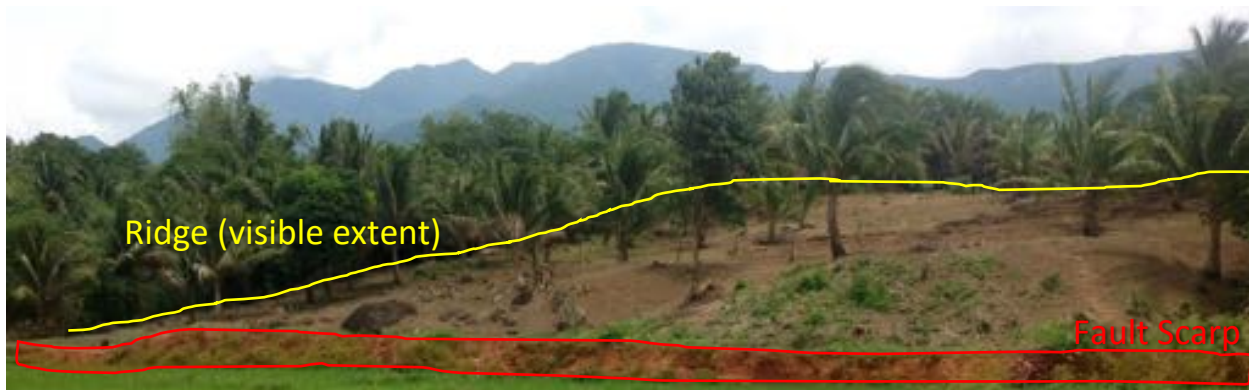
Figure 3.21 View looking northwest taken at 15.40°N 121.8°E illustrating the fault scarp and visible extent of the offset ridge situated near the active channel of the Dingalan River.

Two NW-SE trending offset ridges were recognized from the remotely sensed data. Lithologically, both are composed of igneous rocks of the Caraballo Formation. Subdued edges denote that these isolated bodies have undergone subsequent erosion following its detachment. At present, the two are surrounded with alluvial deposits, confirming the ubiquitous fluvial control on the morphology. Regardless of the abrasive forces, the features still have pronounced west-dipping fault scarps, signifying the intrinsic resistive strength of its constituent materials. Upon the field visit, glaring evidences of the anthropogenic disturbance on these ridges are present. Residents built homes and tilled the soil cover for crops on top of the ridges. Figure 3.21 depicts the scarp as well as the modified state of these units and figure 3.22 illustrates their overview form.

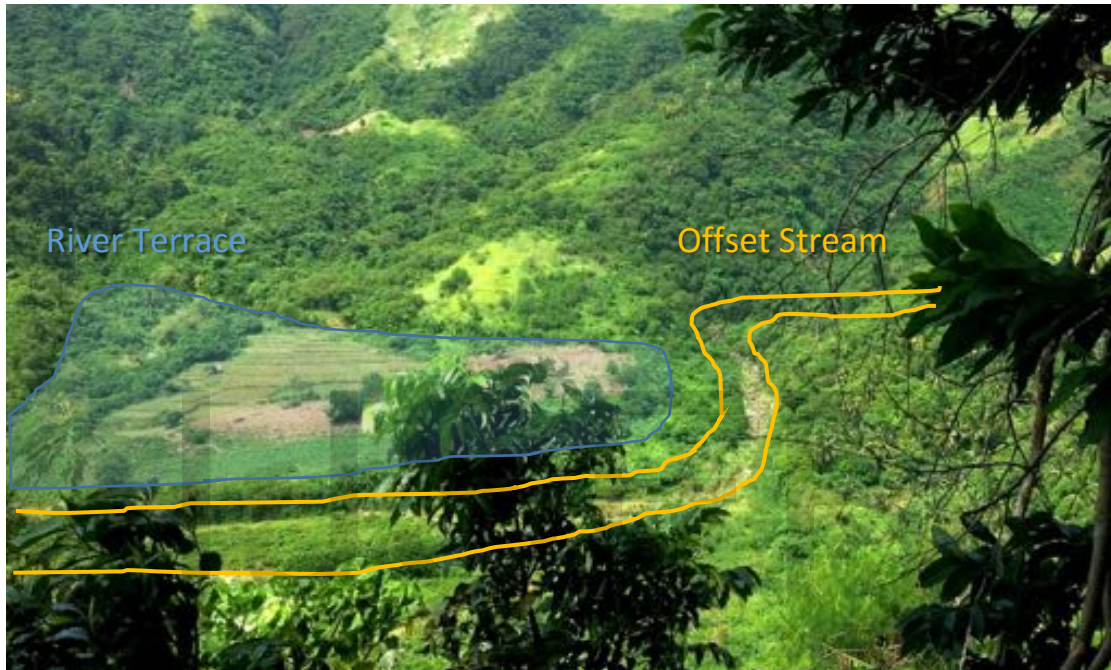
Figure 3.23 First offset stream and a river terrace situated by the footslopes northwest of the study area looking S62°W taken at 15.40°N 121.38°E.

point. As multiple migrations had undeniably occurred on the streams and rivers, this third offset was not extant in the DEM. The disconnected stream had already reassociated considering the difference in dataset age. Figure 3.23 shows the remarkable sinistral first offset stream, figure 3.22 above displayed the second offset stream, while figure 3.24 illustrates the third offset stream from the anaglyph aerial photos.

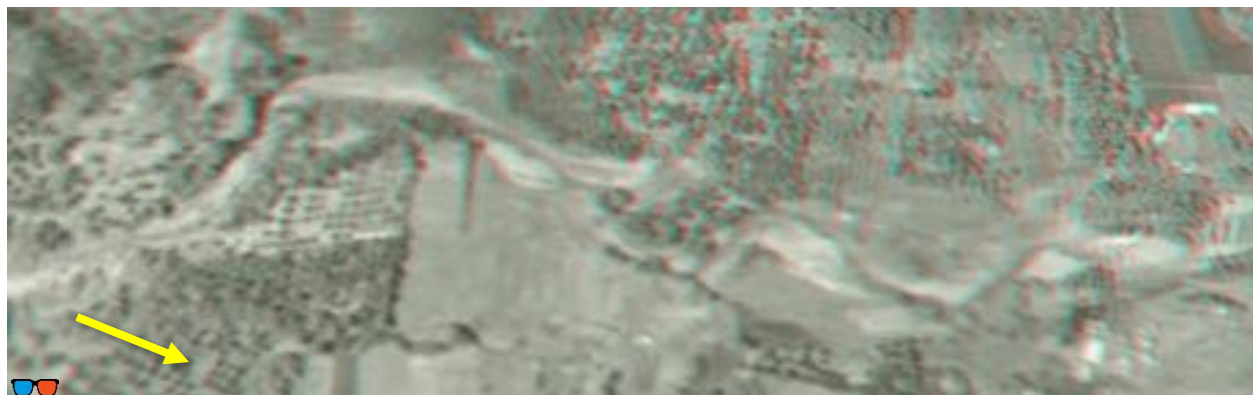
Figure 3.24 Oblique viewpoint taken from the anaglyph aerial imagery depicting the bizarre offset stream nearest to the coastline, which have reconnected by the time of production of the IfSAR DEM. Yellow pointer denotes north direction.

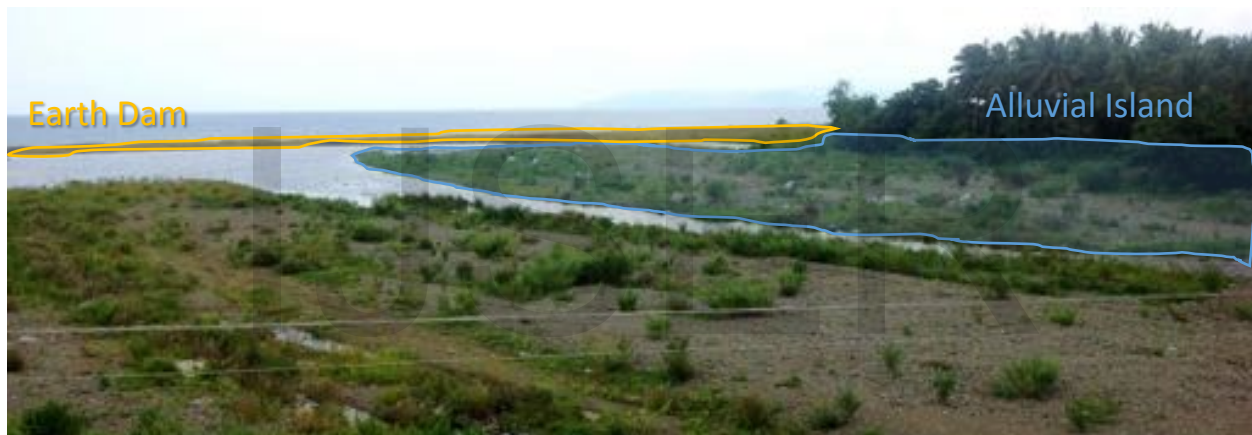
Figure 3.29 View looking S18°W taken at 15.28°N, 121.39°E showing the alluvial islands, active course of Dingalan River, and non-engineered earth dam composed of clay to fine sand materials.

inner bends, the islands expanded and widened until plant growth commenced, providing organic anchorage to the deposited islands. However, the biologic veneer was sparse and limited to grasses. In relation to engineering, this does not improve the intrinsic strength of the islands since they are composed of fundamentally cohesionless sediments, allowing for larger settlements to occur and increasing the susceptibility to liquefaction. These landforms are distributed on the barangays Butas na Bato, Aplaya, Poblacion, and Caragsacan. Figure 3.29 below displays the largest of these islands situated nearest the coastline while figure 3.30 shows the anaglyphic overview of all the delineated alluvial islands in the study area.

Aerial images showed the existence of two deltas in the study area produced by the Langawan River and its confluent streams, and the other, created by Subsob River. Waves instantaneously wash away the sediments deposited by the river, and for this reason, the deltas do not have a specialized structure, albeit they simply followed the concavity of the coast. Upon the field visit, the presence of a non-engineered earthfill dam built to deter the flow of the Dingalan River was duly noted (see figures 3.29 and 3.36). The obfuscated water flow, by virtue of gravity,

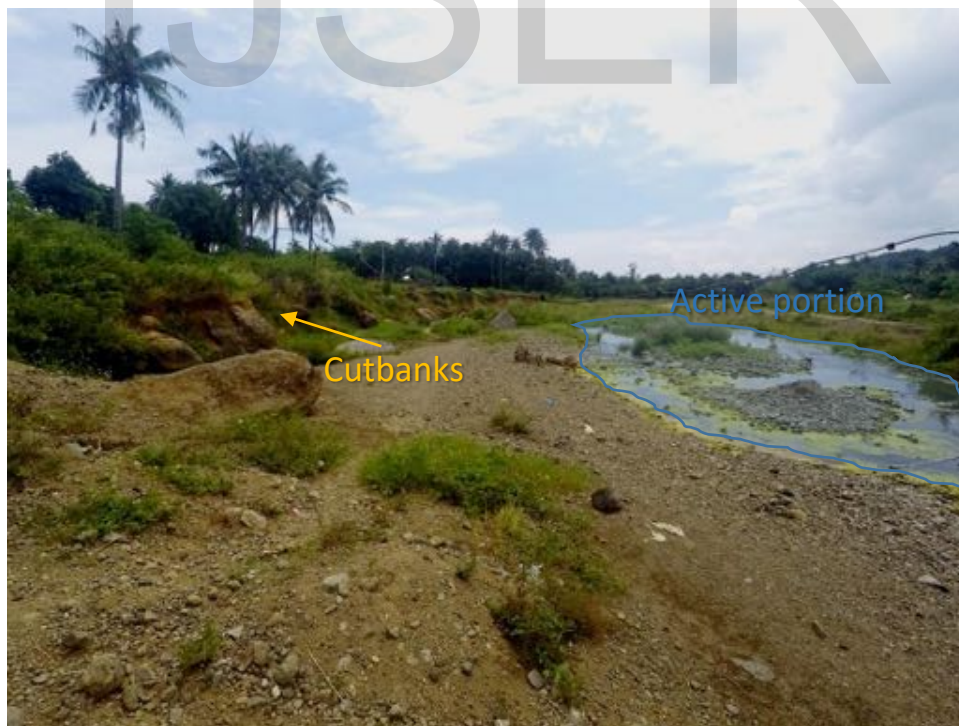
Figure 3.34 View looking S43°E taken at 15.39°N, 121.38°E illustrating the dry portions of the Dingalan River, unsorted coarse bed material, and boulders by its cutbanks.

Other streams present in the coverage area were observed to be dry, and have high freeboards. These streams can geomorphologically be called wadis. Similar to Dingalan River, this gives a qualitative estimation of the flow parameters. Riverine flooding has little to no chance of occurring, though heightened susceptibility to flash flooding is to be anticipated. Figures 3.33, 3.34, and 3.35 show the cutbanks, point bars, and the channel of Dingalan River and Amil Creek, respectively. Langawan River was already displayed in figure 3.10 above.

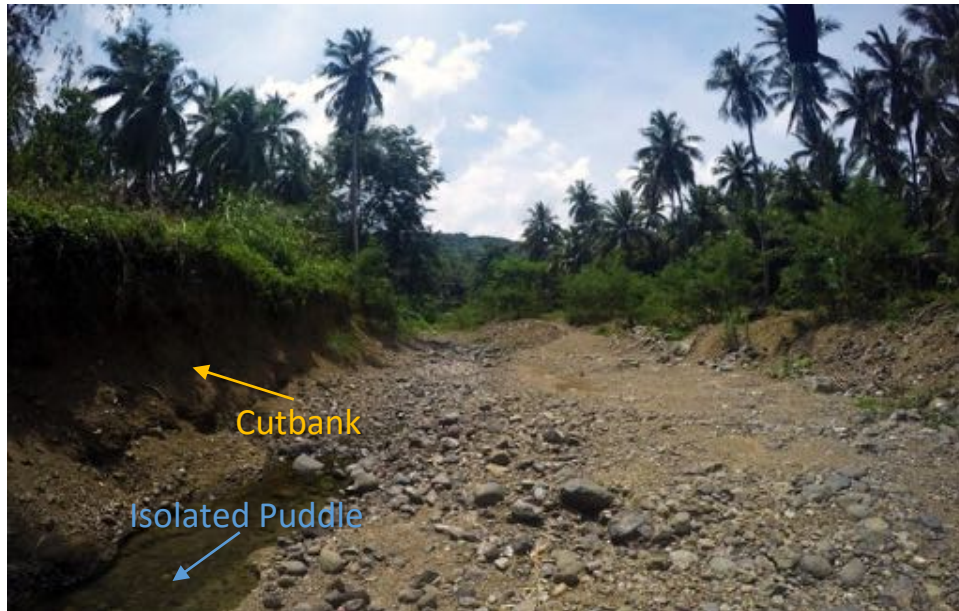
Figure 3.35 View looking N43°W taken at approx. 15.39°N, 121.38°E denoting the cutbanks, isolated puddle, coarse bed material, and presently inactive channel of the Amil Creek.

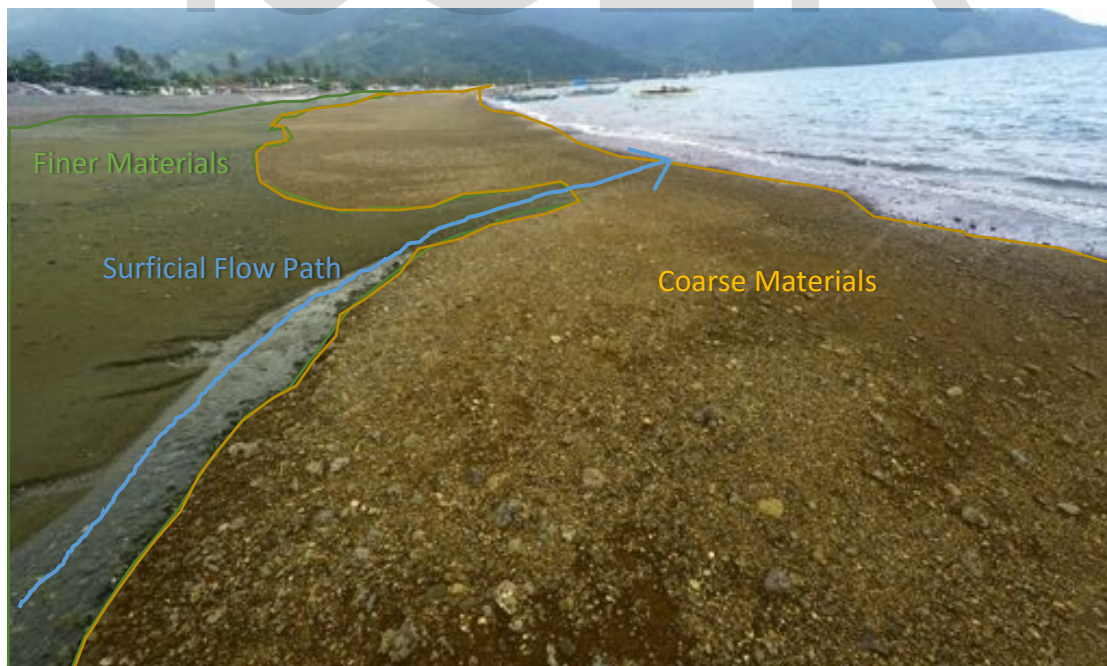
Figure 3.37 View looking E taken at 15.38°N, 121.39°E illustrating the point where fluvial water concatenates with the marine environment, including the flow path, and the difference in beach materials.

probed for alternate routes. Further investigation showed that the water infiltrated the underlying strata, and resurfaced at about 75 meters away from the dam before withdrawing to the sea. Figures 3.36 and 3.37 demonstrate the existing status of the delta.

The beach is in direct contact with the ocean, thus, it receives and accommodates most of the wave energy. The rigorous waves prohibit the development of substantial landforms beyond the terrestrial region. The difference in beach composition is distinct (see figure 3.37 above), with the coarser fraction tend to remain in the beach face and swash zone nearest to the coastline. Finer portions accrue farther away to the berm, at about 3 meters away from the coastline. This phenomenon can be attributed to the waves eroding and washing away the fine material.

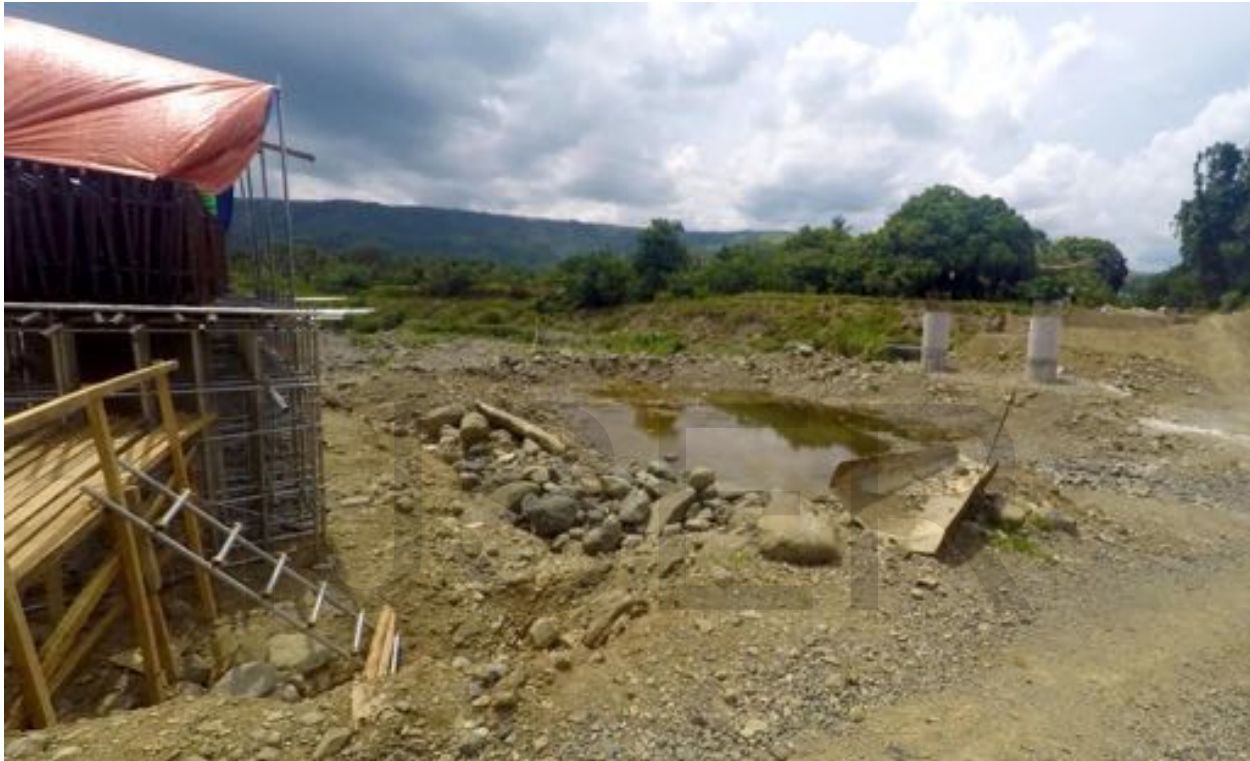
physical mitigation measures cannot be executed due to budgetary constraints. Along related lines, the currently being constructed Langawan Bridge made use of bank heightening to abide by the flood height clearance requirement of the DPWH. Gabions, on the other hand, are applied as cheap and flexible revetment. Figure 3.10 above showcases the gabions, while figure 3.43 demonstrates the bank heightening for the bridge's construction.

Figure 3.43 View looking S35°W taken at 15.39° N, 121.39° E showing the artificial bed excavation for bank heightening purposes in the Langawan River.
