Managing of tailing's stability against earthquakes impact

prof. ass.dr. Kemajl Zeqiri

Key words— tailing, stability, management, environment, mining, industry, failure.

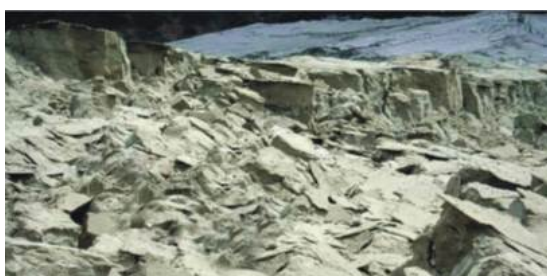
Figure 5. Upstream slope deformations of retaining dyke caused by settling of underlying slimes

The failure mechanisms in tailings sand dams constructed using upstream and centreline methods usually develop sliding-wedge type failure surfaces.
