Investigation of Vertical Column Discontinuity in Reinforced Concrete Buildings

Ceyhun Aksoylu, Oğuzhan Öztürk, İbrahim Hakkı Erkan, Musa Hakan Arslan

Index Terms— Earthquake, reinforced concrete, vertical irregularity, regulation, damage

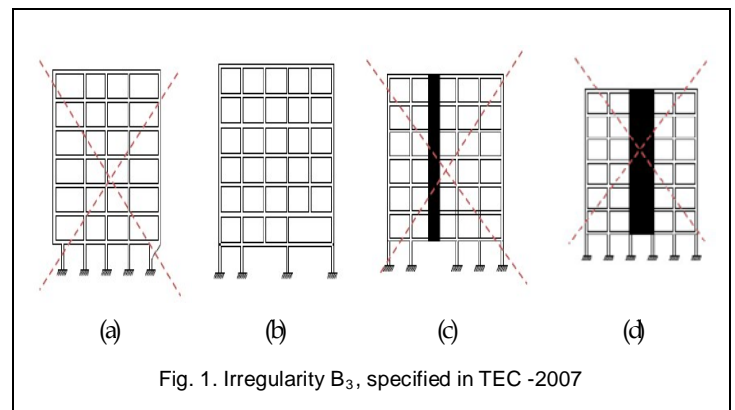
Fig. 1. Irregularity B₃, specified in TEC -2007

The TEC-2007 [10] regulation defines the discontinuity of vertical elements and details the removal of the vertical elements (columns and partitions) on some floors, explaining that they should be placed on or to the beams or thickened edge columns, or laying out the placement of the partitions in the upper floor onto the columns in the lower floor (Figure 1). In the figures below, cases a, c, and d are also

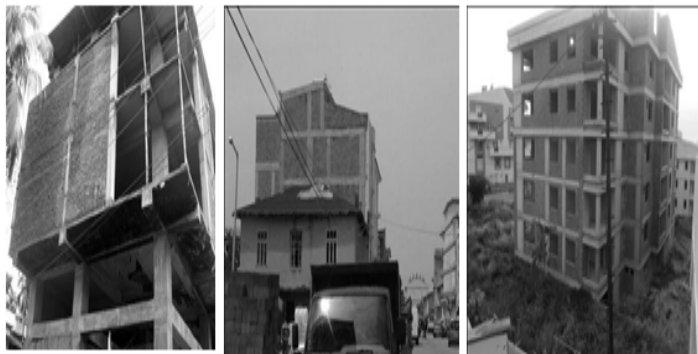
Fig. 2. Some reinforced concrete buildings having the vertical discontinuity

In Turkey as well as many other countries, reinforced concrete structures that have vertical discontinuity, despite the prohibition or heavy regulations against this irregularity in the codes, were built and continue to be built for architectural-related reasons and surveying purposes, such as to obtain large openings, especially on ground floor levels. In Figure 2, some examples of reinforced concrete buildings are shown.

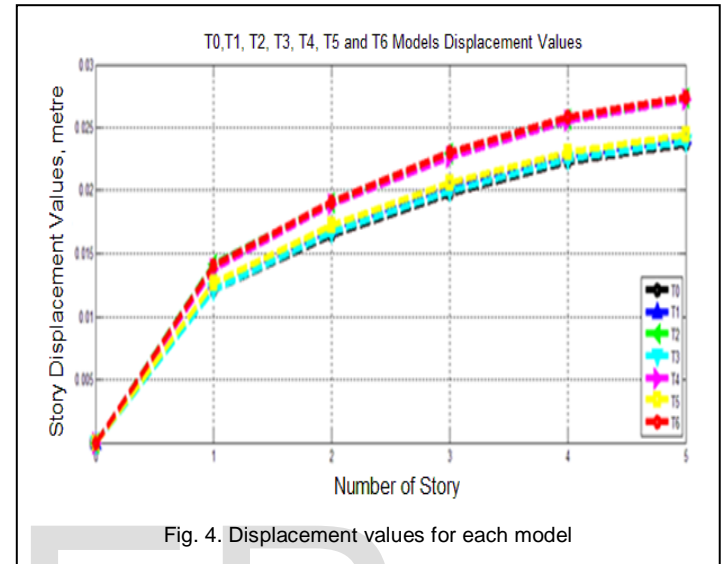
Fig. 4. Displacement values for each model

In table 6, the first mode period of each frame is given. Depending on the periods, the values of displacement also vary. The floor displacement values corresponding to each floor are shown in Figure 4. As clearly seen in Figure 4, in terms of the displacement values according to the reference structure (T₀), Model T₆ makes the maximum displacement, while Model T₃ makes minimum displacement. This situation can also be recognized from the values of mode period given in Table 6, where it shows that a structure whose period is low makes less displacement.

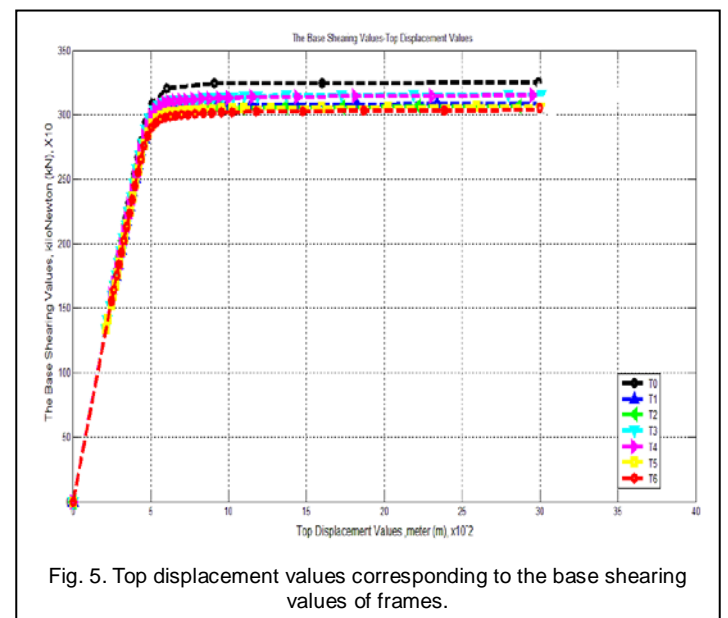
Fig. 5. Top displacement values corresponding to the base shearing values of frames.

To see the change that occurs in the capacity to bear lateral load according to the pushover analysis carried out, the top displacement of each frame – the graph of base shearing force – is shown in Figure 5. In this graph, the value of base shearing force for T₀ is 308.50 ton, while for T₆, it is 290.09; thus, in the base shearing force, there is a decrease of 5.96%.
